6th International Building Physics Conference, IBPC 2015

Deterioration of the wall of a historic stone building in a cold region and measures to protect it

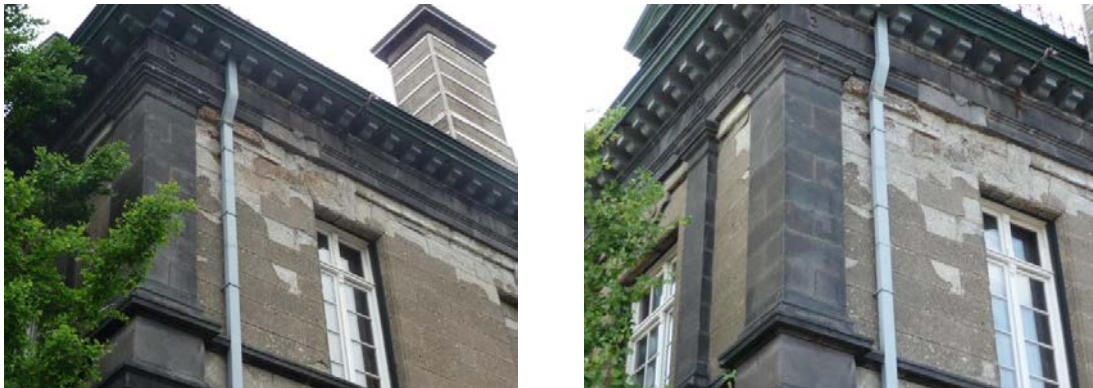
Fig. 2 shows the deteriorated condition of the walls facing north and east. The left photo was taken in June 2009 and the right photo was taken in October 2011. The white parts are places where the surface stone had peeled off or fallen. These pictures show that the surface area of the deteriorated parts rapidly increased in about 2 years.

Fig. 2 Deterioration of stone wall surface (left: June 2009, right: October 2011)

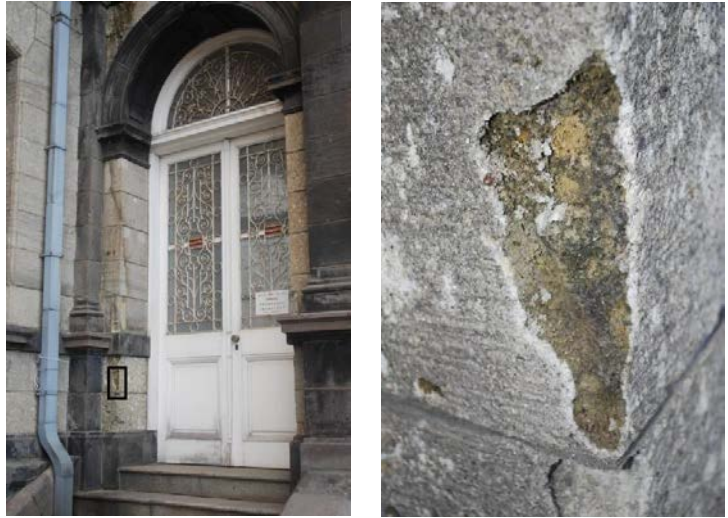
Fig. 3 shows the deterioration of the surface stone on the lower part of the column near the entrance. The right photo is an enlarged image of this part. The white part near the surface is where water repellent material penetrated, and the black part shows where it did not. On the surface of the upper part of this column, the trace of water fall is found. Water may penetrate into the stone through this deteriorated part, and the deterioration will continue due to the freeze and thaw cycles in the winter season [2].

Fig. 3 Deterioration of stone wall surface (right: enlarged image)

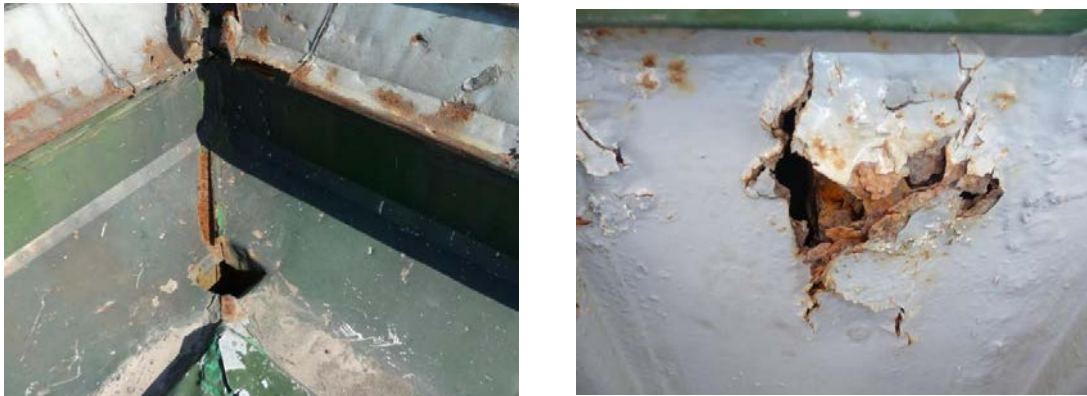
On the whole part of the roof, abrasion due to the movement of snow and ice in winter was found. Corrosion of the metal roof was also found. This could be due to the sea breeze which contains salts from sea water.

Fig. 4 shows the deterioration of the roof. The left photo shows the corrosion of metal near the junction between the roof and the gutter on the west side of the building. In winter, snow accumulates on this area, and melt water may leak through this part into the inside roof. The right photo shows the damage to a 45 x 60 cm area on the east side of the roof. When this part was observed on a rainy day, it was found that rain flew down from the damaged part. This is considered to be the source of the water that increases the water content of the stone of the side wall.

Fig. 4 Deterioration of the roof (left: corrosion of the metal at the junction of the roof and gutter; right: cracks in roof)

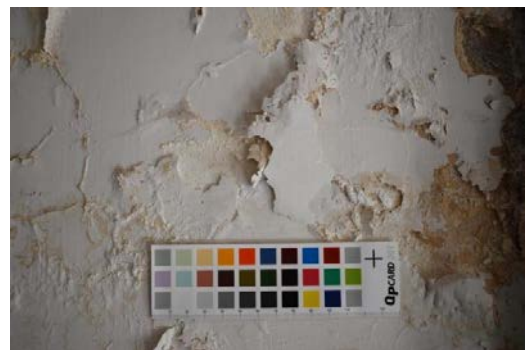
The inside wall and wall paper were damaged by the water that penetrated through the roof as shown in the previous section. This leakage occurs during typhoon season and during the winter. The most damage was found from the middle of February to the end of March when the snow on the roof melts. Fig. 5 shows the blistering of the lime plaster surface. Cracks were also observed to appear in the lime plaster surface of the wall. Wall paper known as *kinkarakawakami* also deteriorated due to the penetration of rain water through the roof. In addition, fungi were found on the wall surface and color changes were observed on the ceiling.

Fig. 5 Blistering of the lime plaster wall surface

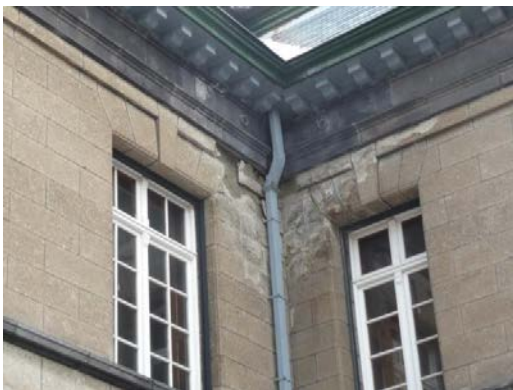
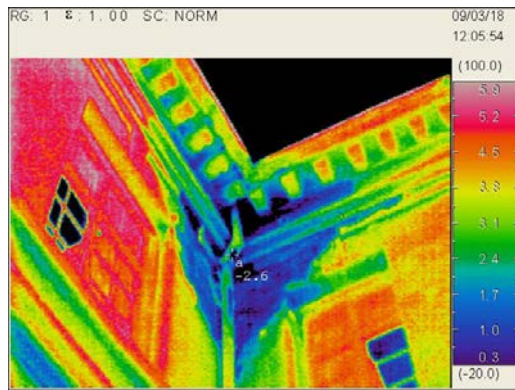
In addition to the temperature and humidity measurements, the temperature profile of the wall surface was measured using a thermo viewer in March, 2009. The left photo in Fig. 8 shows the deterioration of the wall near the gutter under the roof. The right photo shows the temperature profile of the wall. The color of the location near the gutter under the roof shows that the temperature is low in this region. This temperature profile also shows that the water content in this area is higher than the surrounding region due to rain water penetration.

Fig. 8 Deterioration of stone wall surface (left) and the corresponding thermovision image (right)

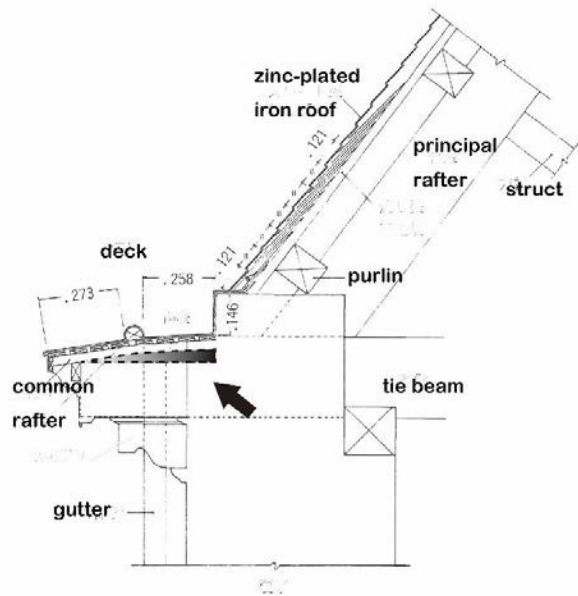
Fig. 9 Schematic diagram of a cross-section of the lower part of the roof.

Fig. 9 shows a schematic diagram of a cross-section of the lower part of the roof. As shown in the previous section, the damage to the roof and gutter is severe, and leakage of rain water through the roof occurred during rainy days and during the snow melt season. In the summer of 2010, Otaru city carried out temporary restoration work to cover the holes in the gutter. However, since this temporary restoration work was only done on limited areas, it was not a final solution to the problem of the leakage through the roof. In March 2011, the leaked rain water penetrated into rooms on the first floor. Some of the rain water and snow melt water that penetrated through the deck flows out from the eave ceiling, and the rest remains inside the deck and penetrates the stone walls, as indicated by the arrow in Fig. 9. It was considered that this leaked water penetrated into the stone wall. In winter, the surface stone was subjected to freeze and thaw cycles. Since the water content of the stone wall was high, ice lens segregated inside the stone wall, which resulted in severe damage to the surface stone wall [3]. We found cracks at the borders between places where water repellent material had penetrated and where it had not. This shows that the water repellent materials are not effective when water flows from inside of the stone wall.

The previous restoration was carried out about 30 years ago. In the restoration, water repellent materials were applied to the surface of the stone wall to prevent rain water penetration. However, as shown in the previous section, the rain water penetrated through the roof to the stone wall. In order to prevent this penetration of rain water, it is necessary to check the present condition of the roof and repair it and to increase the roof's water tightness. It has been reported that frost damage increases as the water content of the stone increases. Therefore, it is necessary to reduce the water content of the stone wall to prevent frost damage.
