Research on the Prevention and Control Technology of Low Oxygen in The Upper Corner of Fully Mechanized Coal Mining Face in Daliuta Coal Mine

Xipei Yang

National Energy Group Wuhai Energy Co., Ltd., Wuhai, Inner Mongolia, 016000, China

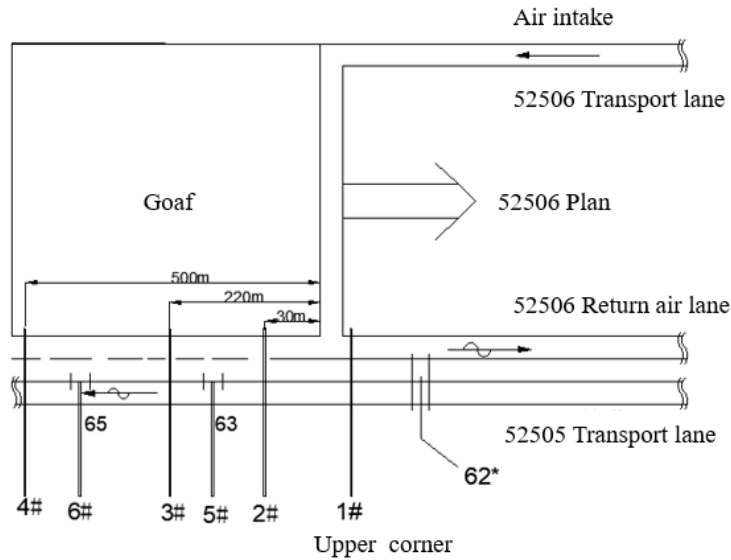
Figure 1. Layout of sampling points for the upper corner of the return air and goaf in the 52506 fully mechanized mining face

The phenomenon of low oxygen in the upper corner of the return air of the 52506 working face is the result of multiple factors working together, mainly including coal seam occurrence, spontaneous combustion characteristics, climatic conditions, goaf air leakage, working face layout, ventilation system, and working face footage [5-10]. Based on the above factors, this paper analyzes and studies the reasons for the low oxygen phenomenon in the 52506 fully mechanized working face of Daliuta Coal Mine. By conducting bundle tube sampling analysis on the upper corner of the return air and the gas in the goaf of the 52506 fully mechanized mining face, the sampling points are arranged as shown in Figure 1. The main components of low oxygen gases were analyzed using a gas chromatograph, and the results are shown in Table 1. Based on the analysis of on-site measured data, it is determined that the occurrence of low oxygen in the 52506 fully mechanized mining face is mainly due to the high concentration of N₂.

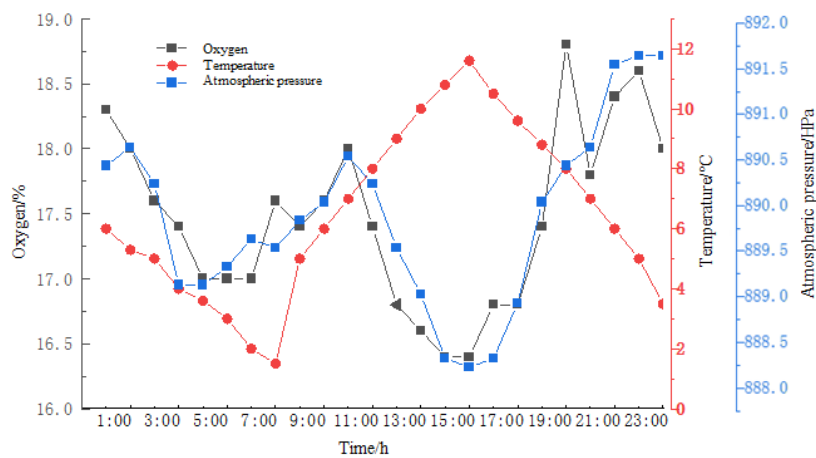
Figure 2. Changes in oxygen concentration at the upper corner of the return air in the 52506 fully mechanized mining face

According to the analysis in Figure 2, it can be seen that from 0:00 to 12:00, the range of oxygen volume fraction changes is 17% to 18.5%, showing an overall downward trend. During this period, atmospheric pressure shows a first decrease and then an increase trend, and the temperature first

decreases and then increases. From 12:00 to 16:00, the oxygen volume fraction gradually decreases and a phenomenon of low oxygen occurs, with the lowest oxygen volume fraction reaching 16.4%. At this stage, the atmospheric pressure decreases by 200Pa and the temperature

shows an upward trend. From 17:00 to 24:00, the oxygen volume fraction gradually increases, with a range of 16.8% to 18.6%. During this period, the temperature and atmospheric pressure showed an overall upward trend.

Based on the actual situation underground in Daliuta Coal Mine and the data analysis in Figure 2, the environmental temperature, atmospheric pressure, and low oxygen gas emission law of 52506 fully mechanized mining face are obtained. An increase in ambient temperature over a period of time can lead to a decrease in atmospheric pressure. Due to the correlation between the air supply of the 52506 fully mechanized mining face and the ground atmosphere, the pressure on the working face decreases accordingly, resulting in a pressure difference between the working face and the goaf, leading to the influx of low oxygen gas into the working face. The amount of low oxygen gas emitted is related to the pressure difference. When the static pressure is lower than the pressure in the goaf, the gas in the goaf is in an expanding state, presenting an output state similar to the sound of wind. As a result, low oxygen gas flows into the working face in the goaf, leading to low oxygen phenomenon in the upper corner of the return air of the working face.
