# Analysis and Recommendations on the Cause of Leakage Failure in CT90 Coiled Tubing

Wenbin Wu, Jianliang Duan and Runqiu Gao

SHINDA(TANGSHAN) CREATIVE OIL & GAS EQUIPMENT CO..LTD, Tangshan 063000, China

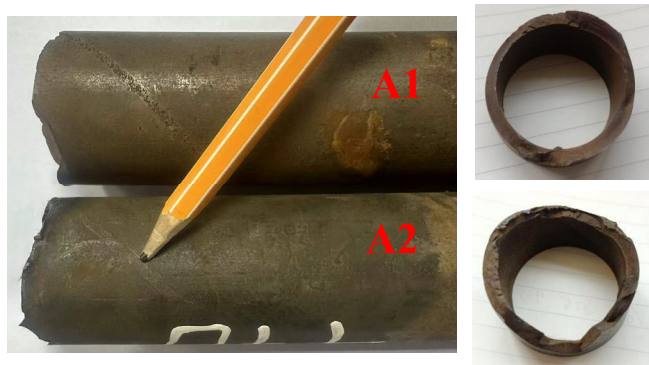
Figure 1. Sample information

The broken tubing was labeled as A1, while the remaining intact tubing was labeled as A2 for analysis. The overall macroscopic fracture morphology shows a brittle fracture with no significant plastic deformation[2], as shown in the figure 1.

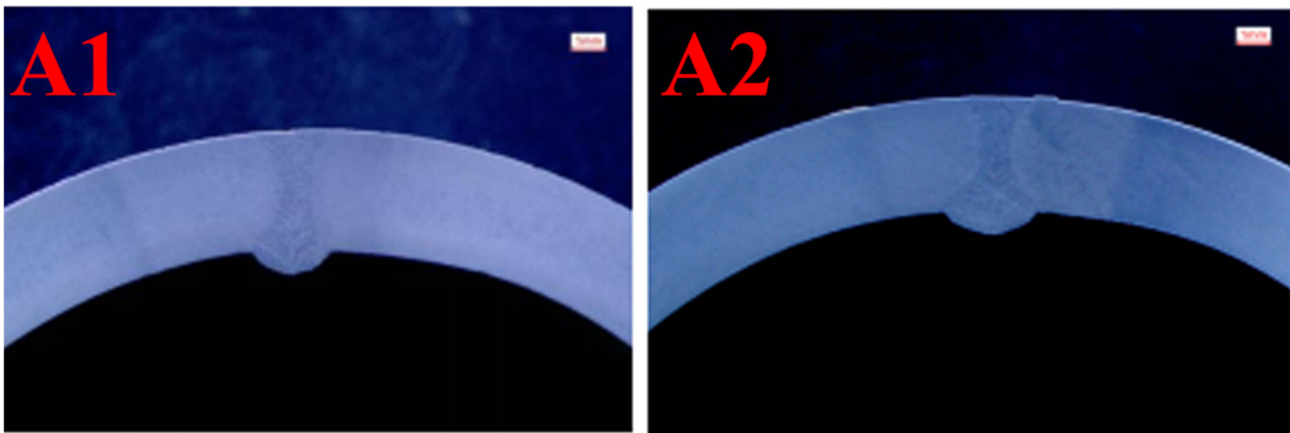
**Figure 2.** Macroscopic surface of metallographic corrosion 6.8X

indicate that the grain size of the samples meets the technical requirements. There was no significant microstructural difference between the weld and biased weld areas. However, pitting was observed on the tube, and the microstructure revealed clear gaps between the grains, which exhibit the typical microscopic morphology of hydrogen-induced cracking.[3]

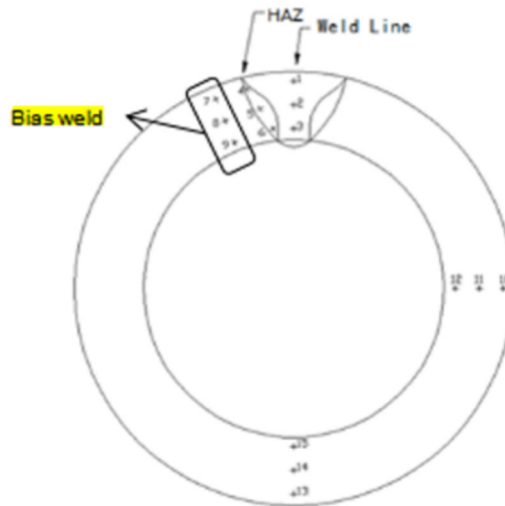
Figure 5. Through-wall Hardness Test Impression Location

standards, with hardness conversion performed as per ASTM E140-2012b (2019) e1. The hardness test positions on the original tube are shown in Figure 5[4], and the data are presented in Table 4. The results indicate that the hardness values meet the technical requirements, and the hardness is consistent across the tested areas.

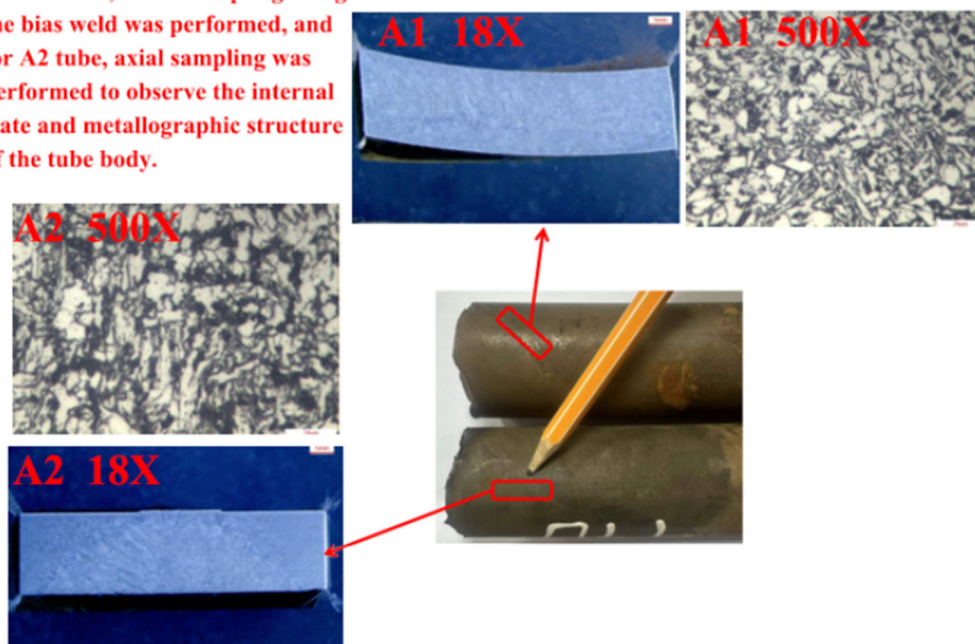
**Figure 6.** Metallographic analysis of bias weld

results are presented in Table 5. The findings indicate that the grain size of the sample meets the technical requirements and is similar to the metallographic structure of the tube cross-section. However, the microstructure reveals clear gaps between the grains, exhibiting the typical microscopic morphology of hydrogen-induced cracking.

For A1 tube, linear sampling along the bias weld was performed, and for A2 tube, axial sampling was performed to observe the internal state and metallographic structure of the tube body.

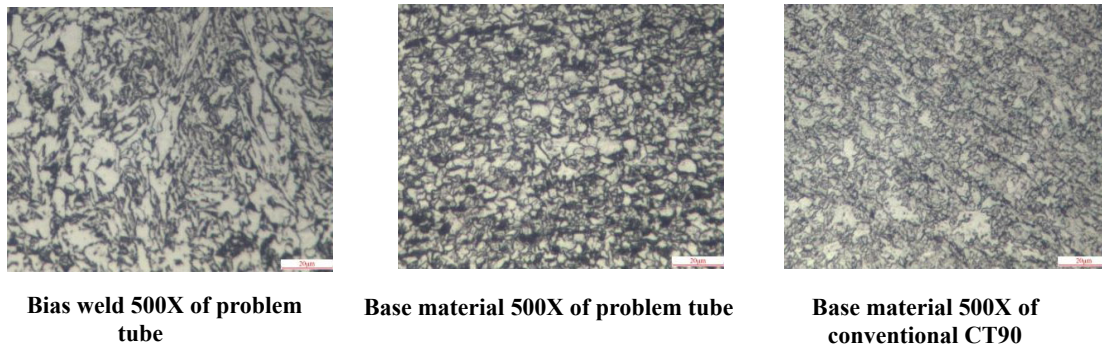
Figure 7. Comparison of microstructure of different samples

weld. However, the microstructure reveals clear gaps between the grains, indicative of hydrogen-induced cracking. The fracture of the tube can be attributed to the combined effects of HIC and SSC in the hydrogen sulfide well environment.[6]

Note: It can be observed that the grain gaps in both the biased weld and the base material microstructure are larger than those in conventional CT90. This suggests the possibility

that hydrogen atoms may accumulate in the grain interstitial spaces, causing these gaps to expand.

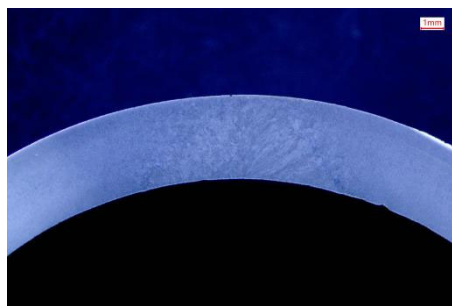
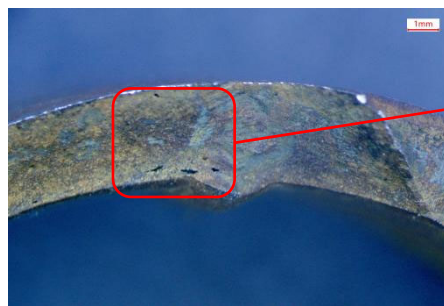
Figure 8. Macroscopic surface of metallographic corrosion 6.8X

Bias weld 18X of problem tube

Weld 18X of A2 problem tube

Note: It is observed that the grain gaps in both the biased weld and the base material microstructure are larger compared to conventional CT90. This indicates the possibility that hydrogen atoms may accumulate in the interstitial spaces between grains, causing these gaps to widen.
