Research on Anti-Leakage Measures for Fully Mechanized Mining Faces in Gently Inclined Thin Coal Seams

Bojie Pan

School of Safety Science and Engineering, Henan Polytechnic University, Jiaozuo 454000 Henan, China

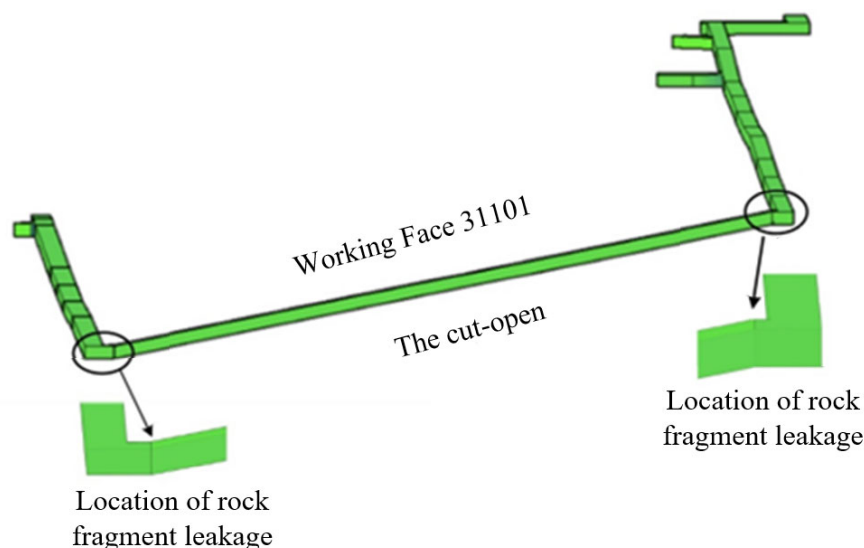
Figure 2. Schematic Diagram of Rock Fragment Leakage in the 31101 Working Face

The locations of rock fragment leakage in the 31101 working face are shown in Figure 2. The causes of leakage are analyzed as follows:

(1) Loss of Stress Balance Between Upper and Lower Strata: Before being disturbed by mining activities, the coal body is in a state of triaxial stress, with equal and opposite forces acting on it. As a result, the coal body and the surrounding rock strata remain relatively stable. However, as the longwall face advances, the integrity of the coal body is disrupted by the shearer, leaving the roof of the coal seam in a suspended state. Depending on the lithology of the roof and the conditions of the coal seam, varying degrees of roof displacement and failure occur.

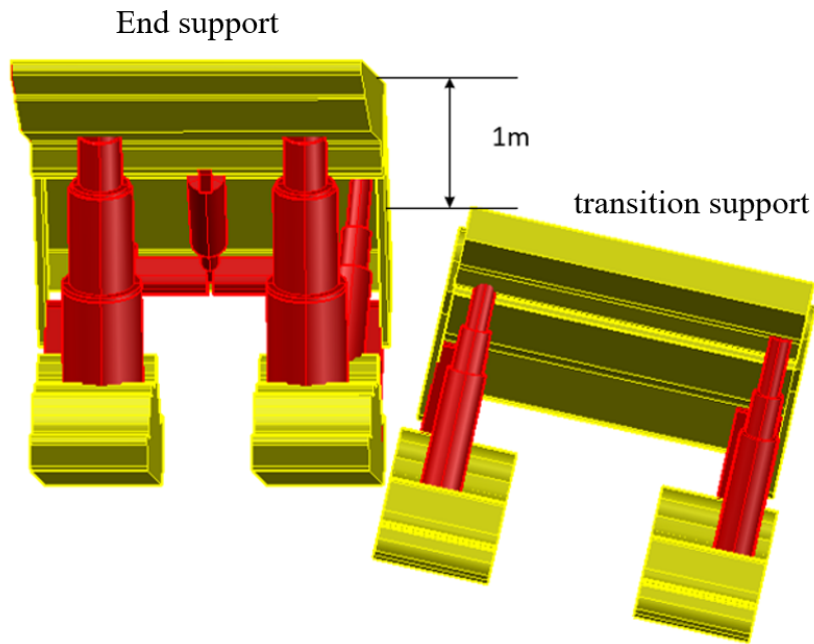
Figure 3. Schematic Diagram of Support Misalignment

(2) Misalignment of Hydraulic Supports: The ventilation roadway of the working face is excavated along the floor of the coal seam, with a height of 2.3 meters. There is a 1.0-

meter misalignment between the tail-end support and the transition support, as shown in Figure 3. During the advancement of the working face, this significant misalignment leads to severe roof leakage of rock fragments, hindering normal progress.

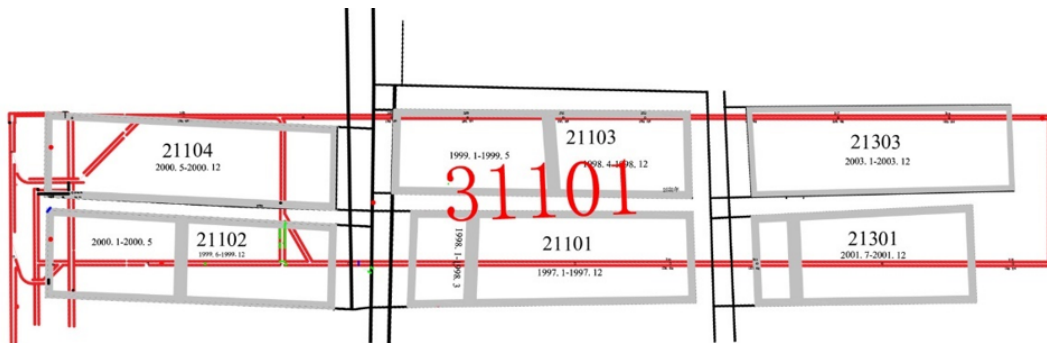
Figure 4. Stratigraphic Relationship Between the 31101 Working Face and the No. 2 Coal Seam

(3) Concentration of Pressure at the Tail End: The tail end of the 31101 working face is located near the coal pillar of the No. 2 coal seam, as shown in Figure 4. Analysis of mine pressure distribution indicates that the central rear section of the working face is a prominent pressure center, where the pressure is the highest. The pressure on other supports decreases radially from this central support.
