# A Study on the Feasibility of Merdeka Market Buildings in Terms of Earthquake Resistance and Structural Strength

The structural integrity of the Merdeka Market building in Bogor City is a matter of particular concern for the Indonesian government, given its age of approximately 25 years and the resulting structural deterioration. The purpose of this study is to assess the overall reliability of the building, its seismic vulnerability, and structural safety, in order to provide effective recommendations for improving the building's performance, in terms of its architectural quality, stability, utility systems and accessibility. Data are collected through physical observations and non-destructive test, such as the Hammer test and Ultrasonic Pulse Velocity (UPV) test. The compressive strength of concrete is calculated and compared to the technical requirements. The seismic resistance is determined through simulation, using a 3D model of the building. The Rapid Visual Screening (RVS) test provides the vulnerability score of the structure. The results of the various tests determine the overall reliability of the Merdeka Market building.

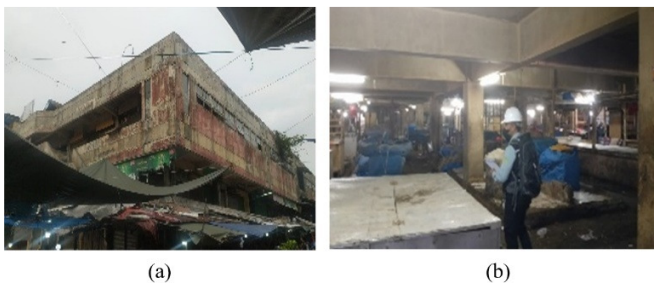
principles of safety, health, comfort, and convenience. The Merdeka Market building (Figure 1) entered its 25th year and is still operating as a place for the trade of vehicle spare parts, serving the needs of the surrounding community. However, it is considered suboptimal in terms of reliability. Its structural elements have deteriorated due to the exposure to humidity, a damaged drainage system and overgrown vegetation on the roof, all of which are results of inadequate maintenance. The reliability of the building will be assessed based on whether it meets the minimum requirements for structural concrete [3]. The seismic design and the applied loads will be taken into consideration, based on previous studies [4, 5].

Fig. 1. External (a) and internal (b) view of the Merdeka Market building.

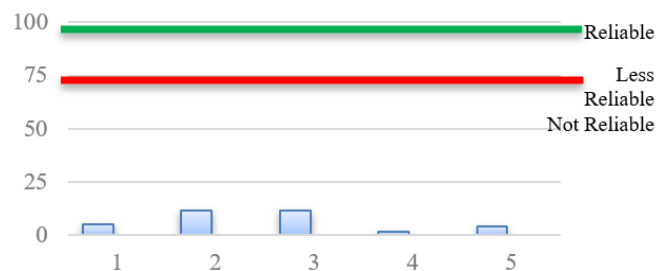
Fig. 4. Reliability graph of Merdeka Market building.

The reliability assessment result for the building marked it as "Unreliable," with a percentage of 33.37%, as displayed in Table V.

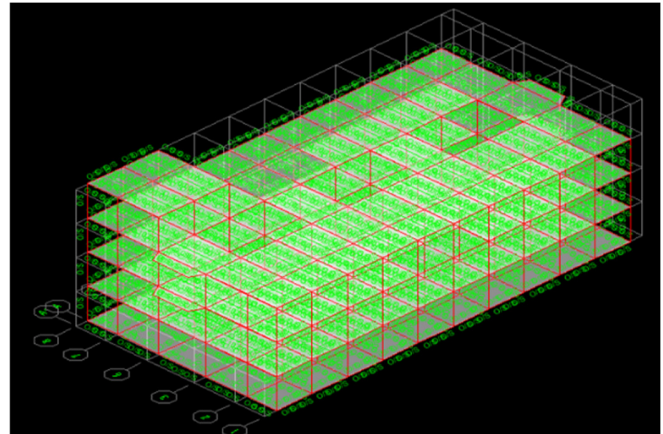
Fig. 5. Building structure model

The results of the modeling analysis (Figure 5) determined that the building is unsafe against the external forces, with the structural elements experiencing overstrength.

Therefore, the building should be demolished and rebuilt.

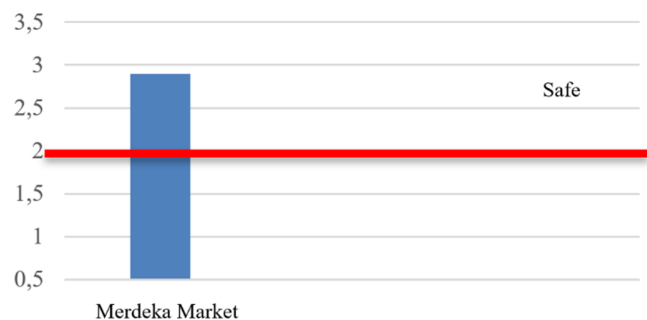
Fig. 6. Vulnerability final score graph of Merdeka Market building.

The score of the building in the RVS test carried out, according to FEMA P-154, was 2.9, as presented in Figure 6. The vulnerability index (S) of the building was then calculated as:

A vulnerability value of 0.126% is very low; therefore, the building is safe.
