REPAIR OPTIMIZATION AND PERFORMANCE ANALYSIS OF THE ASPHALT PROTECTION LAYER OF THE SOUTHERN BREAKWATER IN FRONT OF THE PORT OF AMSTERDAM

Stefan van den Berg¹, Rolf Bruins², Arnaud Casteleijn³, Niek Leguit⁴, Peter Brand⁵

Keywords: breakwaters, asphalt, mastic, protection layer, damage, repair, design, failure modes, hydraulic loads

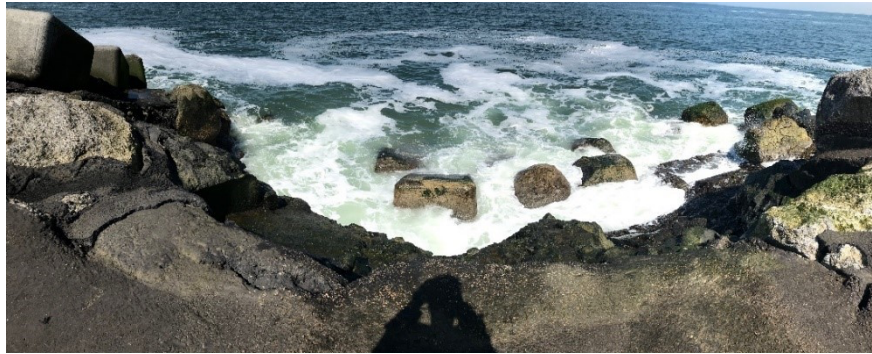
In February 2020 multiple storms passed the Dutch coast and washed away the repair of 2019. The main cause of the damage was the instability of the supporting concrete blocks. At the northwestern area a steep slope was observed, see Figure 6, and the total area of the damage increased compared to 2019.

Figure 6. Photo of the damage at the northwestern side of the breakwater roundhead by E. Lee.

In 2020 the breakwater was repaired again. It was decided to make an amendment to the original design.

- The slope was smoothed to 1:3.5 for stability and reduction of wave loads.
- Armour stone of 40-200 kg instead of 10-60 kg was used to improve the stability of the stones during construction and better penetration of the mastic asphalt.
- The penetration with mastic asphalt of the top layer at the toe was increased with 20% extra mastic asphalt and the main area and the transitions to the existing structure with 10% extra. This to create a fully grouted smooth top layer and robust design.
- The construction was built by different layers with a thickness of approximately 1.0 m each. This construction method was chosen from a practical perspective and penetration tests.
- The repair extends to a level of 5 m below N.A.P. An analysis based on historical data over the past ten years demonstrated that material at this level was stable.

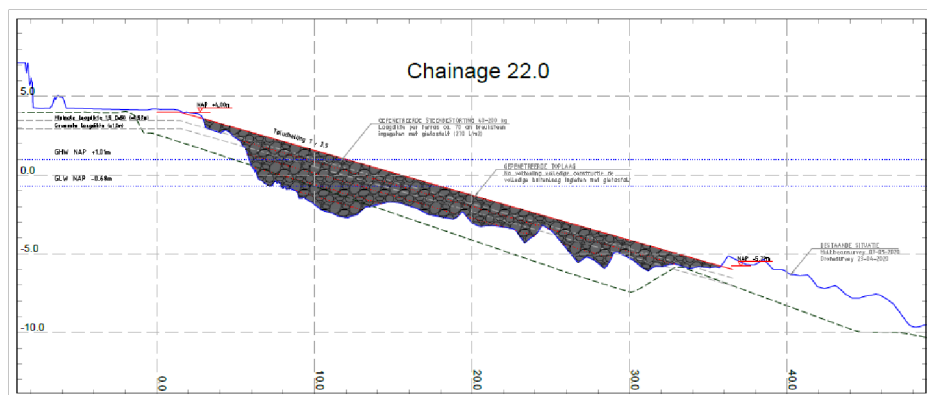
Based on the design parameters and the first survey a map was created of the area that needed to be repaired. It was concluded that some concrete blocks and loose parts had to be removed before armour stone and mastic asphalt could be placed. For several cross-sections the design was plotted, one example shown in Figure 7.

Figure 7. Design of the repair in 2020 for chainage 22.0.

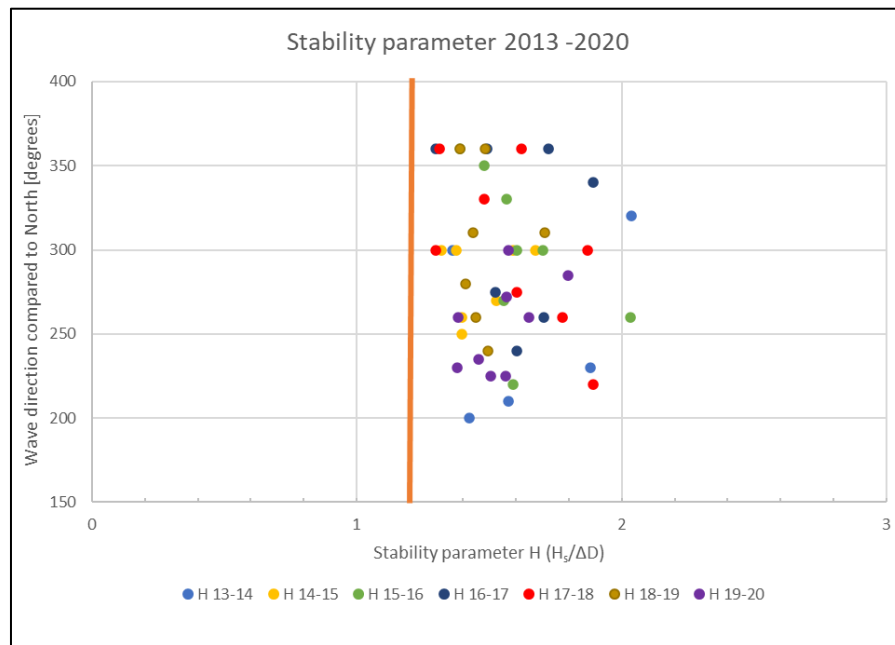
Model studies (W.L. 1971) show that the blocks become theoretically unstable at a stability parameter of 1.2. This is a very low stability parameter, due to the relative small weight of the blocks and the impermeable asphalt layer underneath which does not absorb wave energy. Figure 9 shows the stability parameter for the concrete blocks for the storms in 2013 to 2020 and the conclusion is that during all (relative small) storms the concrete blocks are expected to become unstable. In reality this did not occur in each of those storms and when it did occur, mostly only at the southern roundhead. A reason is that the distance between blocks differ, so some blocks are more exposed than others. Also the blocks were molded in with extra asphalt, which gives more stability. Most damages to the blocks occurred at the southern roundhead, where the blocks experience waves loads from all wind directions.

Figure 9. Stability of concrete blocks during storms between 2013 – 2020. Orange line is the stability number for the concrete blocks, derived in model studies (W.L. 1971). The stability numbers of every winter period (H13-14 until H19-20) are plotted in different colors. For example H 13-14 contains the data of the winter period of 2013 – 2014.

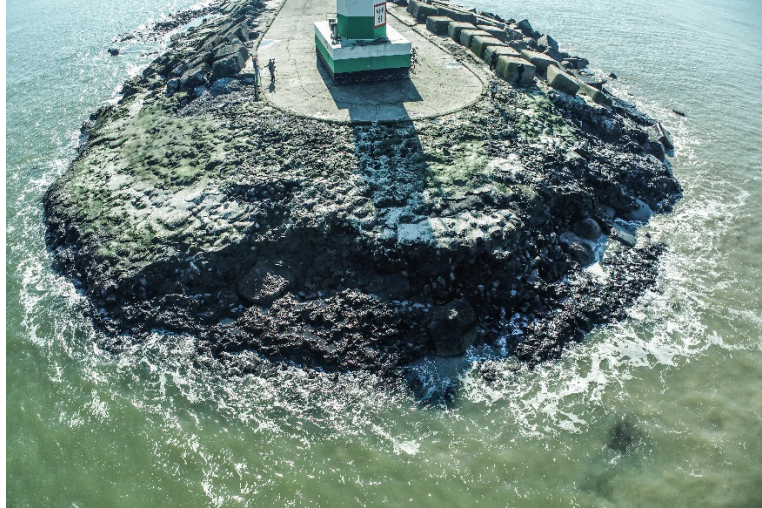
With the repair in 2020 the blocks were removed at the southern roundhead. After removal the asphalt protection layer experienced many severe damages each year till now, resulting in different repairs. These damages occur at wave heights above approximately 4 m, far less than the design wave of 7.5 m for the original asphalt protection layer (1960). Analysis shows that the incoming waves during these storms are ‘plunging’ waves (Iribarren number 1.2 – 1.4), resulting in high impact loads on the protection layer. Different hypotheses were studied, leading to the conclusion that erosion of asphalt starts the process, subsequently exposing the stones in the protection layer. Eventually the stones are pulled out by incoming waves. Figure 10 shows damage of this failure mechanism before the repair in 2023.

Figure 10. Photo of damage at the roundhead of the southern breakwater in 2022.

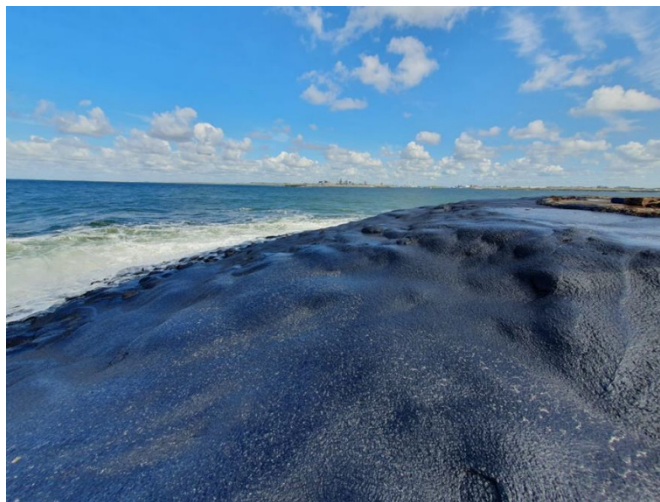
Figure 11 shows the asphalt protection layer directly after the repair in 2023. Details of the repair are discussed in the next chapter. The result is a smooth surface in order to avoid points of impact for local water pressures due to plunging. Figure 12 shows the damage after the first (mild) storm in 2023. First asphalt is peeled off and stones become visible. Then stones are pulled out and the protection layer becomes even more vulnerable for plunging waves, as the surface becomes less smooth. At some parts stones and asphalt are completely gone. This process or failure mechanism is labeled as ‘erosion of the asphalt protection layer’ (consisting of asphalt and stones). The repairs are made in layers of 1 meter and the attachment between layers seems critical for the strength of the repair. At multiple locations the erosion first propagates to the surface between two layers, before the next layer is damaged. The overfilled and smooth top layer could not prevent this failure mechanism.

Figure 11. Photo of the repair in 2023 with the smooth asphalt top.

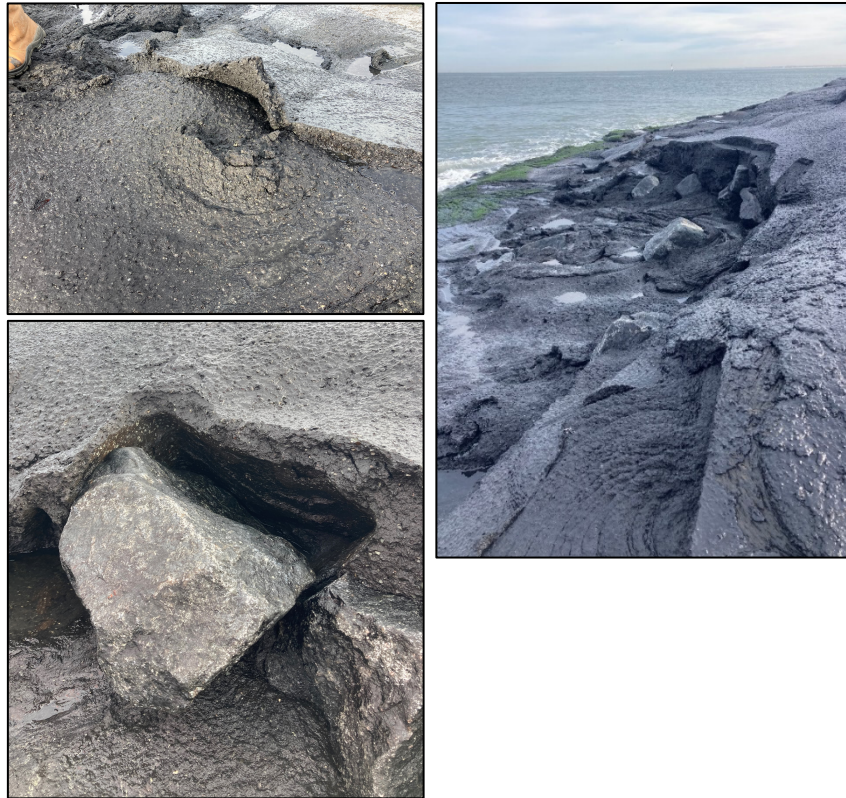
Figure 12. Photo of the erosion of the protection layer in 2023. Upward left: stage 1 - peeling of asphalt, downward left: stage 2 - pulled out stones, right: stage 3 – stones and asphalt are washed away.

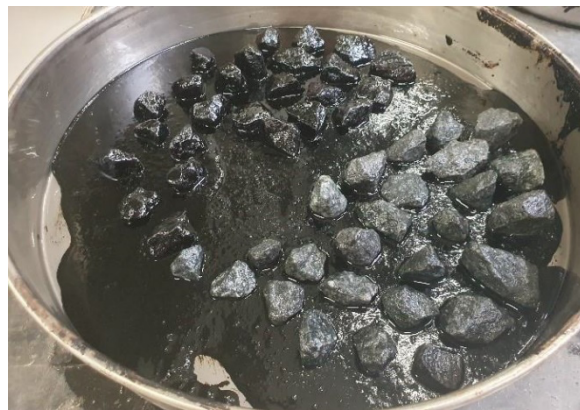
Figure 15. Queensland test with left above the pretreated armour stone and right under the 'clean' armour stone.

The adhesion was quantified by the amount of mastic asphalt that is left at the individual stones after pulling the stones out of the plate. Each stone is quantified by the number of ‘0’, ‘1’ and ‘2’, which respectively means that there is no mastic asphalt left, around 50% of the mastic asphalt is left and most of the mastic asphalt is left on the stone. This number for all tested stones is summed up and gives a number that indicates whether the adhesion is good, relatively compared to each other. The conclusion of the test was (Rijkswaterstaat 2023):

- Armour stone with a rough contact surface does have a better adhesion
- Applying a bitumen layer will have a positive impact on the adhesion
- The adhesion above water is better than under water.

Based on these conclusions the decision was made to apply armour stone with a rough contact surface (Hyperit) and pretreat it with a bitumen layer before construction. These optimizations were also verified in a full scale model pulling test with the same variables as in the small model test. The test was executed in a large container. The different types of armour stone were placed in the container and the mastic asphalt was applied afterwards. This resulted in the best full scale copy of the situation at the roundhead of the breakwater.

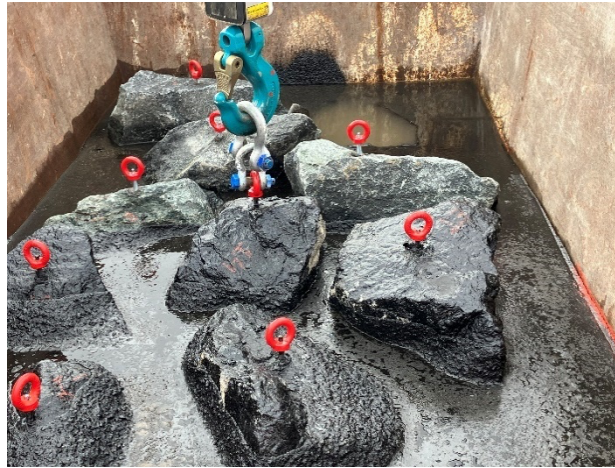
Figure 16. Full scale pulling test with pretreated and not pretreated stones.

The adhesion was quantified by the force that was needed to pull out the stones. The forces needed were relatively compared to each other, to get more insight in the adhesion. The forces needed to pull out clean armour stone was around 15 kN under water and 20 kN above water. For the pretreated stones this was 20 kN under water and 25 kN above water. These are average values of the force, but it is good to mention that for some pretreated stones it was not possible to pull them out, so the mentioned values are a rough estimation, to get an idea of the quality of the adhesion. Results showed that pretreating of armour stone had a positive impact on the adhesion. Another result was that grouting of dry armour stone with mastic asphalt above water led to a better adhesion then grouting wet armour stone under water, probably because a thin water layer is trapped between the asphalt and stone which has an negative influence on the adhesion. Based on the results, the verification was positive and application for execution on the roundhead of the breakwater was verified.

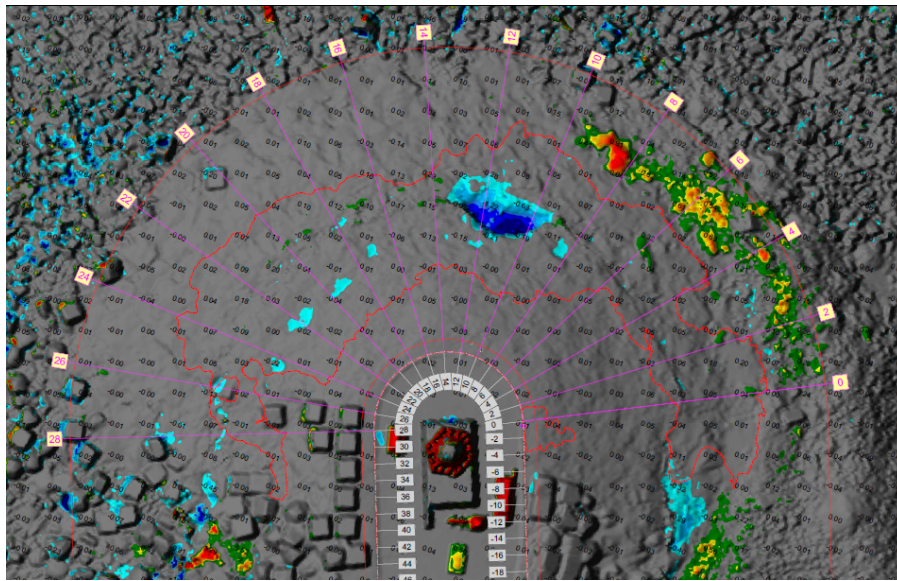
After finishing the work in the summer of 2023, in September of that year new damage occurred. During this storm the significant wave height was more than 4 m. The damage is shown in Figure 21, by the dark blue area. This was part of the recent repaired area, but it is not clear why only this part of the slope was damaged and the other parts were still intact. A positive note is that the damage area was much less than earlier years, when a significant wave height of 4 m with same duration appeared.

Figure 21. Damage after the storm in September 2023. The dark blue area represents the damage.

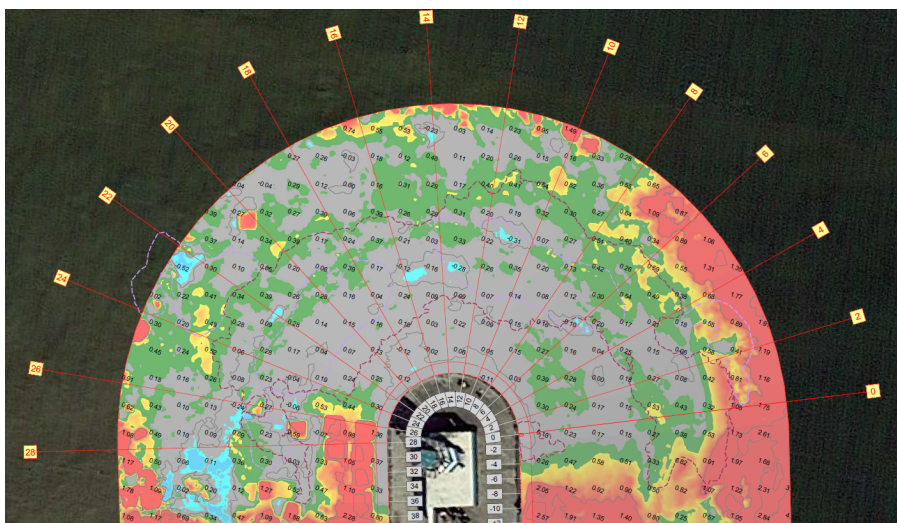
As earlier described the damage area of 2023 was repaired in 2024, to ensure the stability of the roundhead of the breakwater. In November of 2024 new storms with significant wave heights of 4 m appeared, but this time the protection layer was still intact after the storm. Only small parts of the finishing layer disappeared, shown in Figure 22.

Figure 22. Damage after storm in October 2024. The light blue spots are areas where the finishing layer is partly damaged.
