## **RAISING THE ALARM: HOW THINGS GO WRONG**

Chris Brown BSc, MICE (formerly MIEAust - retired)<sup>1</sup>

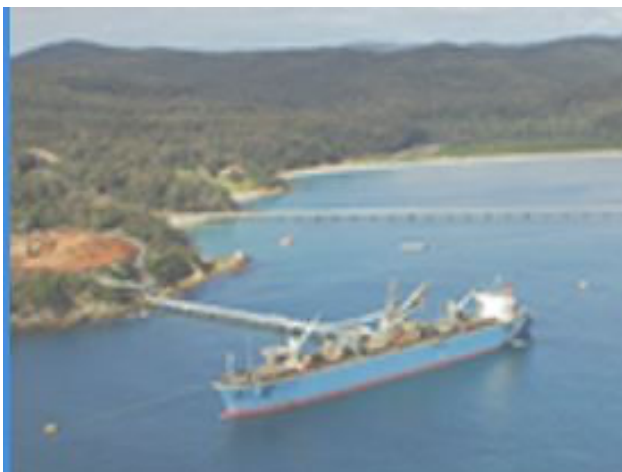
Figure 1. Eden Woodchip Berth 1972-2015

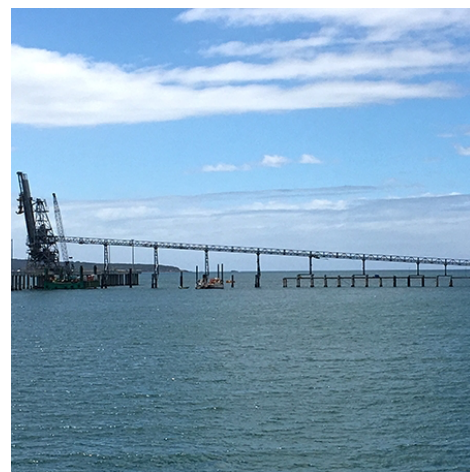
Figure 1. After the 2015 storm & 17m waves

Some 45years later the approach jetty and conveyor were washed out (Figure 2), but the tower survived the high waves (17m recorded at the waverider buoy before it was lost). So, the raise in deck elevation was the result of a proper assessment, but just not communicated properly. Nor did anyone, author include, raise the question that if the loading deck level had to be raised, what about the lol level approach jetty: no over-arching peer review of the whole installation.

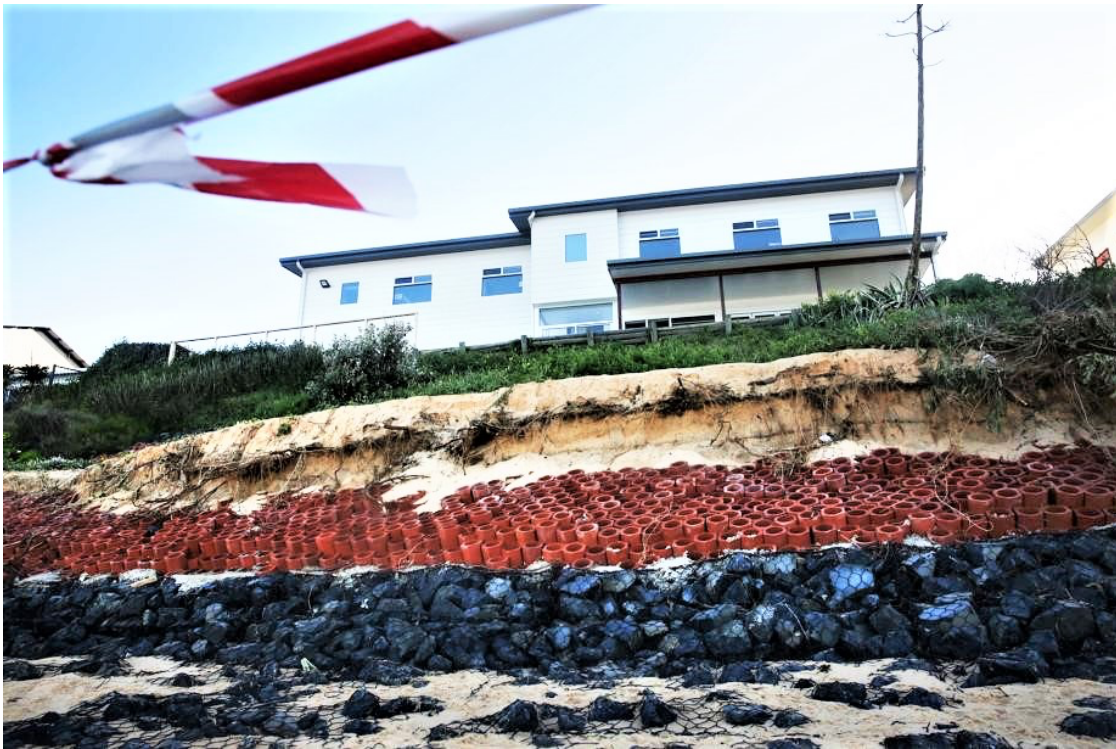
Intervention by neighbouring residents led to a limit on excavation depth, resulting failure to reach original scour horizon. The structure lasted over 40 years before this weakness was discovered by the

sea. The structure failed by sliding due to deep scour and probable slumping of wet sand below. The two lateral gabions wings, designed to cater for erosion on each side of the revetment lasted well. Provision of a mesh link to the crest along the whole width may well have saved the structure from this failure mode

Figure 3. June 2016: a rare survivor of the storm: performed as expected, but failed by scour & sliding in 2020.

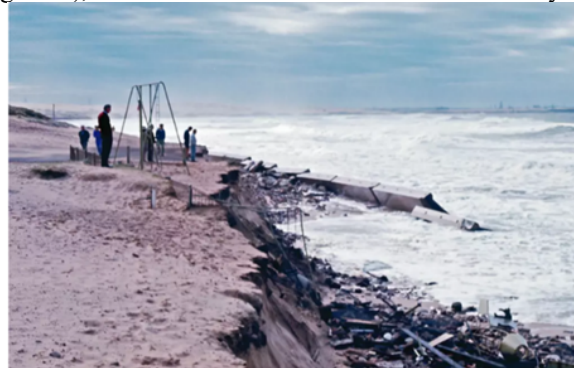
Figure 5. Immediately after the storm, 1974

This loss of sand from the dunes of Bate Bay increased markedly in the postwar years. In 1974 a severe storm demolished this wall, resulting significant erosion of the dune face. A programme of studies was initiated to reduce the loss of sand to the North, and how to prevent further recession of the dune.

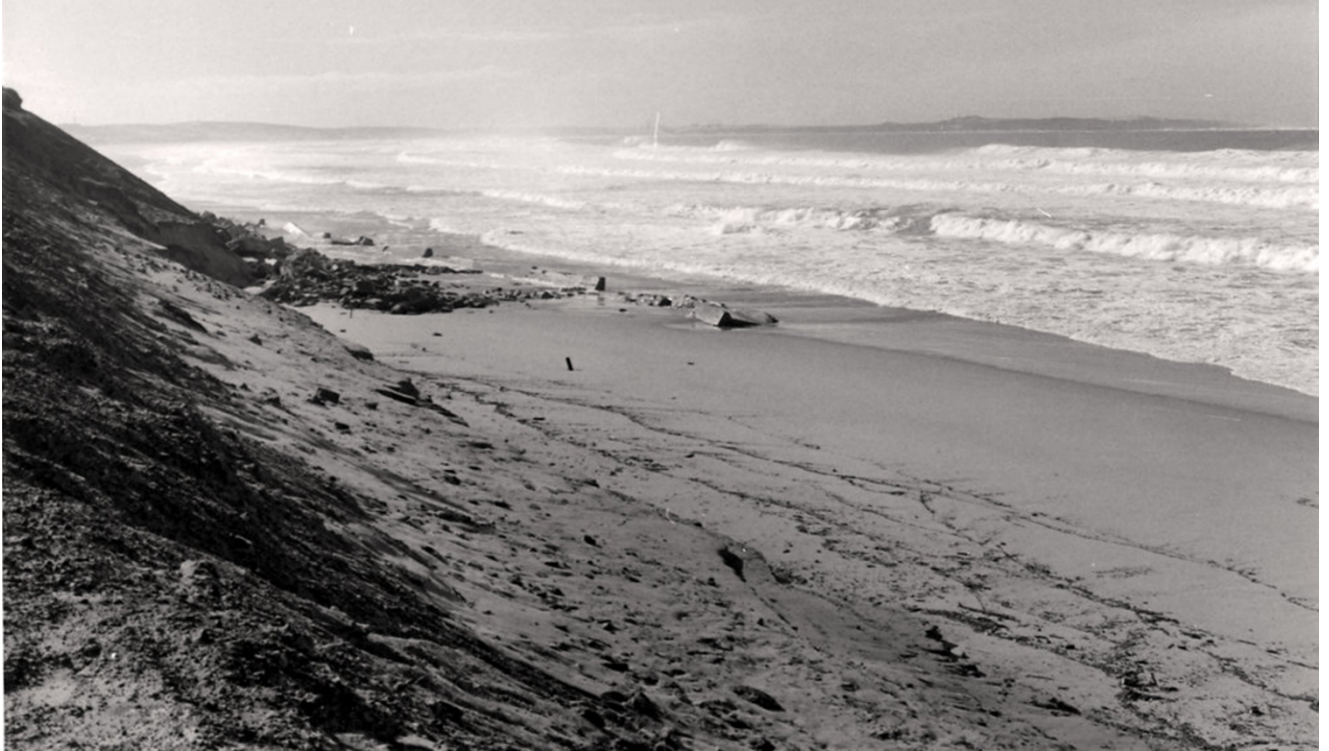
By 1979 the rate of recession was deemed critical (Figure 6) and a range of options to stabilise the dune and secure were considered. The proposal was put forward to excavate the dune to renourish the beach and construct a seawall well back from the beach was the chosen solution.

Figure 6. Continuing recession of the dune and burial of the remains. Unfortunately, not surveyed and soon lost to view.

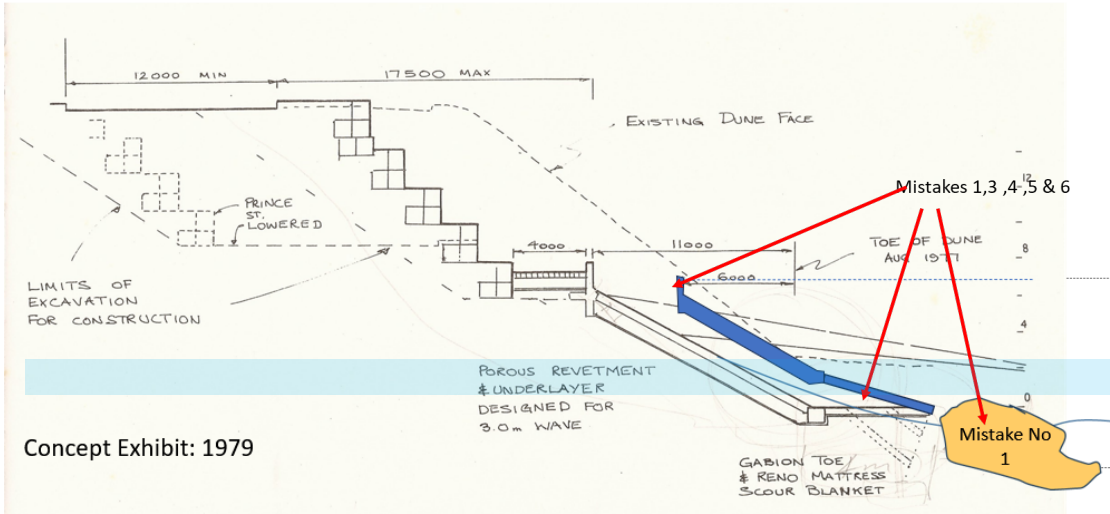
Under cost pressures from the client, the crest level was lowered, and more importantly, the scour apron became a sloping revetment, with transition raised to High Water mark, so becoming a revetment

in its own right, and the whole profile was moved seaward, becoming subject to frequent exposure to wave action (Figure 8). The design of this lower gabion revetment was not checked against the design criteria established in 1979.

Figure 8. Evolution of Design from Concept to Construction

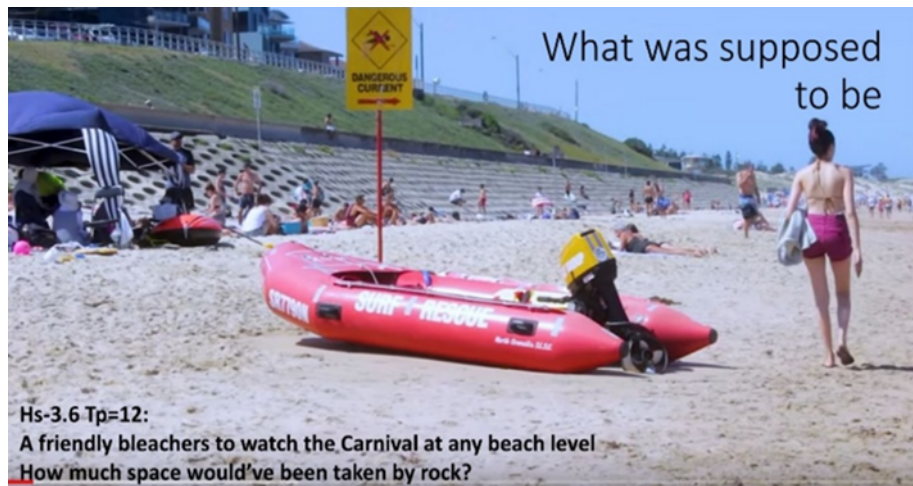
Figure 9. Early realisation of the concept with gabion scour apron supposed to be at low water mark. –

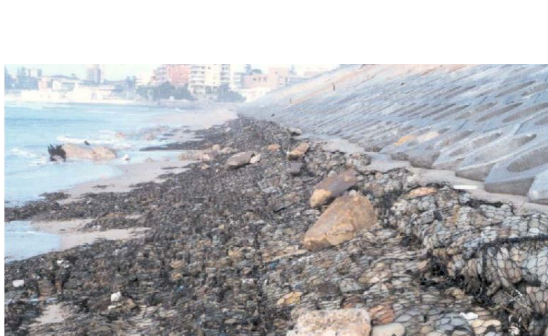
Figure 10. 1986 – Damage in first months of service

The site was not cleared of waste. In its first year of operation, the whole scour apron/lower revetment was subjected to significant wave action, and damaged by uncleared waste being thrown up on to the gabions (Figure 10). The gabion structure survived some 25 years before sustain severe storm damage caused a replacement of the gabion revetment (Figure 11). This compares with the design rules promulgated in the Gabion Report (Brown 1979), which set a limit of 3m waves for gabion revetments, for very infrequent exposure.

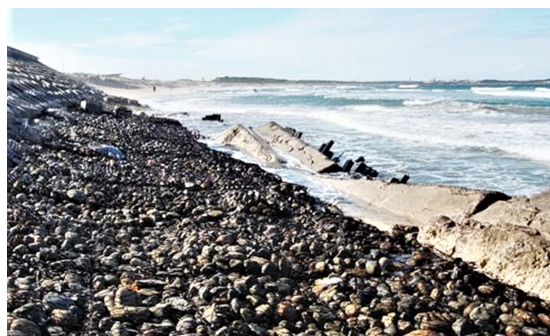
Figure 11 2007 Damage at the downdrift end

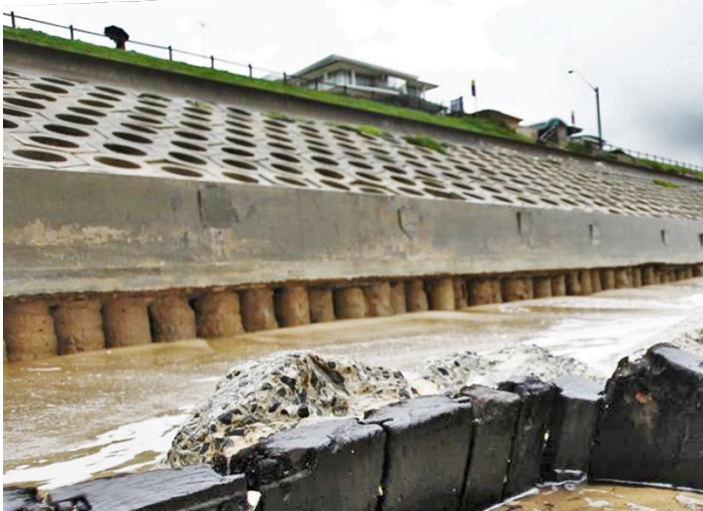
Figure 12. Contiguous pile wall after completion: note the pile gaps

Subsequent restoration involved removal of the gabion revetment, and installation of a contiguous bored pile retaining wall, with a capping beam to support the Seabee revetment, all built within a sheet-pile coffer-dam (Figure 12).

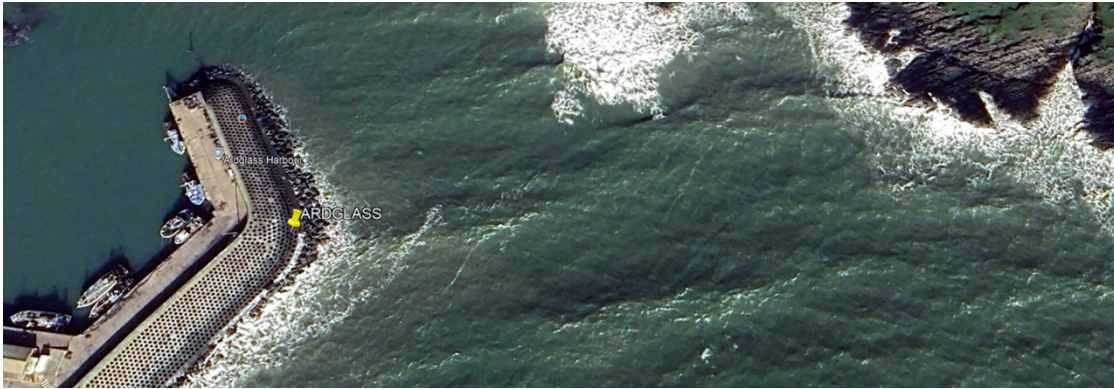
Figure 16. Ardglass Breakwater: mach-stem waves were experience on the trailing leg during model studies

concrete dressed up to the crest of the wall. The inevitable result of these changes came sometime later, when the storm run up was not resisted by the unusually smooth slope, and having nowhere to go, went over the crest of the wall. This crest was significantly above the harbour quay, and the overtopping water fell clear of the quay into the open hold of a fishing vessel, sinking it.

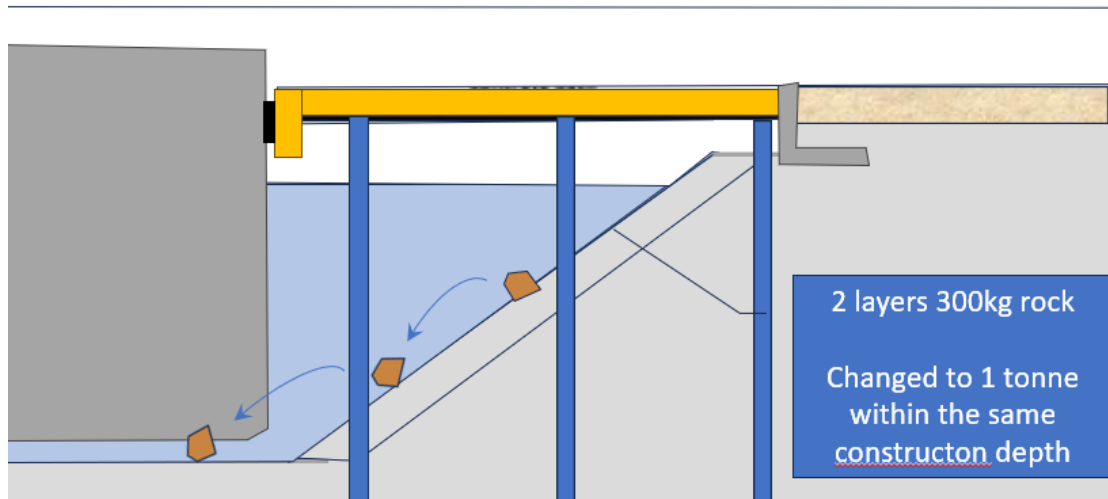
The construction sequence had been to drive the piles, then advance the fill and construct the armoured revetment followed by the suspended deck, retaining wall and laydown areas. The actual armour layer had been measured by weighbridge docketts – no profile surveys could be found in the records. And no final inspection had been carried out before the end of the Maintenance Period, so the contractor was free of defects responsibility. No perched rocks were revealed by a sidescan survey along the completed berth face

Figure 18. Schematic of suspended deck and underquay revetment with possible errant rock

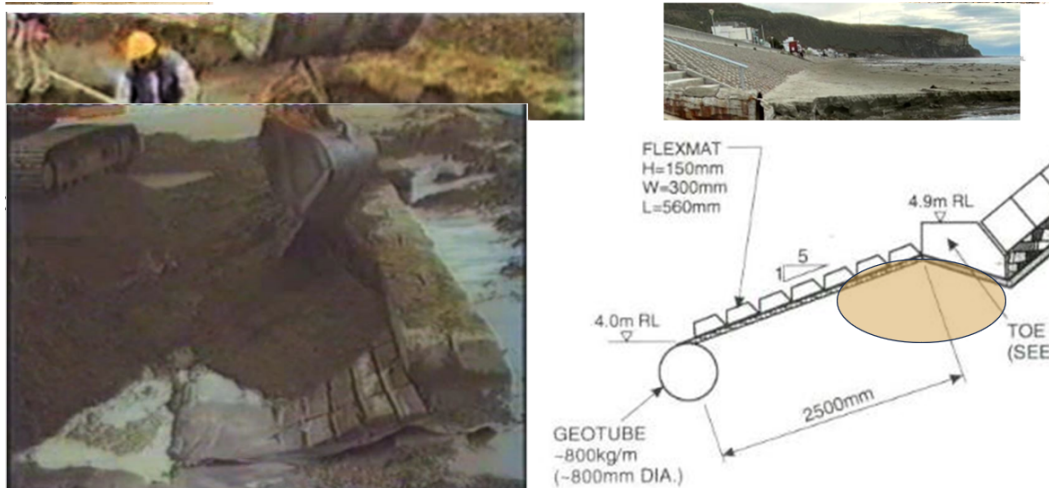
A video recording of the construction shows a different profile being built, with no geotube at the toe and probably to Profile A in Figure 22 (without the underlayer) rather than the profile recommended by the Laboratory (Figure 23). No documentation has been discovered to explain this discrepancy, neither contract nor as-built drawings, or any other reports. The shape of either toe beam was such that seaward rotation and sliding is possible if the scour mat fails to retain the underlying sand.

Figure 23. Comparison of actual construction with recommended profile. No As-built information available

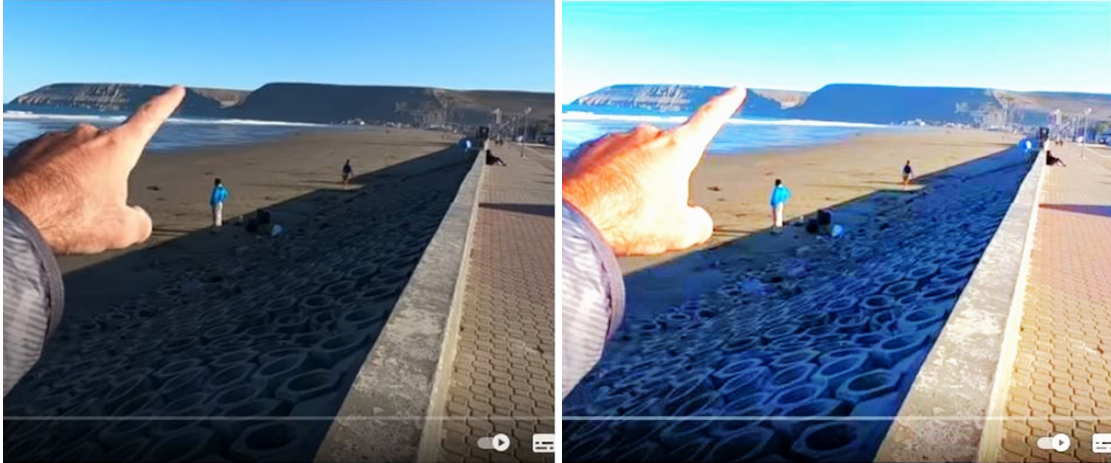
In 2021 while googling Rada Tilly to update the abstract for the 2022 rerun of the conference, something in the background of a video was out of place. Some of the Seabees near the toe were out of alignment and standing high. Examination of a video-still raised serious concern. After a month of searching for photos and videos on the internet, it was possible to provide a timeline of probable cause and effect.

Figure 24. Video still -as seen on screen

Video still, shadows enhanced: units in loose array.

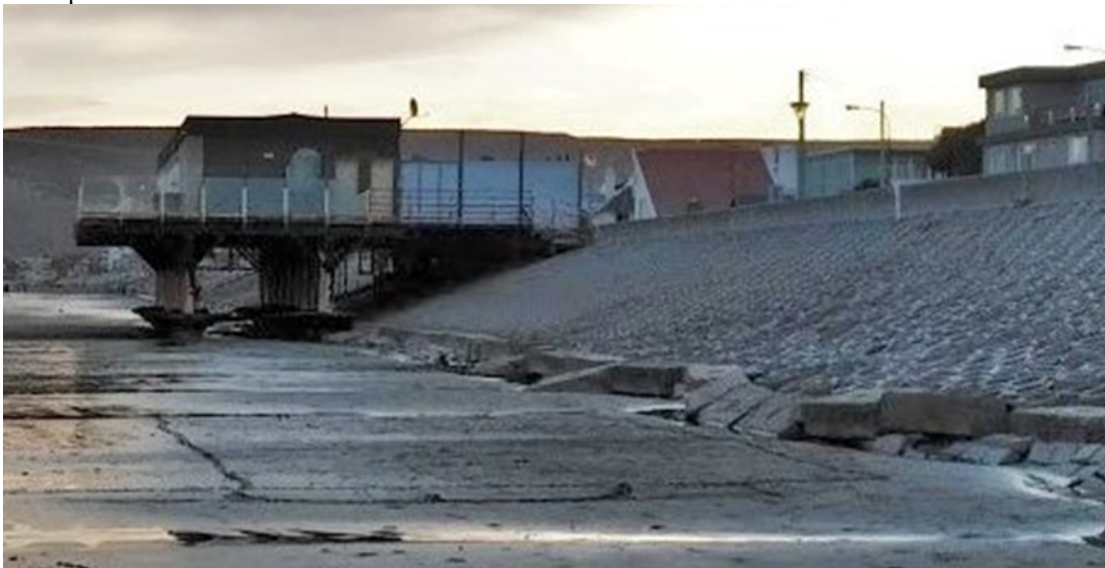
Figure 25: Rada Tilly - one year on, 8<sup>th</sup> Dec 2018

These inquiries found that in March and April 2017 catastrophic rainfall events occurred in the area. devastating Comodoro Rivadavia and at Rada Tilly the outwash and waves lowered the beach over a significant length, exposing the whole face of the toe beam, exposing and disturbing the Flexmat scour apron.

The beach did not recover during that autumn and winter and subsequent equinoctial storms in September dislodged lengths of the toe beam which slid and rotated seawards. Overtopping similar to that reported in the model tests was observed, so conditions may have approached the design limits for the structure. The addition of a cabled-block mat or a gabion toe and scour apron over the top of the Flexmat could have stabilized the situation in the winter of 2017 at very low cost.

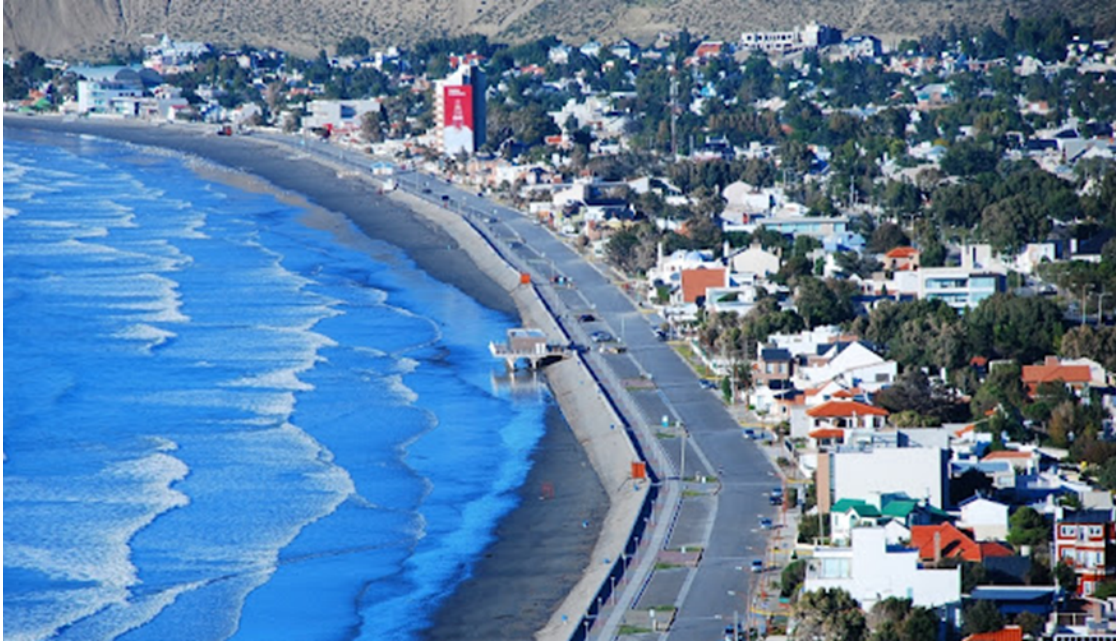
Figure 26. Rada Tilly as it was 2013 [photo H.F Garrudo]. Was the bay chord stolen to gain ground?
