A CASE STUDY ON THE MAJOR DAMAGE AT A PORT: DAMAGE ASSESSMENT AND UPGRADE OF THE BREAKWATER

INTRODUCTION

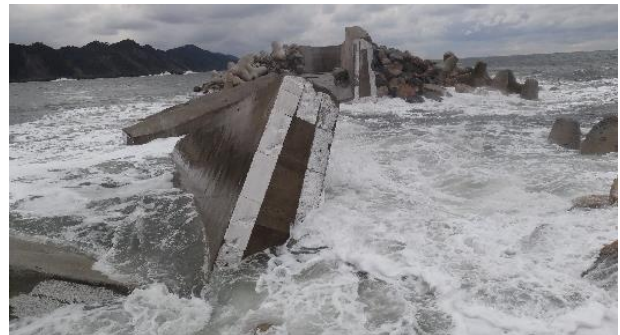
The breakwaters were severely damaged during a storm at the Black Sea. The port was visited to observe and record the damage, collect available data, and interview the eyewitnesses. This field survey showed that Sections 2-2 and 10-10 of the breakwaters (Fig. 1) close to the entrance, failed during the storm. The crown-walls at Section 2-2 overturned towards the harbour direction (see Fig. 2) before the crown-walls at Section 10-10 overturned towards the seaward direction. The seaside and the rear side armour layers of the non-failed sections

of these breakwaters also suffered excessive damage. It is also important to note that the seaside armour regions at the crest levels of both breakwaters were filled with 4-6 tons of quarry rocks to repair the damage after a previous storm that damaged the tetrapod units initially available there.

Figure 2 - Failure of the main breakwater at Section 2-2.

The main reasons for the damage at both breakwaters are considered to be the insufficient tetrapod unit size at the armour layer and the use of rock as armour close to the crest level of these breakwaters. The storm waves broke

the tetrapod units and dragged a significant portion of the tetrapod units and the rocks at the armour layer. Therefore, the underlayers and eventually the core became open to wave action. Furthermore, the excessive wave overtopping along the main breakwater dragged the rear-side armour rock, reducing the supporting forces to the crown-walls, especially at Section 2-2. It also removed the protection over the underlayers and core at the rear side. The crown-walls at Section 2-2 overturned towards the port area. On the other hand, as the support beneath the crown-walls at Section 10-10 was removed when underlayer and core rock was dragged at this section, the crown-walls overturned towards the seaside.

After the event, the breakwaters were repaired based on the initial design, placing tetrapod units along the armour layer (up to crest level properly) and reconstructing the overturned crown-walls as a temporary protection. As it was required to upgrade the initial design, a series of physical experiments were carried out at METU, focusing on both the trunk and head sections of the main breakwater using a Froude-type length scale of 1:60. The upgraded breakwaters were designed and tested utilizing a wave climate study specifically carried out for the port area (METU, 2020), where the deep-water design H_s and T_p having a return period (R_p) of 100 years were estimated as 9m and 12.1s, respectively. The main breakwater was also extended as it was easier to construct a new head than to repair a failed head. Moreover, it created a more protected area from the storms coming from the Northwest direction. Special attention was given to the transition zone between the existing and the extended head sections of the main breakwater. The main idea in the design was to minimize the removal of the existing structural units. Furthermore, Antifer units were selected to upgrade the existing structure that are relatively easy to place on top of a not-even surface consisting of (broken) tetrapod units. In all experiments, six wave series and water level combinations were considered including the waves having an exceedance probability of 10 hr/year and return periods of 50 and 100 years at high and low water levels. The number of waves in the wave series was selected assuming 6-10 hours of storm durations.

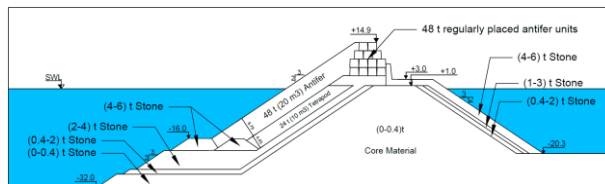
Sections 2-2 and 4-4 (see Fig. 1) were the two trunk sections tested in the experiments, which have toe depths of 32 m and 18 m, respectively. These cross-sections were upgraded using 48 tons of Antifer units placed randomly along the cross-section and regularly at the crest-level. Tested Section 2-2 is presented in Fig. 3. The stability of the armour and toe layers of the cross-sections were evaluated based on the damage number (N_{od}) and number of rocking armor units in addition to the rear side damage evaluated using damage parameter (S) based on the eroded area due to the wave action and rock diameter. Furthermore, mean wave overtopping discharges (q) over the cross-sections were measured. The results of the experiments showed that N_{od} values are acceptable considering the cumulative damage along the cross-sections after the application of six wave series. On the other hand, the measured q values are within the acceptable limits for the port operations given by the

client, except for the waves having a return period of 100 years. (The port operations are recommended to be terminated for these storm conditions).

Figure 3 - Upgraded Section 2-2 (in prototype scale).

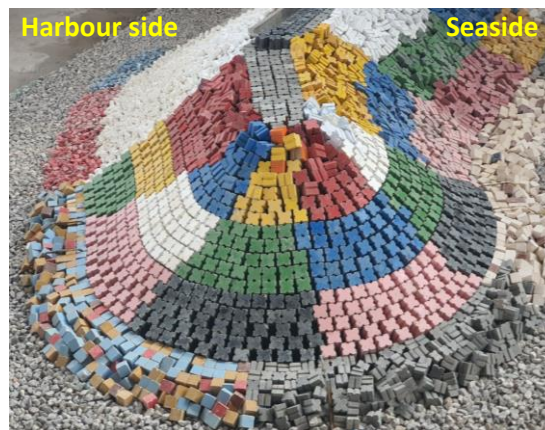
For the head section experiments, Sections 1-1 and 2-2 in addition to the extended part (Section 0-0) were constructed in the wave flume as shown in Fig. 4. The most critical transition zone between Sections 0-0 and 1-1 was placed perpendicular to the wave direction. 60 tons of Antifer units were used at Sections 0-0 and 1-1 at the beginning of the experiments. These units were irregularly placed at Section 1-1 and were regularly placed at Section 0-0 (see Fig. 4). The damage was evaluated based on N_{od} at different regions of the head section.

Figure 4 - Extended breakwater head section in the wave flume (Sections 0-0 and 1-1).

The initial experiments resulted in excessive damage, especially at the lee side of the head section. Therefore, the 60 tons of Antifer units in the highly damaged regions were replaced with 80 tons of Antifer units. The final experiments showed acceptable damage levels at all regions around the head section. In conclusion, both the trunk and (extended) head sections of the breakwater were upgraded successfully by these experiments.
