# Analysis of the Causes of Reclamation Embankment Collapse after Final Closure

Yeong-Su Nam, Catholic Kwandong University, [ska@naver.com](mailto:ska@naver.com)  
Kyu-Han Kim, Catholic Kwandong University, [khkim@cku.ac.kr](mailto:khkim@cku.ac.kr)  
Kyu-Tae Shim, Catholic Kwandong University, [atqshim@gmail.com](mailto:atqshim@gmail.com)

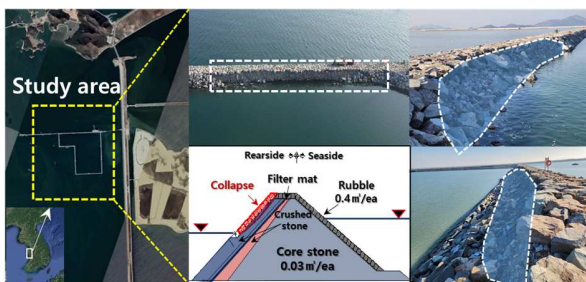
The target area is a reclamation project district located on the West Coast of Korea. After the final closure work, there was an occurrence of slope collapse on the backside of the embankment. The collapse of the embankment occurred in several places, and all were located on the backside slopes. The riprap ( $0.4 \text{ m}^3/\text{ea}$ ) on the backside slope collapsed, exposing the filter mat and the underlying foundation stones ( $0.03 \text{ m}^3/\text{ea}$ ). The section was temporarily reinforced using crushed stones for landfill before embankment. As shown in Figure 1, the collapsed embankment consists of core stones with  $0.03 \text{ m}^3/\text{ea}$  and covering stones with a volume of  $0.4 \text{ m}^3$ , with a non-woven filter mat installed.

Figure 1 The Study Area and Damaged Seawall

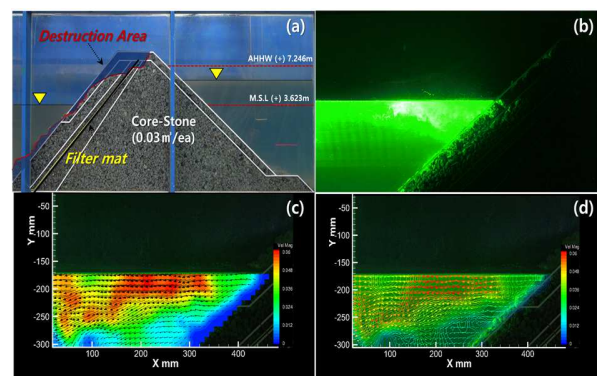
To reproduce the collapse phenomenon of the embankment section and analyze the cause of the collapse, a two-dimensional sectional hydraulic model test was conducted. The movement characteristics of the aggregate due to the difference in water levels inside and outside the embankment were examined using the observed tidal data at the time of collapse, and the change in water pressure within the stone structure was also

examined. In addition, a PIV simulation was performed to evaluate the change in flow due to water level changes, and the hydraulic characteristics resulting from the change in the porosity of the filter mat were also measured simultaneously.

Figure 2 Results of Physical model Test (a) Stability test due to tide level change ; (b) Snap shot of PIV test; (c) & (d) Analysis results of Flow field

As a result of the analysis of the causes of the collapse, it was confirmed that the rapid fluctuation of the flow field due to the change in the difference between the internal and external water levels of the embankment caused the displacement of the riprap. The cause of the collapse was that the design of the embankment did not reflect the dynamic fluctuation of the flow field due to the water level difference. The sectional collapse phenomenon was influenced by the change in the difference in water levels as a major variable. It was deemed necessary to increase the weight of the riprap and install a filter mat with an appropriate permeability coefficient in preparation for reaching the critical water level, and guidelines for this were provided. It is found that an increase in the weight of the materials or a change in the permeability coefficient of the filter mat is necessary to enhance the stability of the section.
