## **CHAPTER 260**

### **Rehabilitation of the West Breakwater - Port of Sines, Portugal**

O.T. Magoon, J.R. Weggel, W.F. Baird, B.L. Edge, R.W. Whalin, D.D. Davidson, & E. Mansard

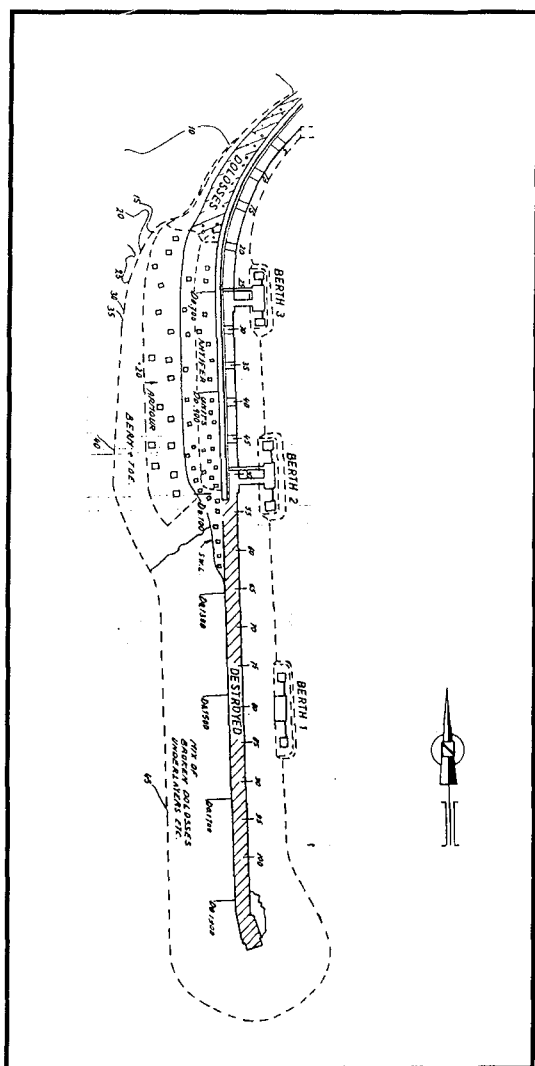
breakwater were completed in May 1981. Repairs to the breakwater included the placement of 40 ton dolosse from the landward end of the breakwater out to berth 3 and the placement of 90 ton "Antifer" cubes between berth 3 and berth 2 on a slope flatter than that of the original breakwater.

Subsequent to construction, hydraulic model tests of the emergency repairs were made in 1981 at a 1:12 scale (the results of these tests are summarized by Mol, et al., 1983). Generally, the model tests showed that no modifications to the armor adopted for the emergency repairs were necessary. The gaps between the armor blocks and the parapet could be filled to reduce wave impact pressures. The tests also showed that the pipelines on the west breakwater needed protection from overtopping and that improvements to the breakwater from its landward root to berth 3 were necessary.

Figure 2. Sines West Breakwater Following Emergency Repairs, April 1981 (After Ligteringen, van der Meer and Rita, 1993)

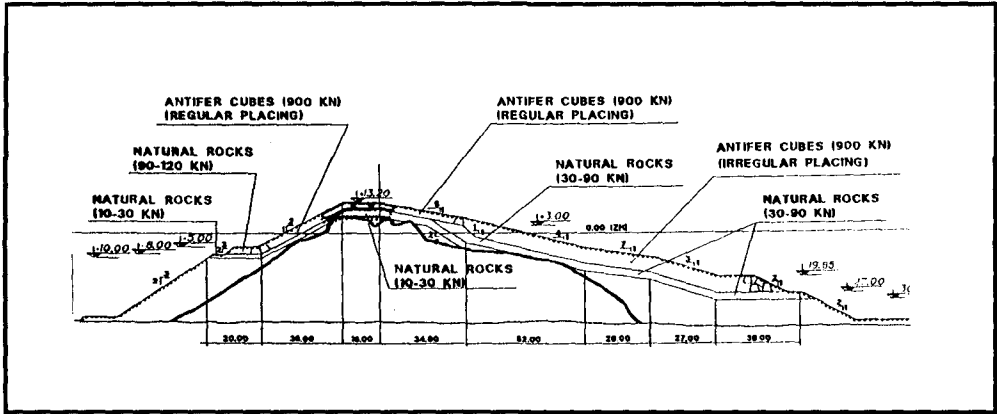
Figure 3. Sines West Breakwater Cross Section Through the Rehabilitated Trunk  
(After Condotte d'Acqua, 1993)

The geotechnical analysis indicated that the leeward side of the breakwater trunk had to be flattened to a slope of 1:2 for seismic stability. The leeward side was then armored with a single layer of 90 ton Antifer cubes and 9-12 ton dolosse rock was placed below the elevation of -5 meters CD (CD -- chart datum is approximately 2 meters below MSL). The crest elevation was lowered from +14 meters CD to +13.2 meters CD -- allowing more overtopping but improving stability. The pipelines were designed to withstand overtopping by the 100 year event and the gap in front of the parapet wall on top of the breakwater trunk was filled with large rock to reduce impact pressures and 90 ton Antifer cubes were extended down across the outer berm of the breakwater trunk as shown in Figure 3.

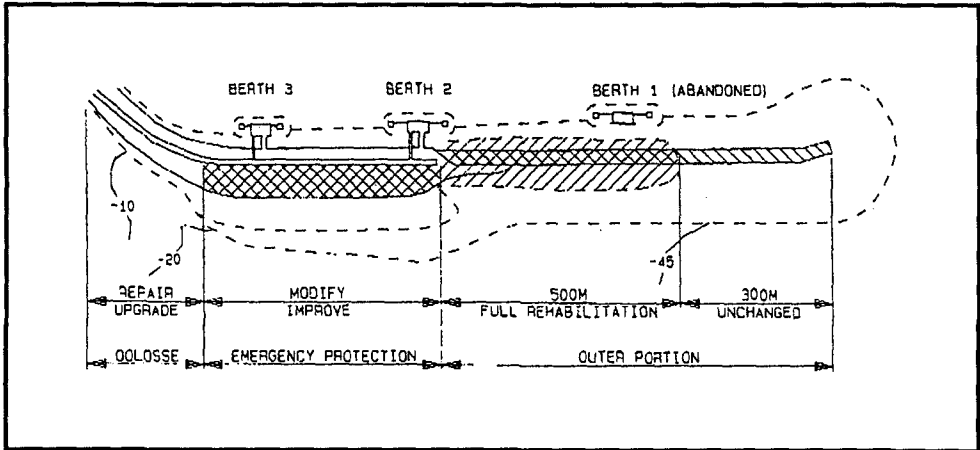
The outer end of the breakwater, beyond berth 2, underwent continued deterioration following the 1978-1979 storms and the design of the new rebuilt breakwater head would have to include some of the remaining debris. See Figure 4. Some of the debris was removed by blasting and excavating, but most of the debris formed the new base of the breakwater head. An optimization study led to the decision to rebuild 500 meters of the outer portion of the west breakwater -- out to the location of the former berth 1, rather than just 300 meters as had originally been planned. This new, round head was armored with 105 ton Antifer cubes having the same dimensions as the 90 ton cubes. Concrete with a density of  $3.1 \text{ ton/m}^3$  was used to produce the heavier cubes. The final design, which uses three layers of high density Antifer cubes over the entire breakwater head section, was not model tested.

Figure 4. Sines West Breakwater After Complete Rehabilitation  
(After Dias and Toppler, 1993)
