Exxon Valdez: Human Error, Plain and Simple

by Arthur D. Barondes,
Alexandria, Virginia

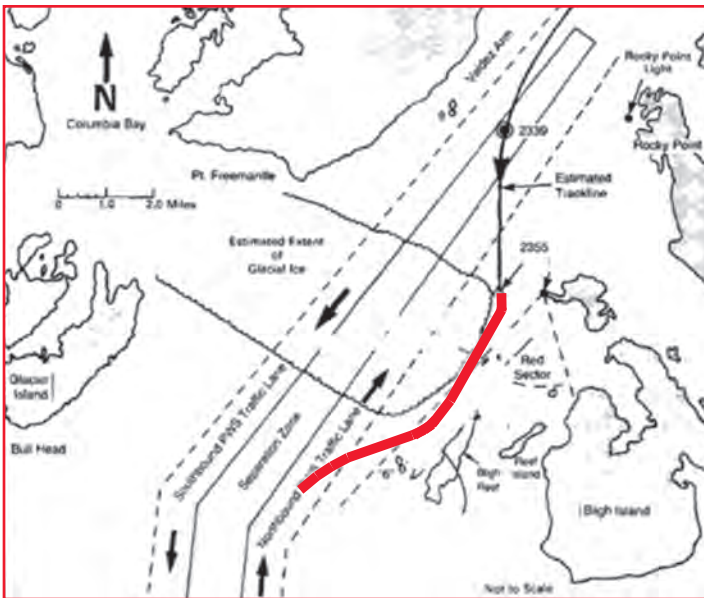
Figure 3 — Master's Planned Course

has started the turn. He asks the third mate if he feels “comfortable” with what he is to do. (Note: As shown in Figure 3, the master has the ship crossing the TSS inbound lane rather than entering it as approved by the Coast Guard.) The third mate, who is not certified to control the ship in coastal operations, decides to remain on watch until the vessel has cleared the ice and not call his relief, the second mate, who is scheduled to come on watch at 11:50.

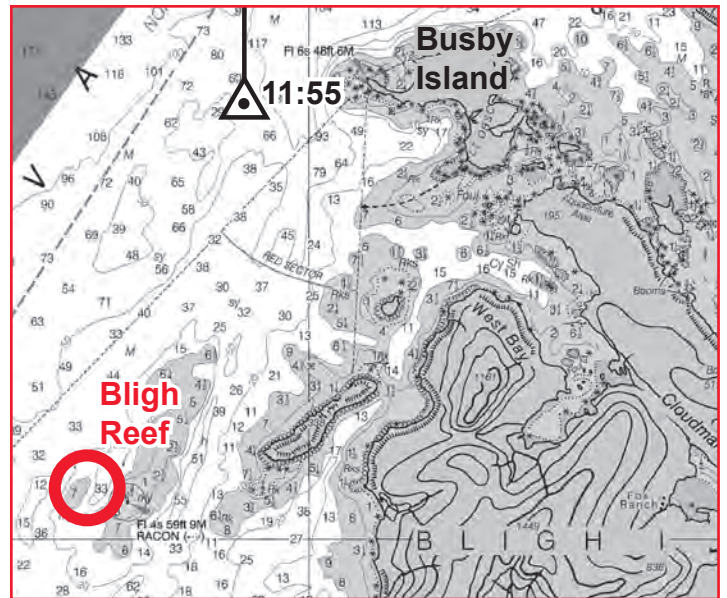
Figure 4 — Exxon Valdez abeam.

11:55 p.m.: The ship is abeam Busby Light — three minutes after the unauthorized departure of the master. As the third mate is plotting the fix (Figure 4), the lookout advises him that the red light of Bligh Reef is to starboard (right). (Note: A red mark to starboard when leaving port is cause for concern, but with the ship deliberately heading due south across the TSS, the red light of Bligh Reef should have been to starboard.)

11:59 p.m.: Now four minutes late, the third mate orders, "20 degrees right rudder." He checks the ship's rudder indicator to confirm the change. He notes that the ship is not yet in the "red sector" of Busby Light (Figure 4).

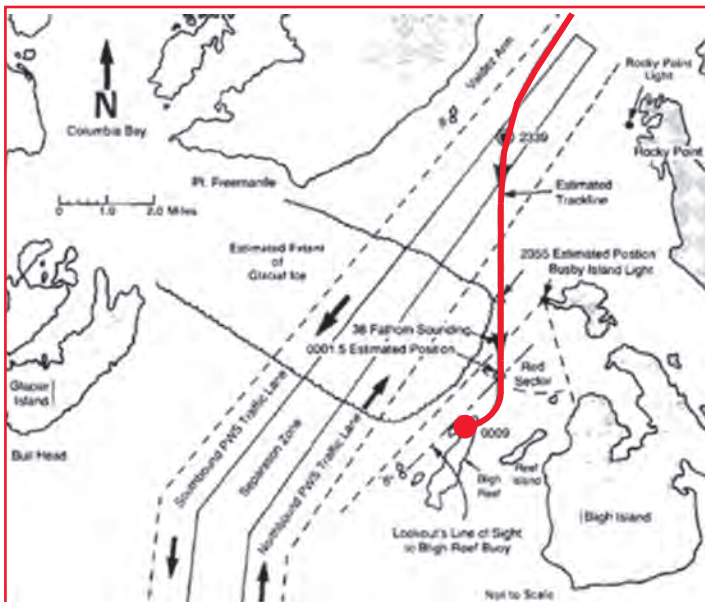
Figure 5 — Track of the Exxon Valdez.

00:09 a.m.: The ship is aground on Bligh Reef (Figure 5).

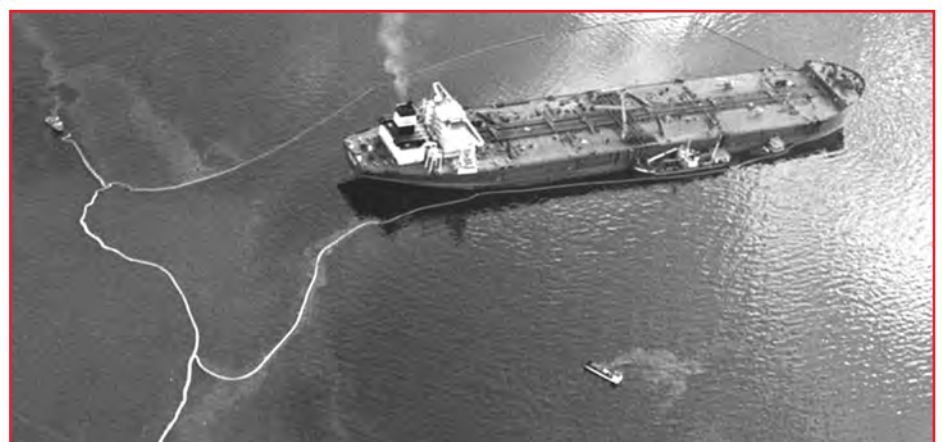
Figure 6 — Exxon Valdez aground.

There has been no shortage of claims made to explain the *Exxon Valdez* going aground (Figure 6). Those claims — offered by various interests and sources ostensibly to prevent a recurrence of ships going aground in the Valdez Arm of Prince William Sound — have led to a variety of proposed, and oft-adopted, fixes. For the most part, these so-called fixes neglect to recognize that the *Exxon Valdez* went aground because of a series of strictly human failures. Worse, they were predominantly a failed safety culture that tolerated deliberate failures to adhere to established policies and procedures. It was not because of mechanical or electrical failures or shortcomings in Coast Guard navigational aids and supervision.
