RECONSTRUCTION OF THE MONASTERY NEXT TO THE PRAGUE CASTLE

ABSTRACT. The paper deals with a rehabilitation of the historic building of Carmel Monastery next to the Prague Castle. A structural survey of building was carried out and the historical drainage and ventilation system was identified. Based on structural survey in-situ the reasons of failures were analyzed and remedial works of historic monastery were proposed.

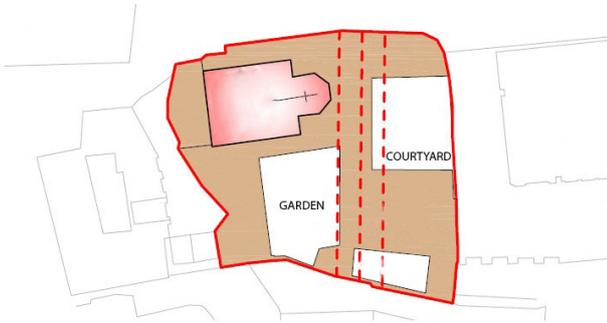
However, serious static problems manifesting by cracks have appeared and the building was moving slightly downhill to the street Radniční schody (Town-hall Stairs). According to the report based on visual

FIGURE 3. Carmel Monastery: Proposed remedial measures.

inspection it was proposed to stabilize the building by grouting of the foundations and by fixing with reinforced ring beam and ties (Fig. 3). The costs of remedial measures were estimated at almost CZK 100 million, which was above the possibility of the nuns, as the owner of the building.

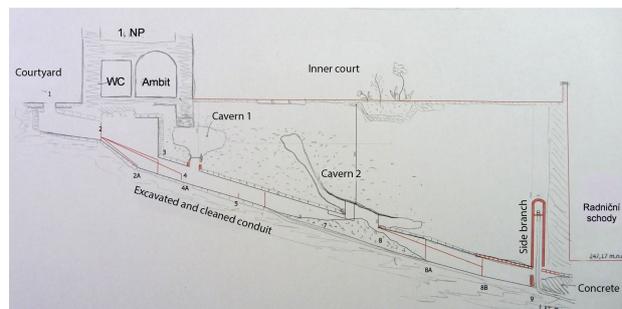
- Closure of the main gallery
At the same time, by the drill hole the rest of a lateral gallery was discovered. The main gallery, according to later found historical documentation, led originally from fountain in the courtyard, but later was closed and abolished. The whole area, as it turned out, belonged to the historic drainage system of the monastery and was covered with earth and debris. From this part of underground, about 70 tons of building waste - probably from the time of reconstruction in the 1990s before the return of the monastery to the nuns, was removed.

- Collapse of the gallery walls
The side walls of gallery have collapsed due to lack of maintenance of the underground system. This resulted in the vault falling in and the cavern originated here. If this situation is not solved, it could threaten imminently the surrounding buildings.

- Break of the toilet pit
In the main gallery, fully filled up with rubbish, under monastery corridor the toilet (latrine) pit was discovered. The pit originally led up to the first floor, where it gradually moved into the size of a larger chimney and was led up to the roof. Thanks to the chimney effect, this shaft provided sufficient air dynamics to help drying of the entire building through the drainage system. The chimney effect produced a negative pressure in the system, ensuring the odor from the pit will remove above the roof and at the same time preventing the odor from entering the building. During the reconstruction of the monastery, after the expulsion of the nuns in the 1950s, this toilet pit was interrupted on the ground floor by the corridor, thus preventing natural air flow and effective drying of the building.

FIGURE 5. Carmel Monastery: cross section of the main gallery with marks of the caverns.

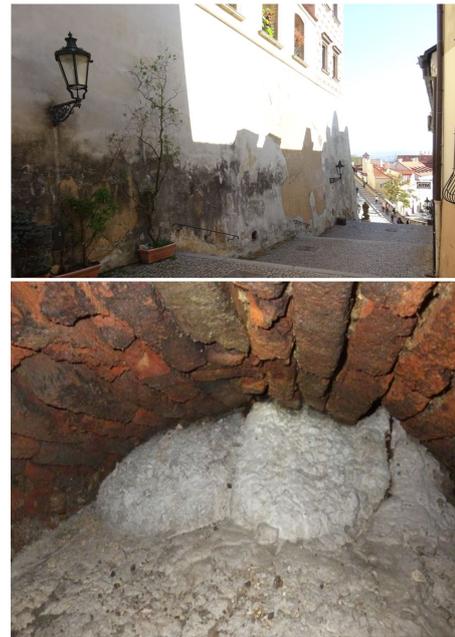
In 2013, due to removing of waste fill and rubbish, new part of historic underground drainage system was found. Newly discovered gallery led up to the edge of the retaining wall of the monastery terrace. However, the gallery was filled up with concrete at the level of the retaining wall foundation. It is clear, that the drainage system continues further down below the Radniční Stairs and ensures the drainage of moisture and water also for the houses laid down below, where the survey subsequently confirmed this assumption. By blocking the gallery, the system could not perform its function. In addition, before the concrete "plug", leaking sewage pipe is connected to the gallery, which explains the critical state of the plaster on the supporting wall of Radniční Stairs. Spalling of the plaster was caused by a leaking pipeline that supplied backfill by water, so it functioned as a water reservoir and constantly subsidize the support wall with moisture.

FIGURE 6. Carmel Monastery: Radniční Schody (Town Hall Stairs) - spalling of the plaster due to water-saturated backfill, the gallery clogged with concrete.

Water-saturated backfill was manually removed, sewer pipes were repaired, opened up and unwanted ground water discharged from the building. The connection to a ventilation shaft was completed. Moisture from the gallery is now diverted into the cleaned ventilation shaft and due to the chimney effect permeates up through the building above the roof. At present, the galleries of the old system have been mended and they serve as drains and part of the measures securing the building from moisture.

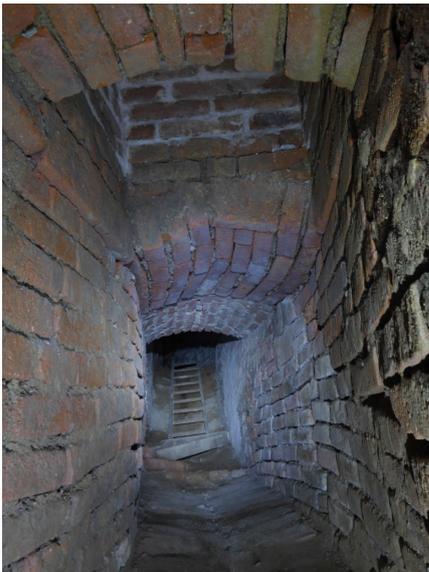
FIGURE 7. Carmel Monastery: reconstructed main gallery.

Currently, it can be stated that the drainage and ventilation system is functional and moisture regime in building is stabilized. Realized remedial variant has proved to be functional and effective - within three years it has completely succeeded in drying the walls. The process of plastic deformation with cracking was stopped, cracks were bonded and sliding stabilized. It is clear, that these measures are sufficiently effective to prevent any further development of former structural problems, no other structural intervention were needed.
