On the Accident at Fukushima Daiichi Nuclear Power Plant from the Inherent Safety Points of View

Kazutoshi Hasegawa

National Research Institute of Fire and Disaster, Japan
hase-k@jcom.home.ne.jp

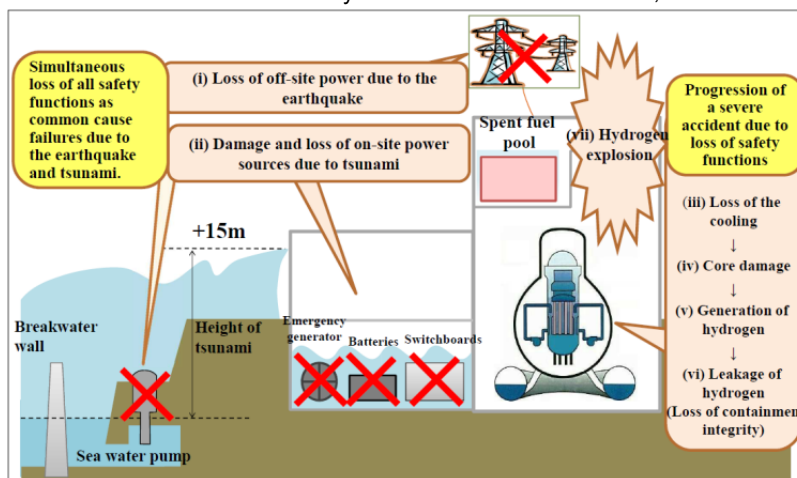
As shown in Figure 1, it was the main cause of the FDNPP accident that a station blackout occurred, that is, loss of off-site power due to the landslide caused by the earthquake and loss of the on-site power sources due to tsunami, and the seawater pumps for the cooling systems broke down simultaneously. And furthermore, the TEPCO was clearly aware of the danger of an accident. It was pointed out to them many times by the NISA since 2002 that there was a high possibility that a tsunami would be larger than had been postulated, and that such a tsunami would easily cause core damage (NAIIC, 2012), (IICAFNPS, 2012).

The electric power sources of the FDNPP, that is, the off-site power, the emergency generators and the batteries, were in sufficient redundancy against accidental failures and power loss in a regular setting. However, all safety functions were lost simultaneously due to the earthquake and the tsunami. It was fragile when faced with the simultaneous outage of multiple power sources from natural disasters, with no power supply diversity ensured among different plants, and with its fail-safe feature dependent on the switchboard and direct-current power supply (NAIIC, 2012).

These were not in diversity of design and/or technology to avoid common cause failures of submergence and common mode failures of electrical power loss. Not only redundancy but also diversity had to have been realized to ensure that the safety function remained available, as written in the details of I12 in Table 2.

Figure 1. An overall aspect of consequence to FDNPP (NRAJ, 2013)

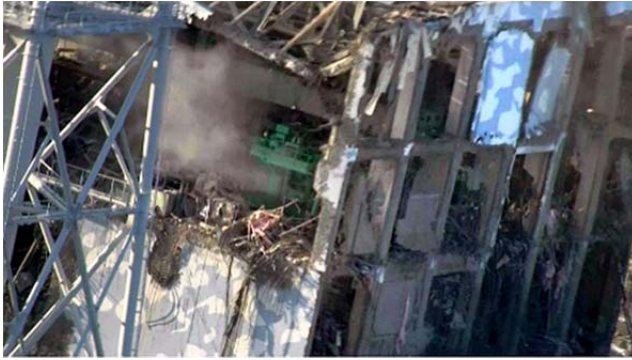
Figure 2. A plume of white smoke rises from around SFP of Unit 4 after the hydrogen explosion (Taken by TEPCO on 16 Mar. 2011)

An alternative method of water injection into the cores by fire engines which required no electricity started about twelve hours after the tsunami. On the other hand, since white smoke looked steam was confirmed to be coming from around the spent fuel pool (SFP) of each damaged reactor building as shown in Figure 2, water sprinkling by helicopters, water spraying by high-pressure water cannon trucks and water spraying by fire engines started in order to maintain water levels of the SFPs six days later (ICAFNPS, 2011). These water supplies were necessary for not only the reactors but also the SFPs.

The hydrogen explosions caused serious damages to the reactor buildings as shown in Figure 2 and could give some damages to the RCVs including the suppression chamber, the devices and piping systems. The explosions had an effect on the escalation of the accident. On the other hand, the hydrogen explosion did not occur at the Units 2 reactor building. It is because a blowout panel (Area: Approx. 4.3 mx6.0 m, working pressure: 3520 Pa) had opened due to the impact of the vibrations or blast from the Unit 1 explosion and much of the leaked hydrogen inside the Unit 2 reactor building was released outside the structure from the blowout panel opening along with steam. Thus this served most likely to hold down the volume of hydrogen that built up inside the Unit 2 reactor building. (ICAFNPS, 2012)

By means of inherently safer ways of limiting the effects of explosions, the building should have been designed so that the explosions that do occur could not produce knock-on effects. In designing the building the TEPCO should have considered the way in which it is most likely to fail, and should have located or designed the equipment so as to minimize the consequences. To provide the building having an explosion-proof and/or the limitation of the effects, the explosion release structure and/or the installation of a rupture disc must have been introduced beforehand. These are K4 and K6 in Table 1.

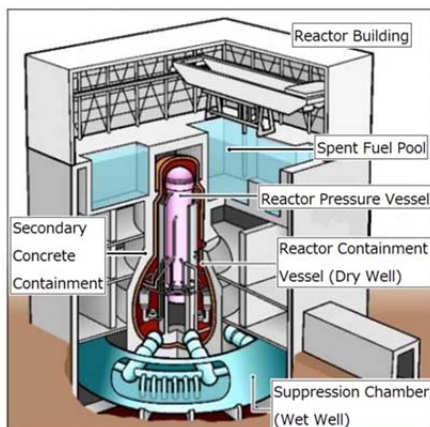
The SFP is storage water pool for spent fuel from nuclear reactors. Not to maintain water level, melt-down of spent fuel might occur due to heat of radiolysis in the worst case. As shown in Figure 3, the SFPs were installed in the reactor buildings of the BWR containments, which made the accident complicated and the countermeasures difficult. The pool having a great hazard should be completely separated from the building. The simplification of K5 in Table 1 was not introduced into the reactor buildings.

A series of hydrogen gas explosions occurred at the top spaces of reactor buildings of Units 1, 3 and 4 individually. The great amount of hydrogen was generated through a zirconium-water reaction because damage to the reactor core progressed, and leaked from the reactor pressure vessel (RPV) into the building via the reactor containment vessel (RCV) (ICAFNPS, 2012). The exploded hydrogen could have come from also the SFP due to radiolysis of hot water, but no quantitative evaluation was given at the stage (NAIIC, 2012). The RPV, the RCV and the SFP are sketched in Figure 3.

Figure 3. Cross-section sketch of Unit 1-5 reactors in FDNPP (US.NRC, 2015) (RPV height: Approx. 20 m)

Inherent safety must tolerate hydrogen gas generation so as not to explode. For instance, a hydrogen gas should have been blanketed with an inert gas. There was no tolerance toward the hydrogen gas generation. Tolerance is K9 in Table 1.

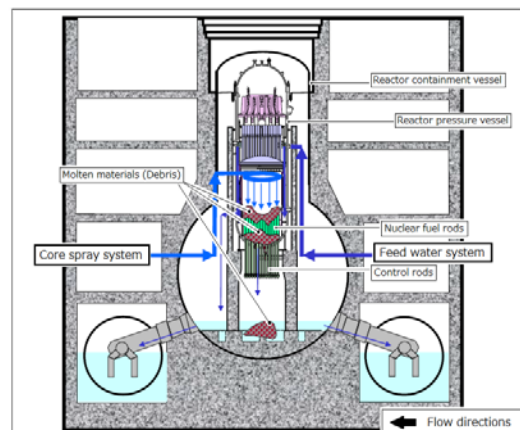
Positioning (withdrawing or inserting) control rods, which are installed on the bottom of reactor pressure vessel as shown in Figure 4, is the normal method for controlling power in the BWR. Fortunately, it was confirmed that all control rods had been fully inserted for shutdowns after the earthquake. However, then the situation became worse and core meltdowns occurred in three reactors of Units 1, 2 and 3 at last (NAIIC, 2012). The structure of the pressure vessel with bottom holes seemed to be vulnerable to water and gases leakage due to extreme heat or contaminant pressure rise followed by the meltdown. This type of the BWR could not directly inject water into the bottom of the reactor containment vessel (pedestal). The vessel should have the tolerance of K9 in Table 1 for an accident.

Figure 4. Presumptive state inside the reactor pressure vessel of Units 2 (TEPCO, 2013)
