Forensic Reconstruction of the Explosion that Occurred at the Cordero Flour Mill, Cuneo, Italy

This paper contains the forensic reconstruction of a powerful explosion that occurred in a flour mill in Italy in 2007. The mill produced wheat flour and was organised over 4 floors inside a very old building. The explosion occurred just after a tanker had been loaded with flour which was to be delivered to customers. Since the truck was loaded with a slight excess of flour, a small amount was sent back to one of the silos, via pneumatic transport, through a rubber hose connected to a steel pipe. The explosion destroyed the building and killed 5 workers.

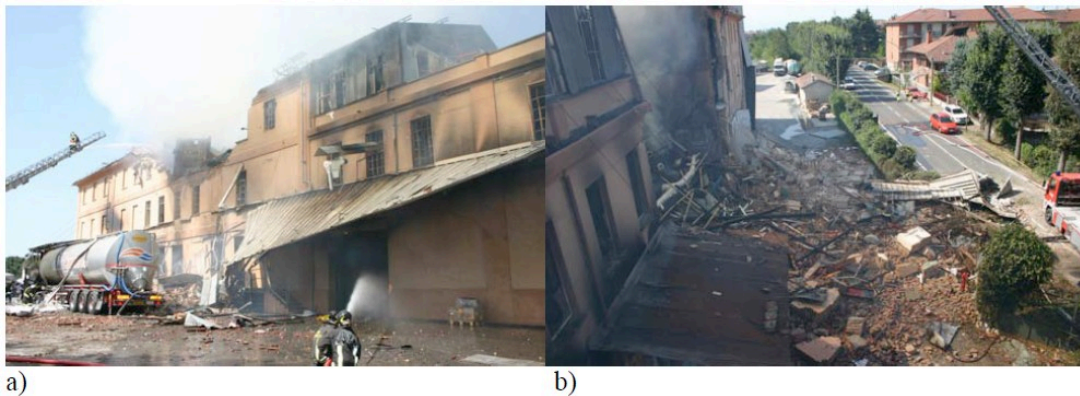
Figure 2 Damage to the main building: a) southern face; b) northern face

Because of the explosion, most of the main building of the mill underwent a significant, but not complete, collapse, in the areas marked as A and B in the plan (Figure 2 a/b). Other parts of the building suffered from less (areas C and F) or very slight (areas D and E) structural damage.

In particular the collapse that occurred in the basement of all the B rooms and of the relative equipment should be pointed out: plansifters, mills, cyclones, cochleas and elevators ducts. Most of the equipment was not involved in the fire and it still shows the original paintwork. The north wall collapsed completely, while the internal ones were damaged, but remained in their original position. The internal staircase was still in its original position, even though its stability was totally compromised.

The equipment and walls in the A area of the basement mainly showed signs of fire, which had burned in the area over a long period. The equipment in this area did not show any sign of internal overpressure, while the ceiling of area A0 was damaged by internal overpressure. The same applies for the A1 area (Figure 1), as well as for the hoist bay, which appeared to be destroyed by internal overpressure. The overpressure from the hoist provoked major damage to the structures on the Southern side of the building. The rooms in the A areas of the intermediate floors were completely destroyed: the roofs and the perimetral walls. The upper hoist slab was also wrecked.

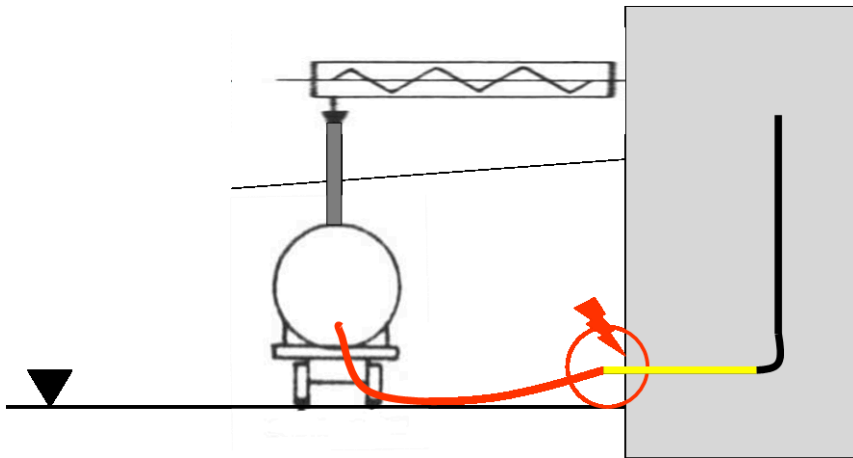
Figure 3 Simplified representation of the unloading operation with the triggering location.

The day the accident occurred, a delivery had to be made to a confectionery company. The tanker was loaded, as usual, by gravity, using a bucket elevator and a specific cochlea. At the end of the loading operation, an extra amount of product was loaded. The operator unloaded this surplus, pneumatically conveying it back to a silo located in the flour-warehouses. During this operation, the tanker discharge device was connected to the pneumatic transport line through one of the tanker hoses. The unloading system, thus, consisted of two metallic conductor bodies, the truck and the pipe, separated by an insulating one, the hose (6 m long). The two conductors were not equipotential, since the truck was not connected to a grounding system, while the pipe instead was grounded.

In the present case, the charge accumulation occurred due to the friction of the dust in the rubber duct (or even during the loading procedure). When the flour reached the metal pipe at the end of the hose, it found a discharge point and a propagating brush discharge was generated. The discharge occurred between the flour suspension in the pipe and the pipe wall, and a primary explosion was triggered inside the duct. The pressure front propagated along the duct, and escalated due to the confinement.

A propagating brush discharge occurred between the flour in the pipe and the metallic wall and it triggered a primary explosion inside the pipe. The triggering point was identified inside the pipe next to the connection between the hose to the pipe.

None of bucket elevators, which were also heavily damaged by the event, was equipped with an appropriate system to vent possible explosions or with a explosion suppression system. As far as the operation carried out at the moment of the accident are concerned, if the vehicle had been grounded, it would have reduced the charge accumulation during loading operations.

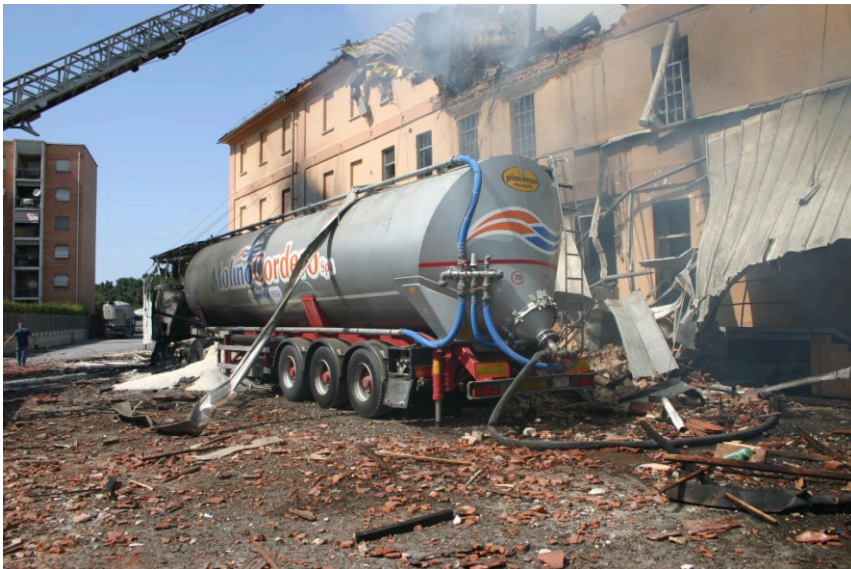
Figure 4 The tank after the accident

The status of the control valves onboard the tanker (Figure 4) showed that the operation was carried out at a low flour flow rate, thus with a low concentration of flour in the duct (near or within the lower flammability limit).

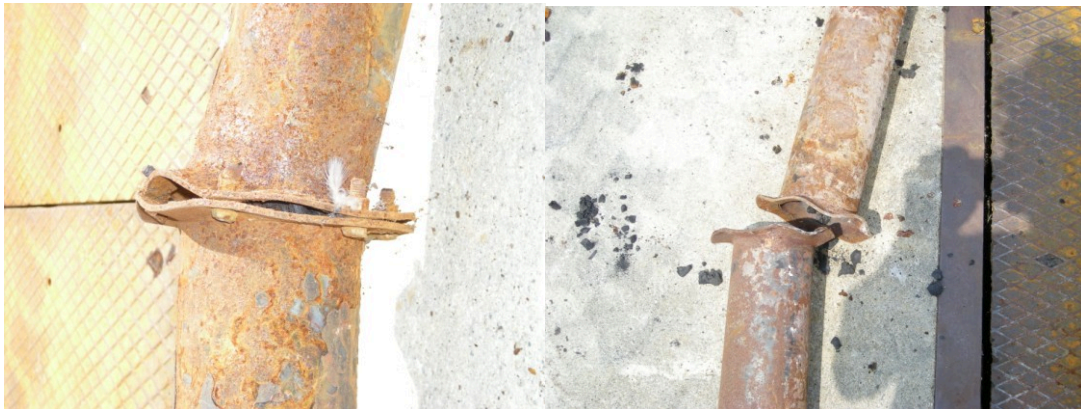
Figure 5 Flanges of the flour discharge pipe

The flanges showed the typical deformations caused by high internal pressure, which produced much higher stresses to the material than the elastic limit and thus creating a permanent deformation.

The mechanical strain produced the deformation of the duct flanges, as can be seen in Figure 5.

The dynamics of the explosion propagation was therefore certainly complex. The deformation of the flanges compromised their sealing capacity, thus creating venting openings for the pressure and the flame front and this led to the propagation inside areas A, over the three floors.
