The Impact of Climatic Factors to the Structure of Unprotected Expanded Polystyrene (EPS) External Insulation on Building

Edgaras Mickevičius¹, Asta Kičaitė^{1*} and Andrius Buska²

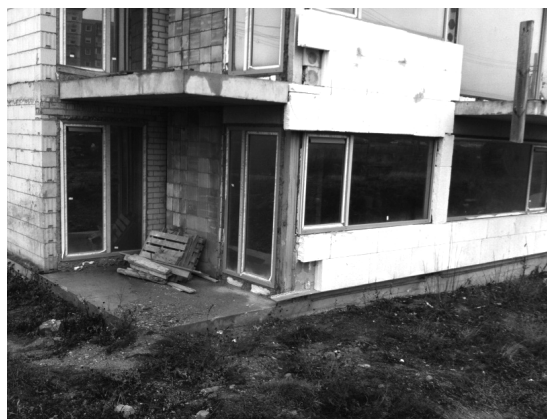
Testing was carried out with expanded polystyrene slabs taken from an unfinished apartment building which construction was suspended for more than two years (Fig. 1). A plastered thermal insulation system with expanded polystyrene slabs (dimensions: 1,000 x 500 x 150 mm) was used on the external side of the building. It can be seen in Fig. 1 that the foam polystyrene slabs were plainly glued and were not covered with any protective layer. In most places, the slabs had already fallen down or were otherwise removed from the facade. Samples for testing were taken from the bottom part of the facade, above the socle.

Fig. 1. Building from which samples were taken

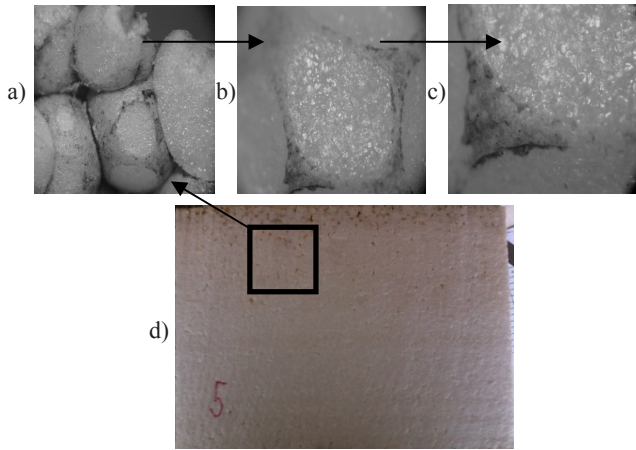
The sample was first of all examined by visual evaluation: darker parts are visible in the upper part of the

sample (Fig. 3 d). Further studies were carried out using optical and electronic microscopes.

Fig. 3. Images of the macrostructure of the sample with and without an optical microscope: a) magnified 12 times, b) magnified 25 times, c) magnified 50 times, d) image without optical microscope

It can be seen in Fig. 3a that water is present between expanded polystyrene granules and its deep penetration inside the sample. Further magnification shows damaged granules of the expanded polystyrene. For more precise results, the structure was studied using an electronic microscope (Fig. 4). Damage to the surface of the granules was established.

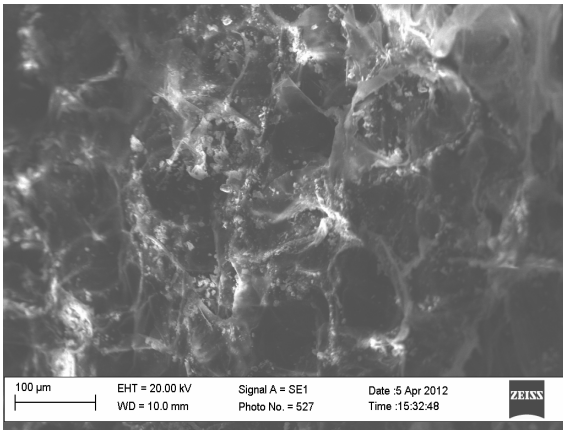
Fig. 4. An image of the microstructure of the sample (magnified 300 times)

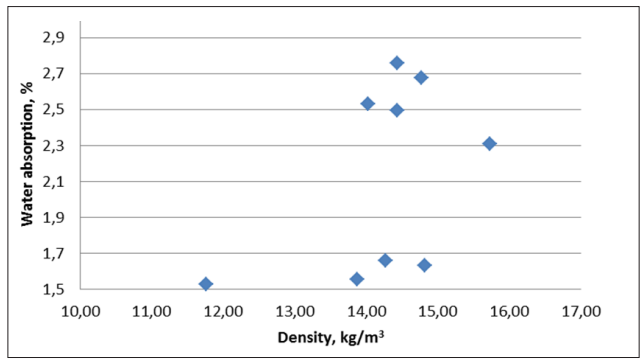
Further long-term (28 days) water absorption testing was carried out. The results of water absorption testing obtained showed that water absorption of immersed polystyrene foam samples with damaged surface fluctuates between 1.4 % and 2.7 %, where density is relatively the same (Fig. 5). Samples, where earlier water absorption influence in natural conditions was voluminous, i.e. water absorption depth were higher, after test characterised bigger amount of water absorption, with the same density. In average 14.49 kg/m³ density water absorption values were 1.7 %, 2.7 % and 2.8 %. These results were obtained due to the depth of the damaged layer in the samples. The pores that merged in the damaged surface formed capillaries, through which water was absorbed into deeper layers (in this case water absorption should be higher).

Fig 5. Water absorption dependence on density

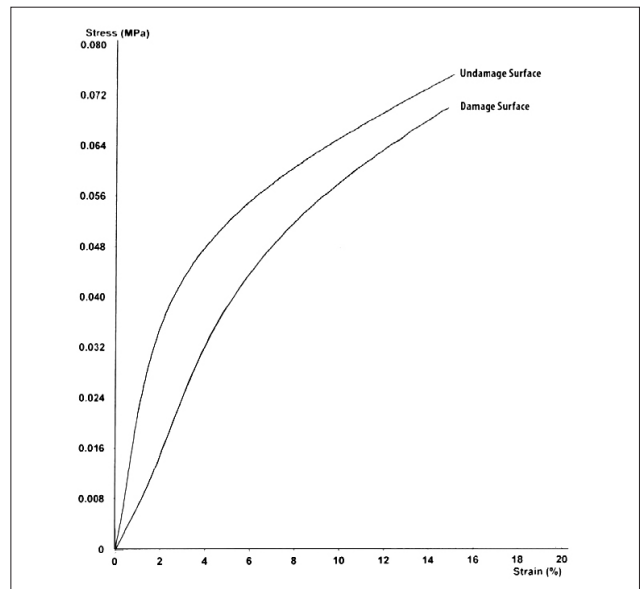
The determination of the compressive strength of expanded polystyrene samples did not reveal any clear destruction of the samples or any precisely expressed value of compressive strength (Fig. 6 and Fig. 7). These parameters are determined in relative terms – as a load complying with the assigned material deformation level at 10 % relative deformation (“Thermal insulating products for building applications – Determination of compression behaviour” LST EN 826:1998 Thermal insulating products for building applications – Determination of compression behaviour).

Fig. 6. Diagram of compression strength of samples

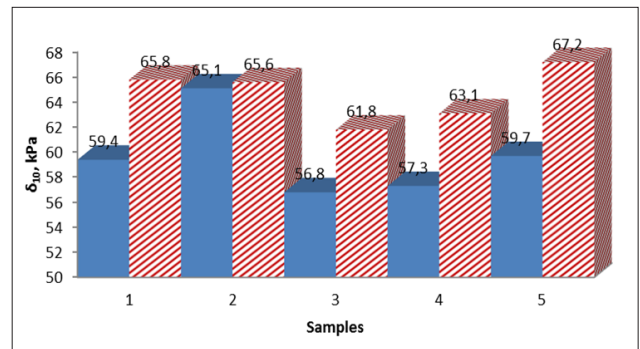
Fig. 7. Compression strength of samples at 10% deformation (Damaged samples are portrayed in blue and control samples are portrayed in red)

2. Testing of compression strength of expanded polystyrene samples damaged by the environment showed that these samples are destroyed quicker. In this case, compression values are from 57,3 to 65,1 kPa.

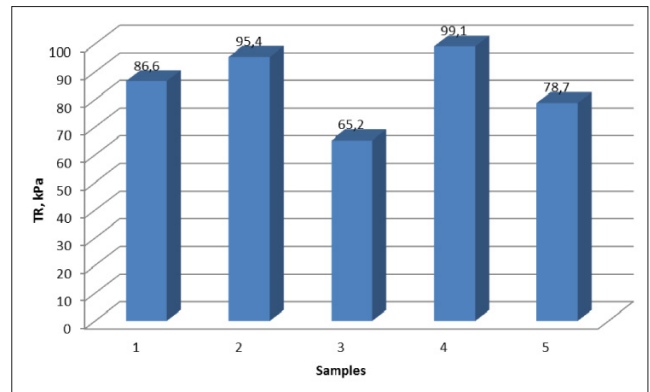
The results of the testing were unequal depending on the nature of breakage. Samples with even surfaces broke at the centre, average tensile strength was 84.3 kPa, while the nature of the breakage of damaged samples varied. It can be seen in Fig. 9 that the values for damaged expanded polystyrene samples were in the range of 65.2–99.1 kPa. The instances of sample breakage can be seen in Fig.11. In comparison with undamaged samples, the sample breakage through the sample lowest value (78.3 kPa) is higher than breakage through damage zone (65.2 kPa) (Fig. 9; Fig. 10). According to the control sample determination of the compressive and tensile strengths, we can maintain that expanded polystyrene should be EPS 70. The producers in Lithuania do not provide tensile strength in declarations of conformity. According to EN 13163 only one strength parameter should be declared. It is strange why producers only declare compression strength as the required tensile strength should be not lower than TR100 for all ETICS systems; therefore, the producers don not have any confirmation that their own system confirms to all required properties according to ETAG 004. According to the possible producers the samples do not meet the normative strength requirements for application. Tensile strength is lower than 100 kPa. Usually, for plastered facades not lower than EPS 70 is used.

Fig. 9. Tensile strength of damaged expanded polystyrene samples

be damaged by solar radiation and moisture-frost impact, which will affect very low adhesion with plaster. It is advised to remove all boards damaged by climatic factors and replace them with new ones or apply onto to the existing expanded polystyrene slabs the additional medium thin products slab, glues and fix to the wall base with the fasteners. The period of 2 years of these boards being outside without protecting layers is too long.

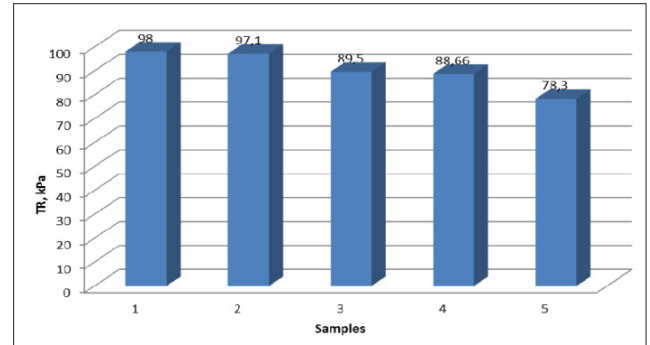
Fig. 10. Tensile strength of undamaged expanded polystyrene samples

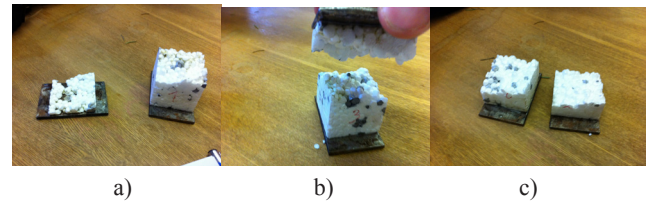
Fig. 11. Instances of sample breakage: a) breakage next to the plate; b) breakage next to the area damaged by water; c) breakage through the sample

3. Testing of tensile strength of polystyrene samples showed that the breakage nature of the samples varies. Breakages occur in the weakest areas, i.e. in the most damaged areas. According to the materials used in external system, tensile and compression strengths do not meet the normative strength requirements. According to EN 13163 EPS boards' tensile strength must be not lower than 100 kPa.
