Nonlinear modeling of unreinforced masonry structures under seismic actions: validation using a building hit by the 2016 Central Italy earthquake

This work aimed at assessing the seismic performance of “Pietro Capuzi” school, an unreinforced masonry structure located in the municipality of Visso, in the Marche region, Italy. The school suffered severe and extensive damage due to the 2016-2017 Central Italy earthquake (also named the Amatrice-Norcia-Visso seismic sequence) and it was demolished in 2018 since a strengthening intervention was considered economically inconvenient. “Pietro Capuzi” school was an excellent case study to investigate the seismic capacity of an existing masonry structure for several reasons. Firstly, the school was part of the public buildings permanently monitored by the Seismic Observatory of Structures (hereafter named OSS). As a result, the entire seismic sequence affecting the school was recorded by the existing system of accelerometers, thus providing valuable information in terms of ground motion and structural seismic performance [4] [5]. Secondly, the inspection and the extensive experimental campaign that were performed in 2010-11 on behalf of the

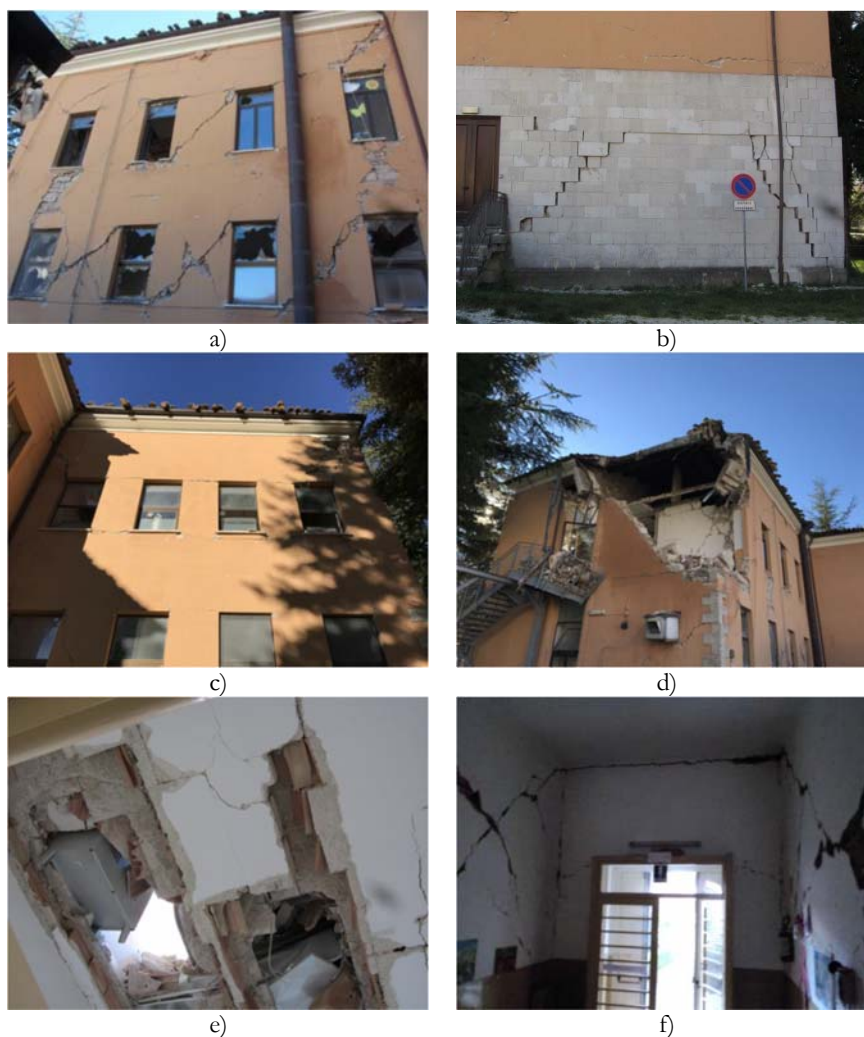
The most significant damage observed in “Pietro Capuzi” school after the Amatrice-Norcia-Visso seismic sequence is presented in Figure 4, updated on December 8th, 2016. A more detailed description can be found in [11]. As shown in Figure 4a, the walls were affected by severe cracks at both the raised ground floor and first floor, especially in the Y direction where the damage was more severe and widespread than in the X direction. The building mainly presented diagonal shear cracks developing through the entire thickness of the walls in both piers and spandrels. Furthermore, a shear-sliding mechanism producing an important residual deformation was activated in the northwest side of the building (Figure 4b). Flexural cracks were also observed on the southeast side of body B (Figure 4c). In addition to the in-plane damage, an out-of-plane mechanism occurred in the northwest corner of the building, resulting in the partial collapse of masonry walls (Figure 4d). With regard to the slabs, two local collapses occurred between the raised ground floor and first floor (Figure 4e). Furthermore, the steel slab between the first floor and attic experienced an extensive collapse because of the out-of-plane mechanisms as well as cracks along the metallic profiles in the portions of slab still standing. As for the connection between vertical walls and slabs, horizontal cracks were present in the external walls at the slab locations. In the interior, severe cracks were observed in correspondence of the connection between walls and slabs (Figure 4f).

Figure 4: Damage state updated on December 8th, 2016: a) diagonal shear cracks in piers and spandrels, b) shear-sliding mechanism, c) flexural cracks, d) out-of-plane mechanism, e) local collapse of the slab between the raised ground floor and first floor, f) cracks in correspondence of the connection between walls and slabs [11].

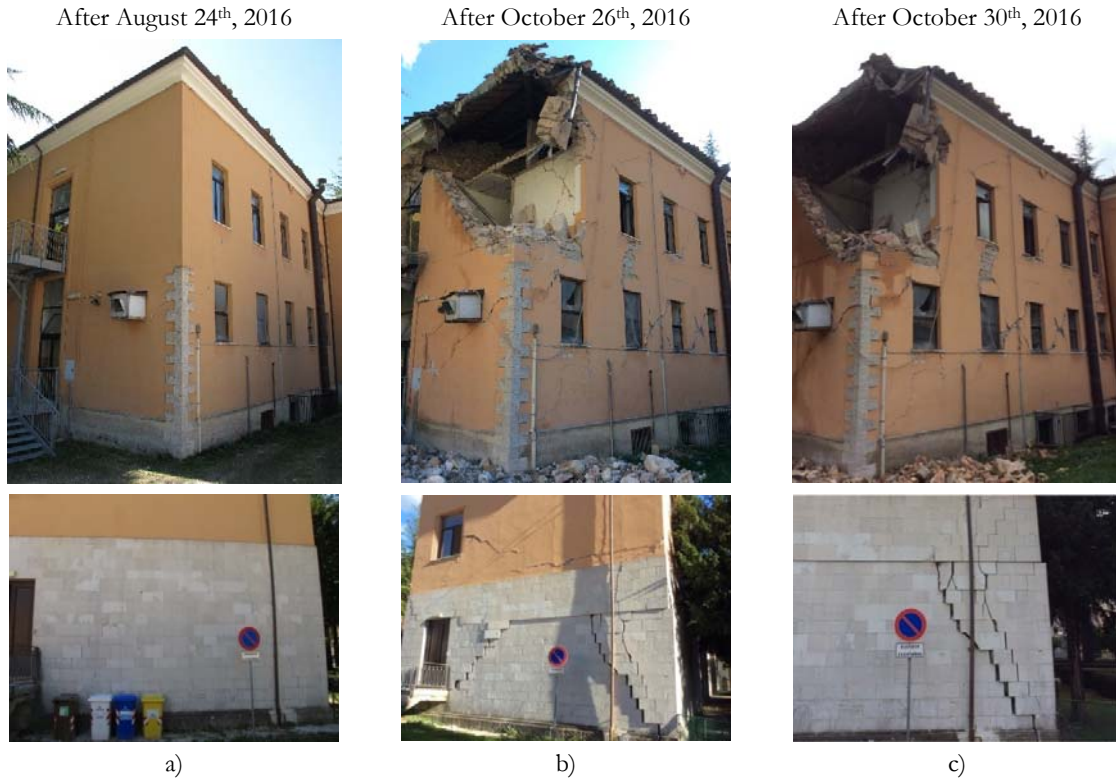
A partial reconstruction of the damage development was carried out thanks to the photographic documentation provided in [11, 12]. As shown in Figure 5a, the seismic event of August 24th induced an in-plane response with slight to moderate cracking affecting the walls. Severe cracks were also observed in few piers of the external and internal walls. Figure 5b shows

the significant deterioration of the building conditions produced by the earthquakes of October 26th, 2016. Large and extensive cracks occurred in most of the walls, especially in the Y direction. Furthermore, an out-of-plane mechanism was activated in one corner. As shown in Figure 5c, the damage state did not change significantly after the shake of October 30th as compared with October 26th.

Figure 5: Damage observed in “Pietro Capuzi” school after the earthquakes that occurred on: a) August 24th, 2016, b) October 26th, 2016, and c) October 30th, 2016 [11, 12].

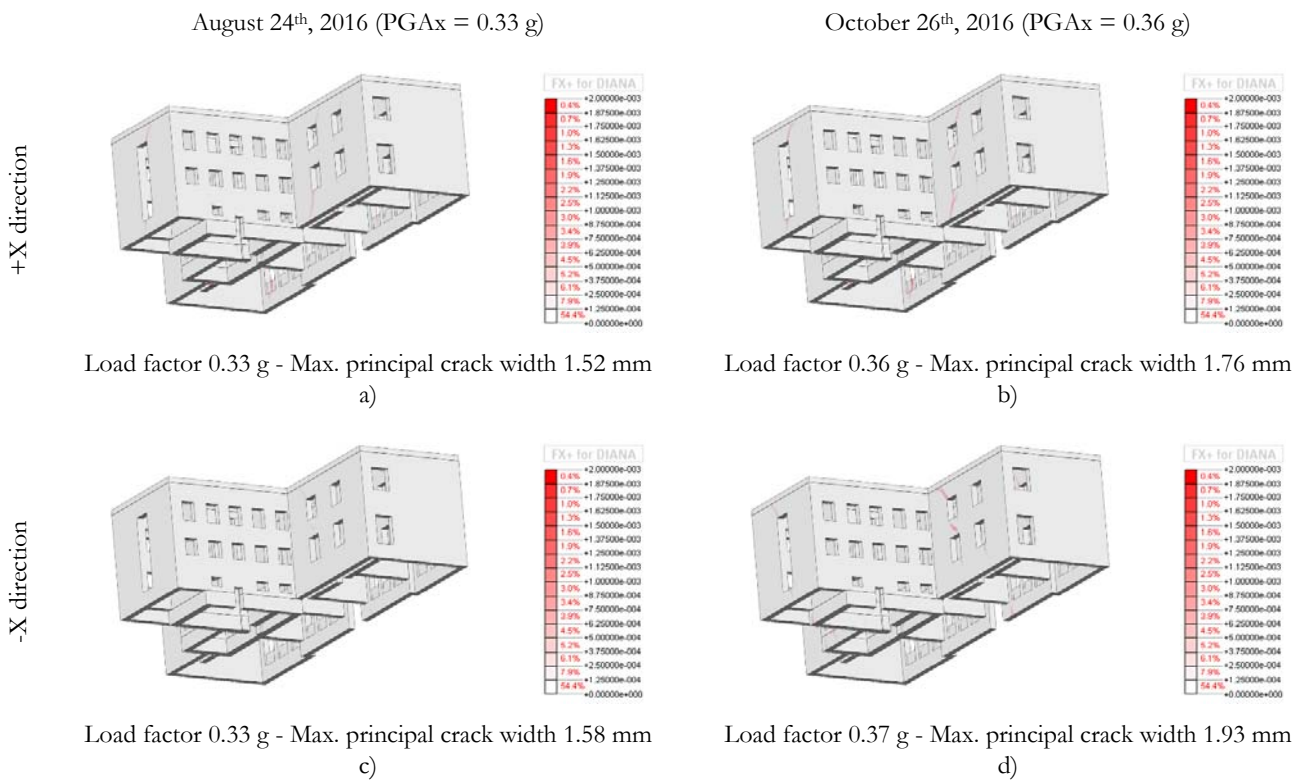
Regarding the pushover analyses in the direction of the X global axis, the damage obtained for the seismic event of August 24th (Figure 16a-c) is similar in terms of extent and severity to the one induced by the October 26th earthquake (Figure 16b-d). Indeed, both shakes produce a slight damage consisting in the formation of minor cracks, mainly due to in-plane shear stresses, around the openings of body A and body B (Figure 16). A slight increase in the level of damage from August 24th to October 26th can be observed on the basis of the values of principal crack width obtained for the two seismic events considered (Figure 16). Regarding the analysis in the +X direction, the maximum principal crack width increases from the value of 1.52 mm, obtained for a horizontal load of 0.33 g (August 24th earthquake), to the value of 1.76 mm, reached under a horizontal load of 0.36 g (representing the October 26th earthquake). Similarly, when the horizontal load is applied in the -X direction, maximum principal crack widths of 1.58 mm and 1.93 mm are obtained for load factors of 0.33 g (August 24th) and 0.37 g (October 26th), respectively. These results were expected since similar PGA values were registered in the X direction of the building in the seismic events of August 24th and October 26th. Furthermore, similar average displacements are obtained at the top of the model for either earthquake, as shown in Figure 15. The average top displacement is 9 mm for the August 24th earthquake, in both +X and -X directions, and is equal to 10 mm and 11 mm in the positive and negative direction of analysis, respectively, for the October 26th earthquake.

Figure 16: Principal crack width for horizontal load factors comparable to the PGA recorded in the X direction of the building in the seismic events of August 24th, 2016 (left) and October 26th, 2016 (right): a)-b) +X direction, c)-d) -X direction.

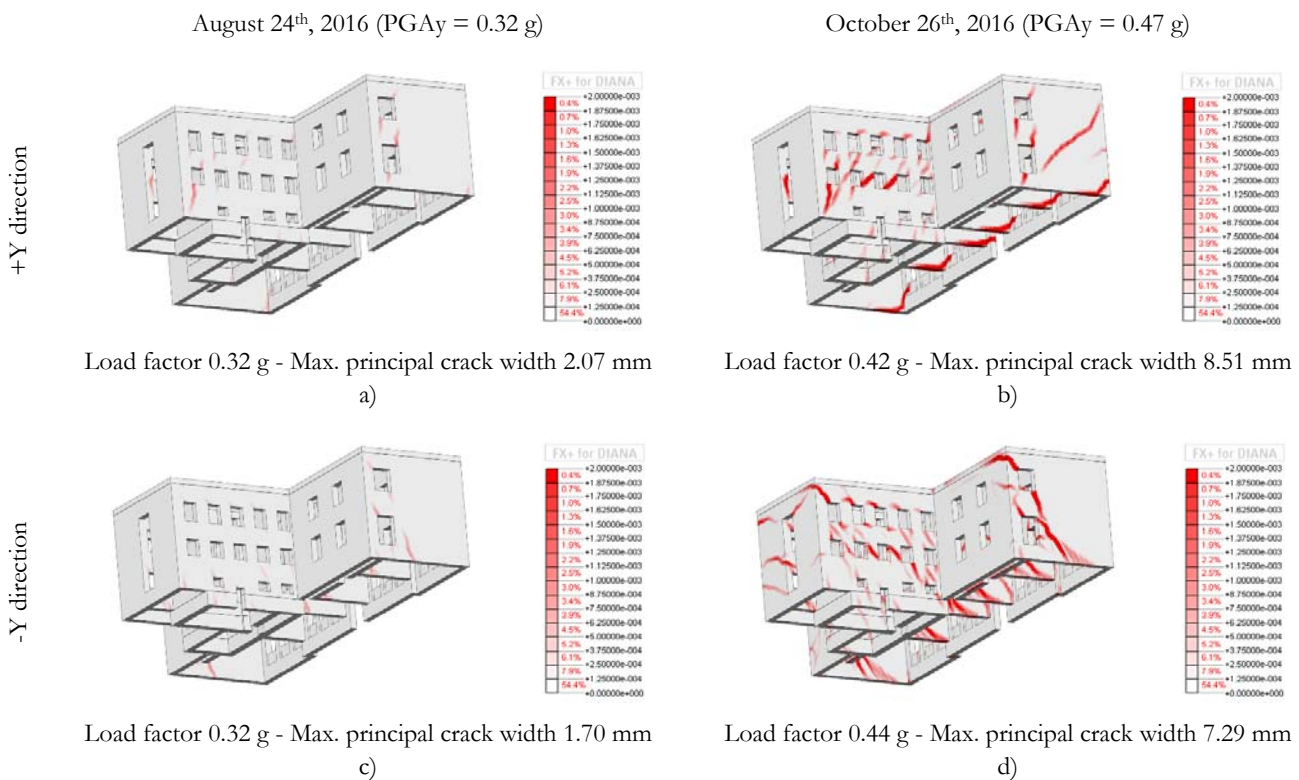
Figure 17: Principal crack width for horizontal load factors comparable to the PGA recorded in the Y direction of the building in the seismic events of August 24th, 2016 (left) and October 26th, 2016 (right): a)-b) +Y direction, c)-d) -Y direction.

With respect to the pushover analyses performed in the direction of the Y global axis, a moderate damage is obtained under the lateral load of 0.32 g , representing the PGA of the August 24th earthquake, in both the positive and negative directions. Differently from what observed for the X direction, the severity of the damage increases significantly under horizontal loads comparable to the PGA registered in the Y direction of the building in the October 26th earthquake (Figure 17). This was expected since the PGA of the October 26th earthquake was 1.5 times higher than the one of the August 24th earthquake (0.32 g). Furthermore, from Figure 15 it can be observed that the structure has just exited the linear elastic range for the PGA of the August 24th earthquake, whereas it shows a highly nonlinear response for the October 26th earthquake. Under a lateral load of 0.32 g (August 24th) an average top displacement of about 12 mm is obtained in both $+Y$ and $-Y$ direction, whereas the top displacement increases to about 37 mm and 42 mm in the $+Y$ and $-Y$ directions, respectively, for horizontal

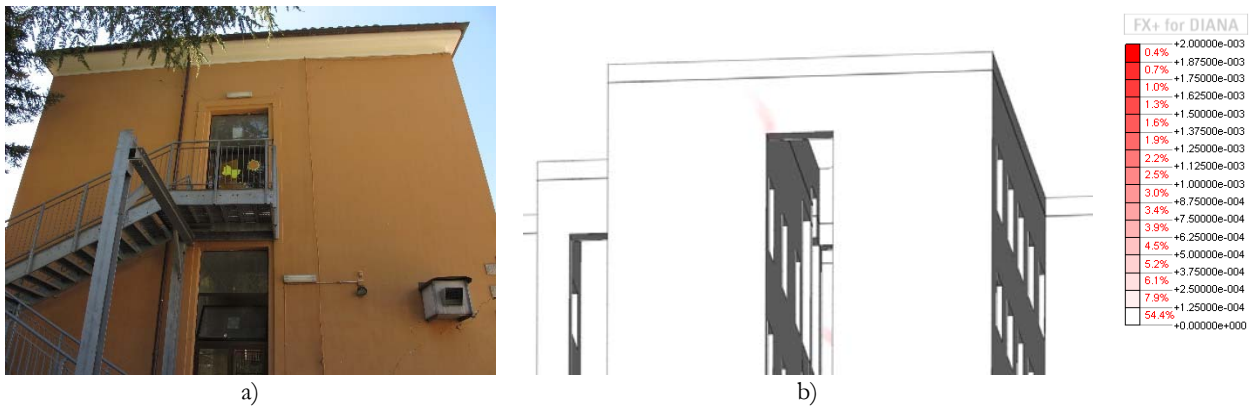
Figure 18 and Figure 19 show a correlation between the numerical and real damage occurred in some walls oriented in the X direction for the August 24th and October 26th earthquakes, respectively. It is observed that the damage obtained from pushover analyses is compatible with the crack pattern observed in-situ. In fact, slight to moderate damage is observed for both the seismic events of August 24th (Figure 18) and October 26th (Figure 19). As shown in Figure 18b and Figure 19b-d, the crack width plot depicts a damage pattern mainly consisting in shear cracks present around the openings, in agreement with the real damage experienced by the structure.

Figure 18: Correlation between the real and numerical damage occurred in the north wall of body B due to the August 24th earthquake ($PGA_x = 0.33\text{ g}$): a) cracks observed in-situ [11, 12], b) crack pattern in terms of principal crack width for a horizontal load of 0.33 g in the $-X$ direction.

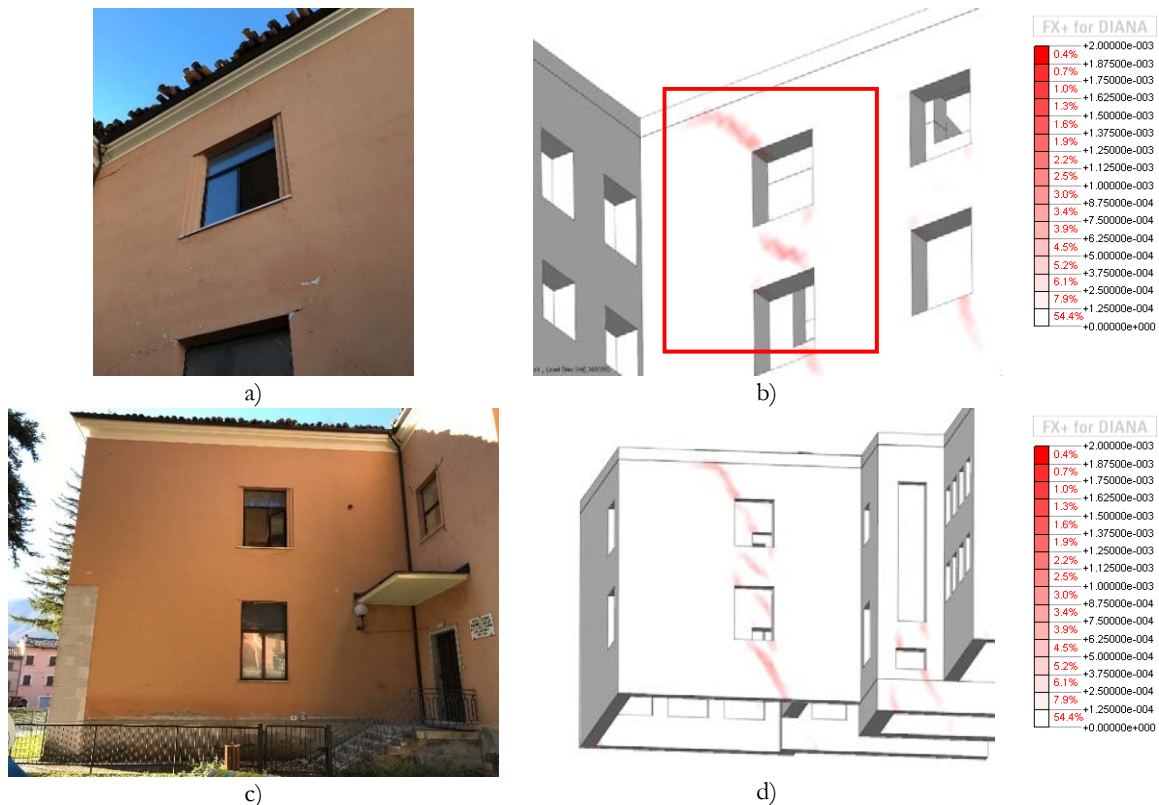
Figure 19: Correlation between the real and numerical damage occurred in the north external walls of body A due to the October 26th earthquake ($PGA_x = 0.36\text{ g}$): a-b) cracks observed in-situ [11, 12], b-d) crack pattern in terms of principal crack width for a horizontal load of 0.37 g in $-X$ direction.

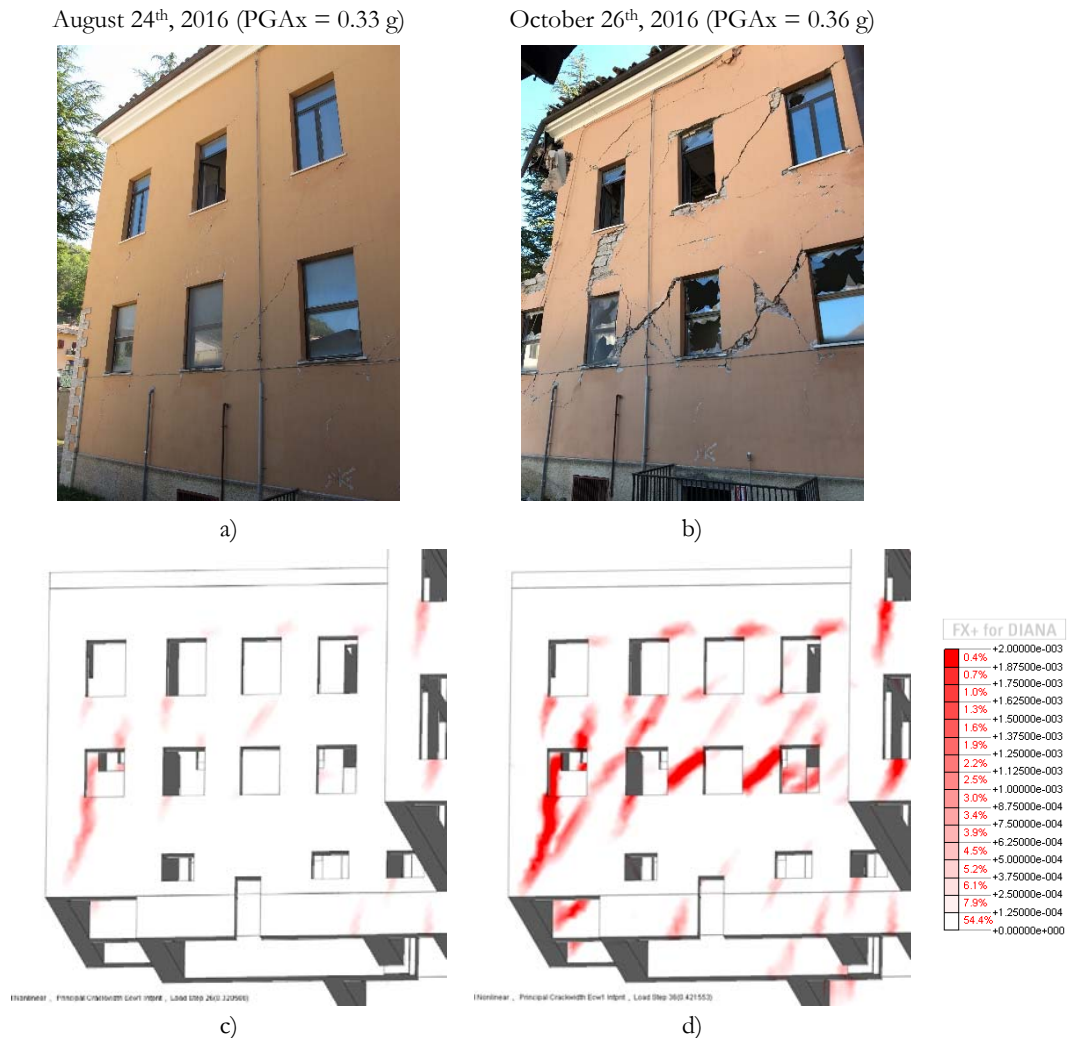
Figure 20, Figure 21 and Figure 22 present the numerical and real damage caused to some walls oriented in the Y direction by the seismic events of August 24th and October 26th. It is observed that the damage patterns obtained from pushover analyses are in good agreement with the damage observed in-situ, this confirming the validity of the numerical model. For the August 24th earthquake, fine and moderate cracks, mainly due to shear, occur in both external (Figure 20c and Figure 21c) and internal walls (Figure 22c). As shown in Figure 20d, Figure 21d and Figure 22d, the earthquake of October 26th produces a significant increase in the level of damage, which consists in the enlargement of the existing cracks and opening of new ones. As a result, severe cracks are observed throughout the building in both the external and internal walls. The damage mechanism mainly consists of diagonal shear cracks developing through the entire thickness of the walls in both piers and spandrels (Figure 20d and Figure 21d). Flexural cracks are also observed around the openings of the external walls, as shown in Figure 20d and Figure 21d.

Figure 20: Correlation between the real and numerical damage occurred in the west external wall of body B due to the August 24th (left) and October 26th (right) earthquakes: a-b) cracks observed in-situ [11, 12], c) crack pattern in terms of principal crack width for a horizontal load of 0.32 g in the +Y direction, d) crack pattern in terms of principal crack width for a horizontal load of 0.42 g in the +Y direction.

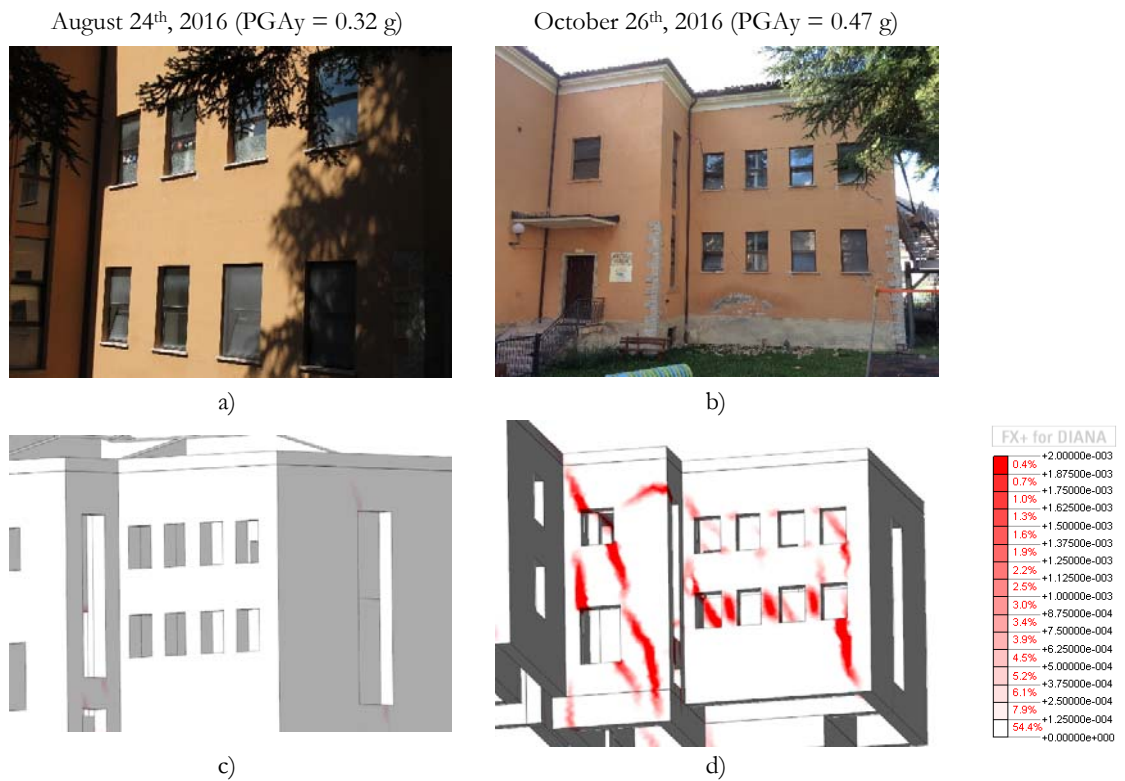
Figure 21: Correlation between the real and numerical damage occurred in the east external wall of body B due to the August 24th (left) and October 26th (right) earthquakes: a-b) cracks observed in-situ [11, 12], c) crack pattern in terms of principal crack width for a horizontal load of 0.32 g in the +Y direction, d) crack pattern in terms of principal crack width for a load of 0.42 g in the +Y direction.

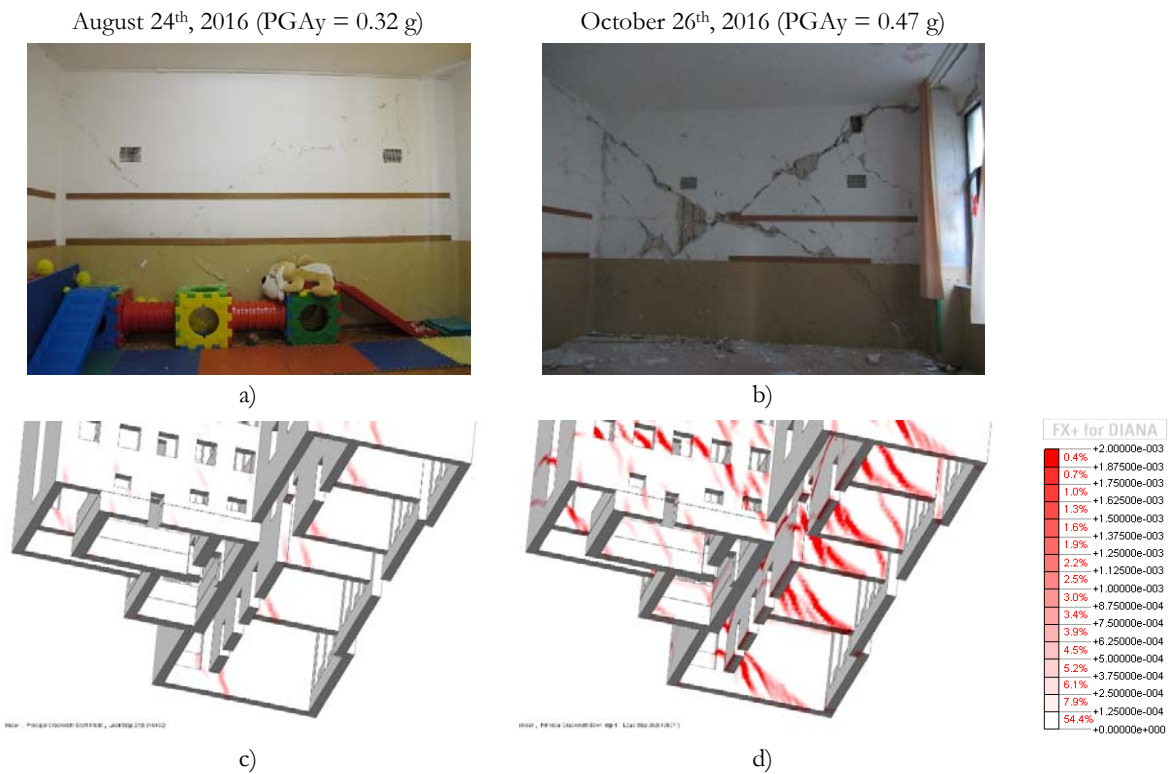
Figure 22: Correlation between the real and numerical damage occurred in the internal walls of body A due to the August 24th (left) and October 26th (right) earthquakes: a-b) cracks observed in-situ [11, 12], c) crack pattern in terms of principal crack width for a horizontal load of 0.32 g in the -Y direction, d) crack pattern in terms of principal crack width for a horizontal load of 0.44 g in the -Y direction.
