Determination of the geometric parameters of the defects based on the tomographically obtained data and their influence on the fatigue behavior of the S960 with laser cladded protective layers

Pavel Doubek

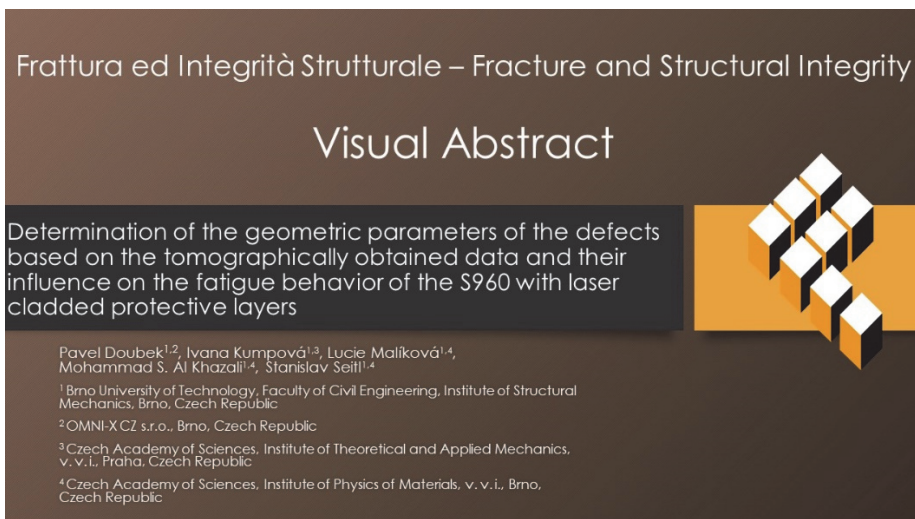
Citation: Doubek, P., Kumpová, I., Malíková, L., Al Khazali, M.S., Seitl, S., Determination of the geometric parameters of the defects based on the tomographically obtained data and their influence on the fatigue behavior of the S960 with laser cladded protective layers, *Fracture and Structural Integrity*, 71 (2025) 67-79.

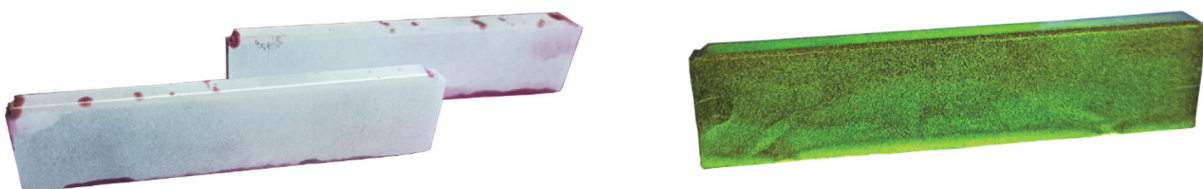
Figure 4: Example of the non-destructive detection of the open surface cracks and non-solids in the aluminium bronze/S960 samples; (a) Dye Penetrant Crack test with indicated surface defects; (b) Magnetic Particle inspection

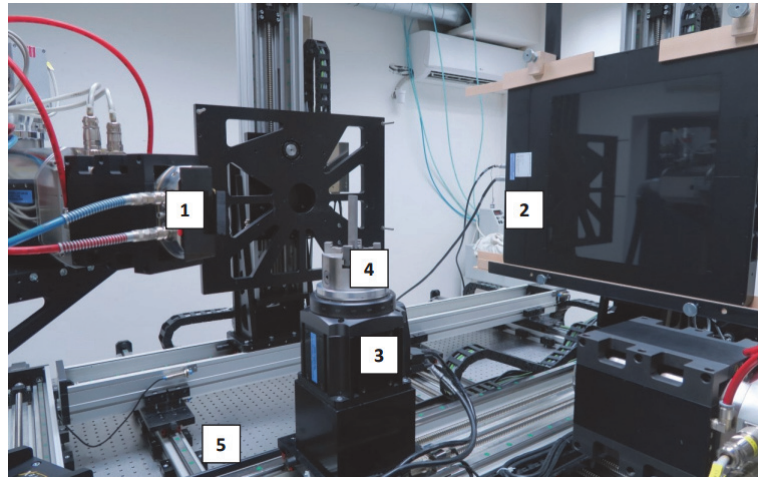
Figure 5: Photo of arrangement of the TORATOM tomograph during an irradiation of the studied samples; (1) X-ray tube XWT-240-SE; (2) flat panel detector XRD 1611; (3) high-precision rotary platform with a vertical axis of rotation; (4) chuck with an attached sample; (5) anti-vibration table with an active damping terminus of vibrations and CNC-controlled feeds component.

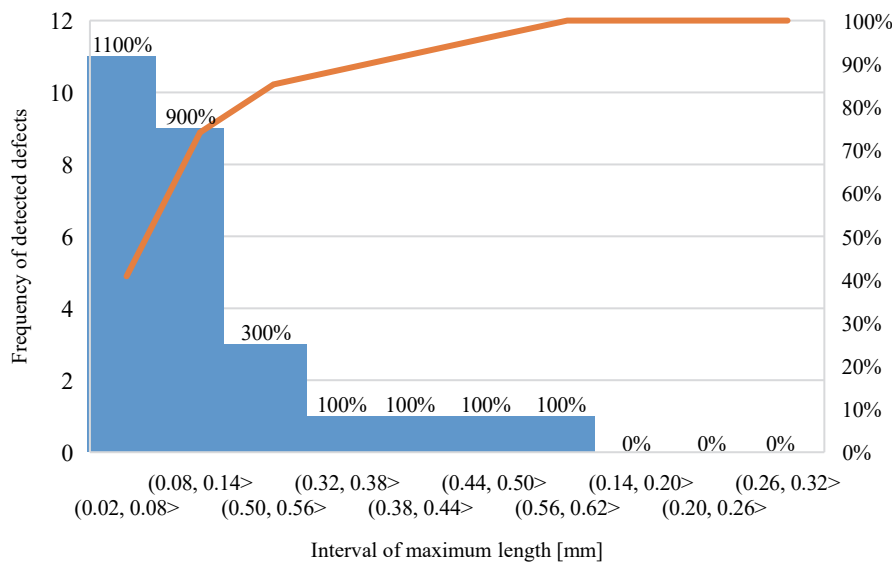
Figure 5: Distribution of frequency of defects detected in sample B9/17.

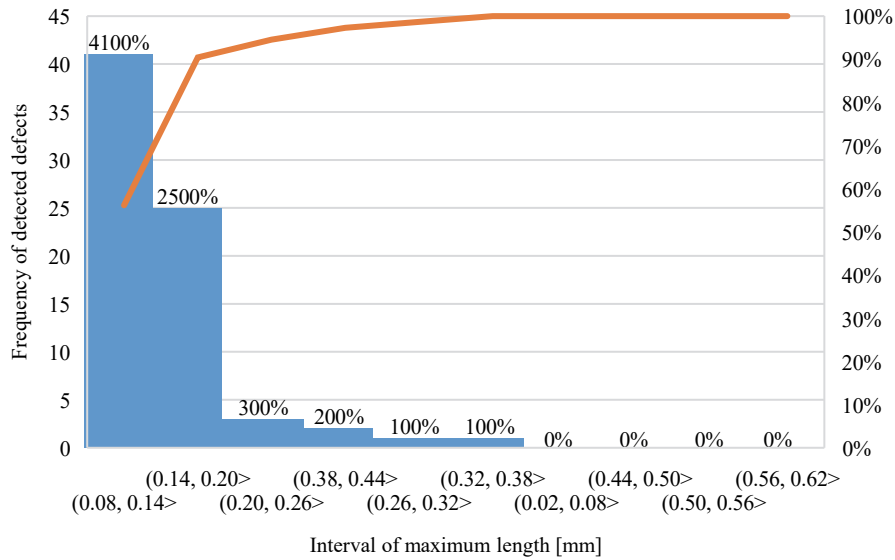
Figure 6: Distribution of frequency of defects detected in sample T34

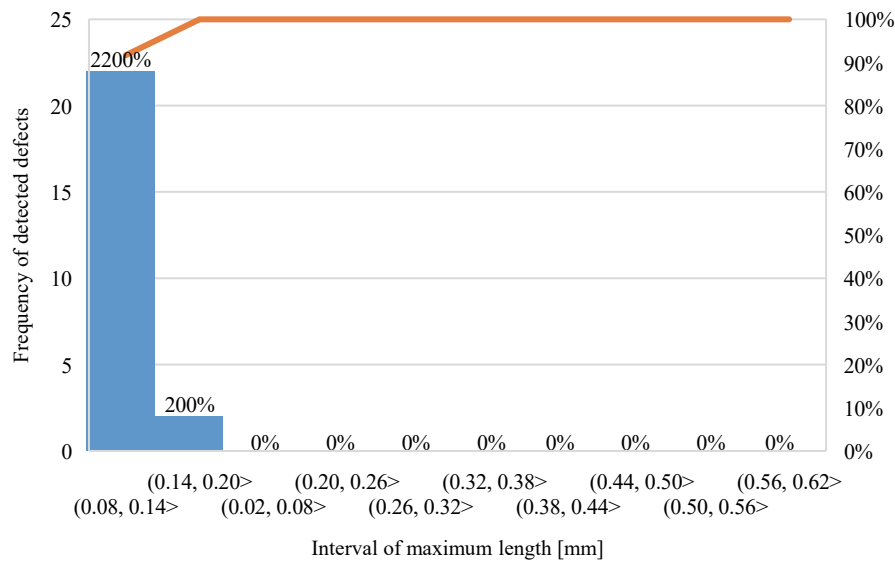
Figure 7: Distribution of frequency of defects detected in sample ST9/14

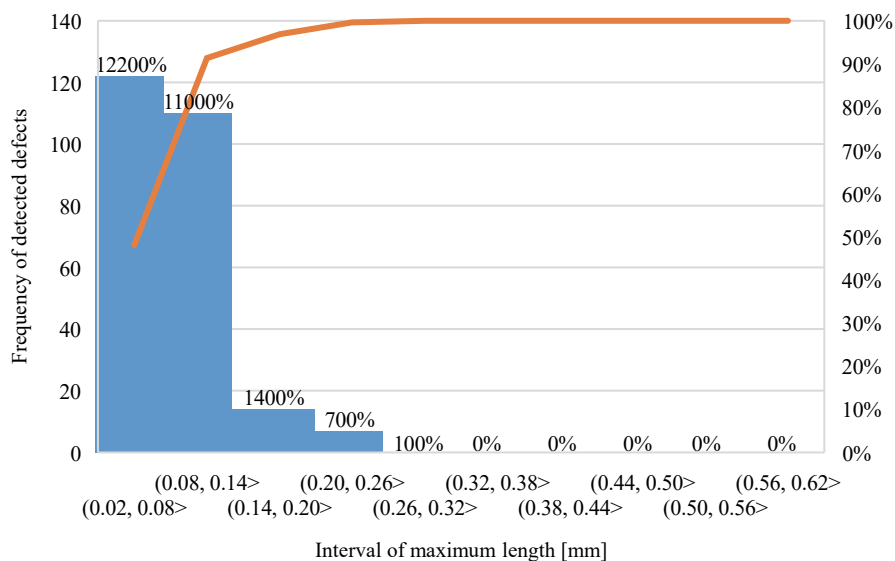
Figure 8: Distribution of frequency of defects detected in sample N9/17

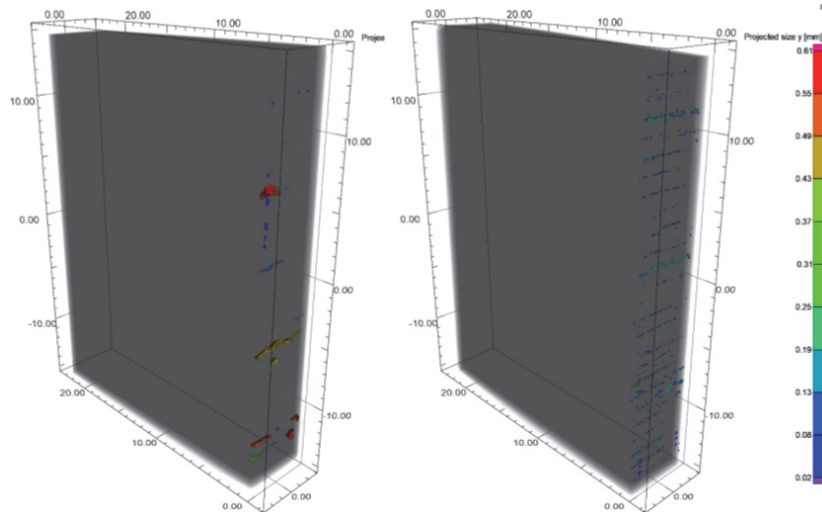
Figure 9: Three-dimensional representation of detected faults for the samples B9/17 (left) and N9/17 (right).

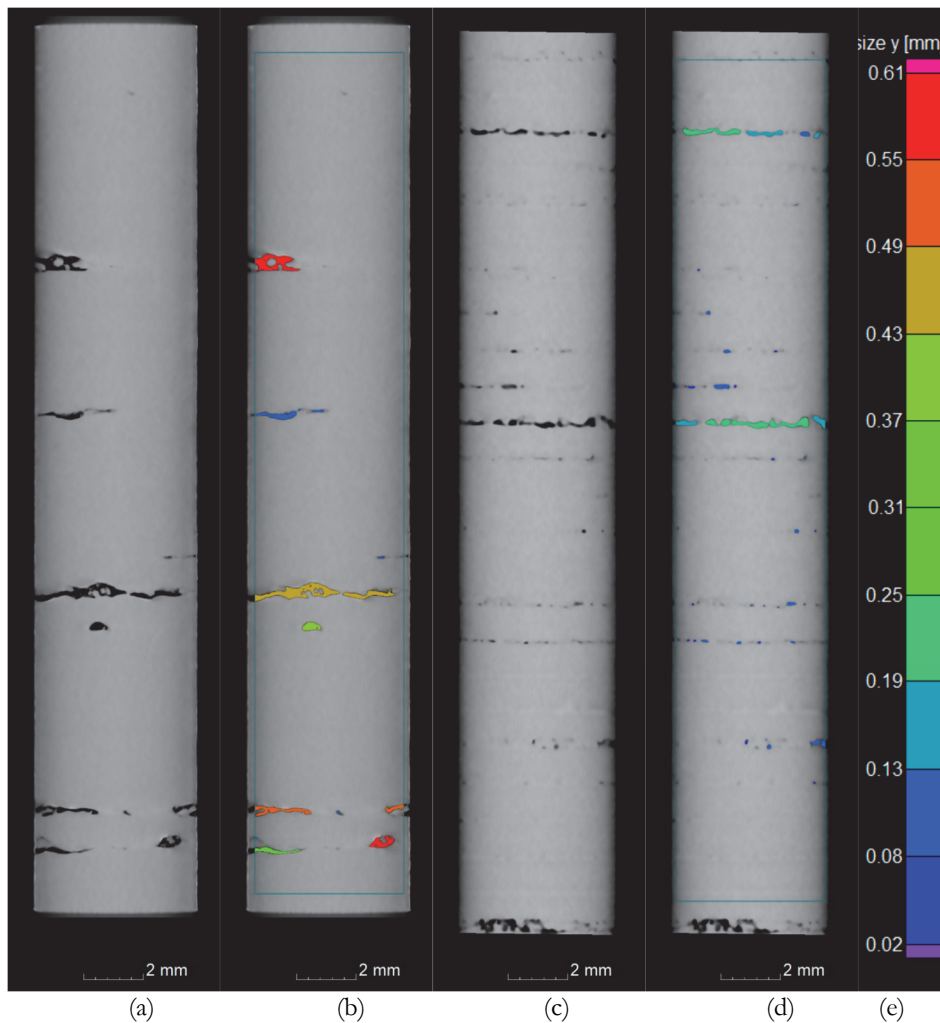
Figure 10: Visualization of the tomographic section of the sample B9/17 (a, b) and N9/17 (c, d) at a depth of approximately 0.3 mm. Plain sections by the tomographic reconstruction (a, c) and sections with the segmented damage (b, d) are shown, a color map of coding of the detected faults according to the length in the Y axis (e)

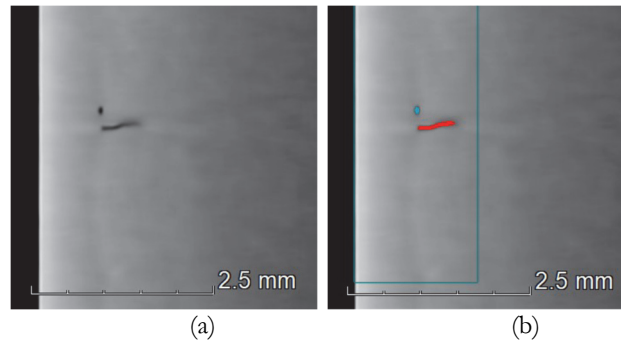
Figure 11: Zooming in on the side section of the largest crack registered with the T34 sample in the YZ plane. From the plain section (picture on the left) as well as the section after registration failure (picture on the right), it can be seen that the crack commences in the material interface and extends into the substrate.

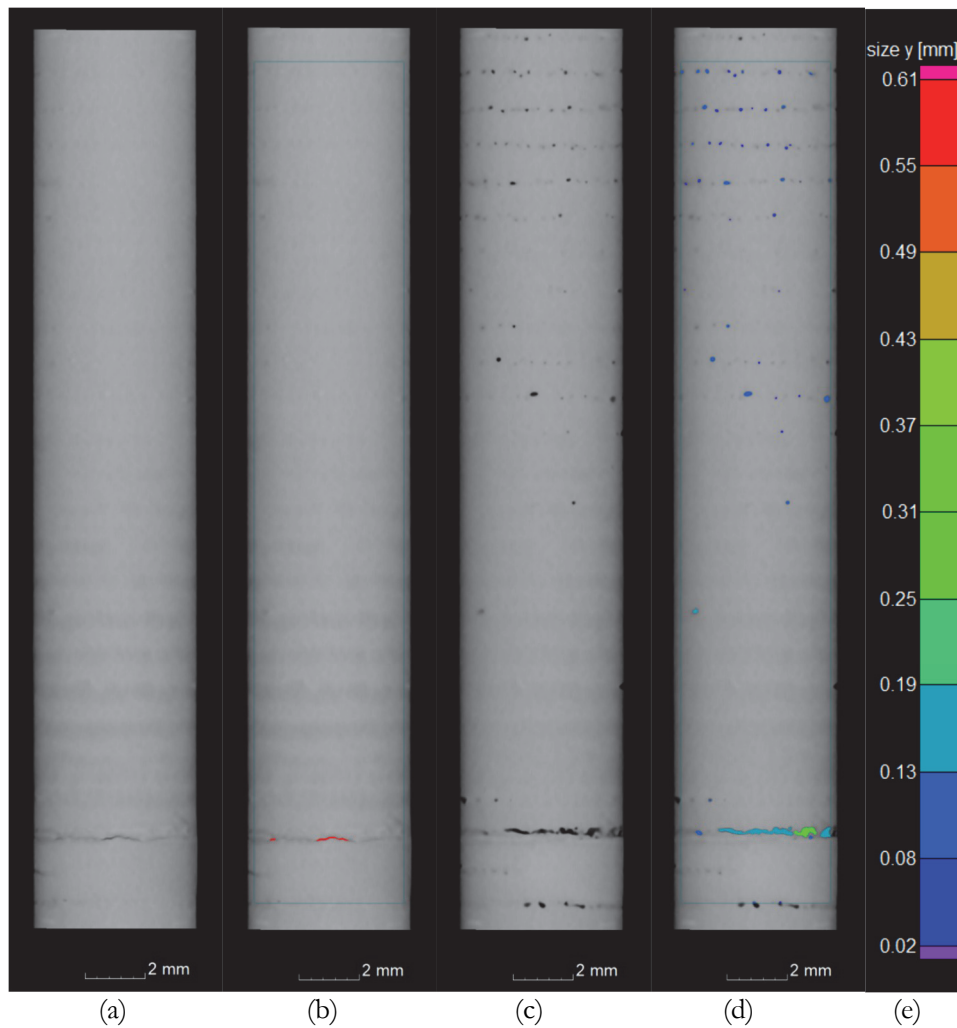
Figure 12: Visualization of tomographic section of the sample T34. Section behind the material interface at a depth of approx. 0.83 mm (a) the same section with segmented damage (b), section in the area of the transition layer at a depth of approx. 0.74 mm (c) the same section with segmented damage (d), color map of the coding of detected faults by Y-axis length (e)

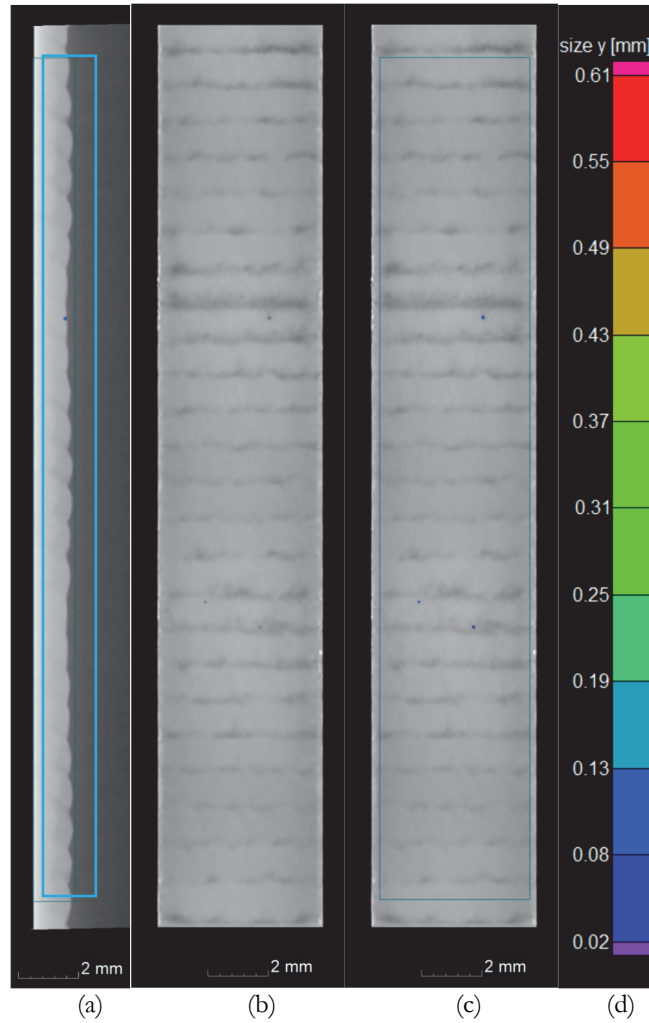
Figure 13: Visualization of tomographic section of the sample ST9/14. YZ plane side section (a) showing the boundary between the cladding layer and the substrate (the blue box represents the ROI boundaries), the section in the transition layer region (b) the same section with segmented damage (c), the color-coding map of the detected defects according to the axis length Y (d)
