A Systematic Approach for Large-scale, Rapid, Dilapidation Surveys of Historic, Masonry Buildings

A SYSTEMATIC APPROACH FOR LARGE-SCALE, RAPID, DILAPIDATION SURVEYS OF HISTORIC MASONRY BUILDINGS

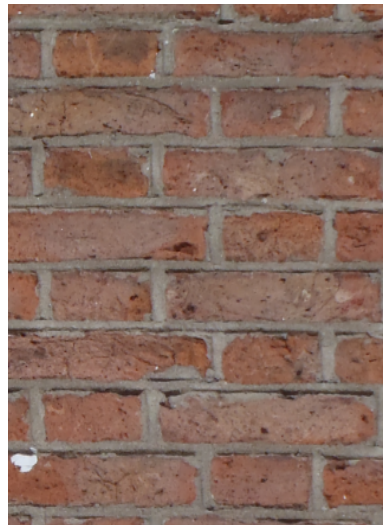
Figure 2. Replaced or repaired brickwork index images (to be used in conjunction with Table 4)

a) Risk category 0

b) Risk category 1

c) Risk category 2

d) Risk category 3

e) Risk category 4

f) Risk category 5

Risk Category	Degree of Damage	Description of Existing Damage
0	Negligible	None
1	Very slight	Brickwork was replaced as a result of filling a doorway or window.
2	Slight	Replacement occurred in rarely occurring small clusters (i.e. 2-6) of bricks
3	Moderate	Replacement occurred in larger clusters (greater than 6)
4	Severe	More than 10% of the wall is comprised of replaced brickwork
5	Very severe	More than 25% of the wall is comprised of replaced brickwork

proposed by Laefer et al. (2008) (Tables 2-7), to be used alongside accompanying index images, which offer a visual standard against which to judge varying degrees of degradation. These index images (Figures 1-3) were taken prior to the study. They provide a means for visual comparison when inspecting a building's façade and aid in the damage classification, allowing testing of the UCDIM, as will be explained.

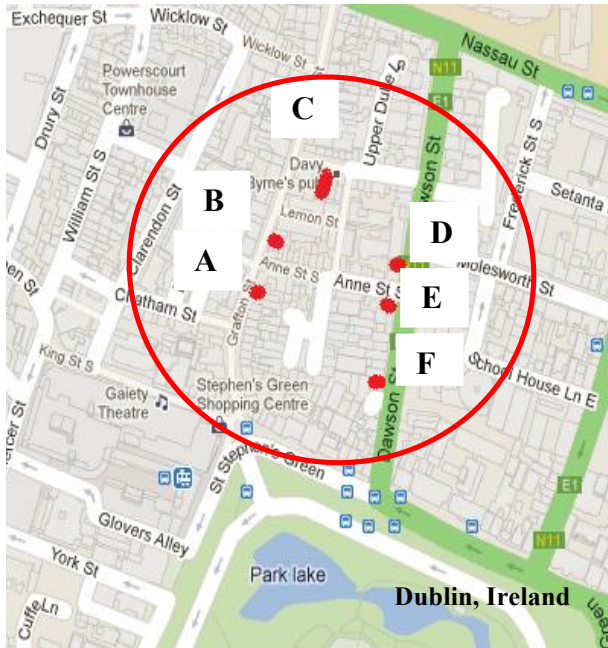
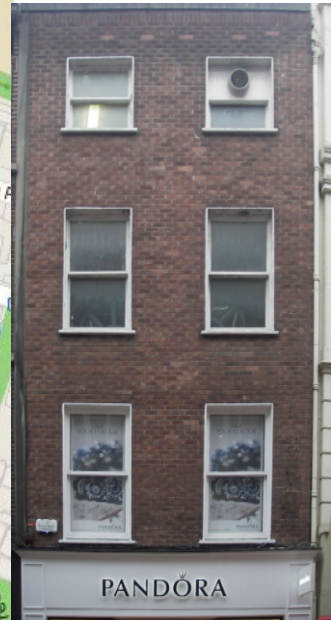
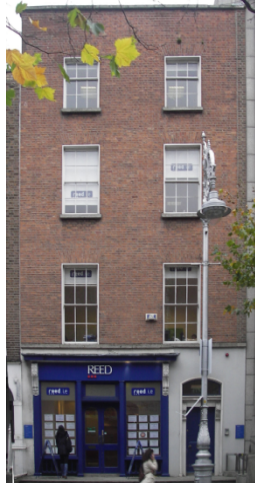
Figure 4. Selected buildings

A) 31 Grafton Street

B) 35 Grafton Street

C) 21 Duke Street

D) 47 Dawson Street

F) 34 Dawson Street

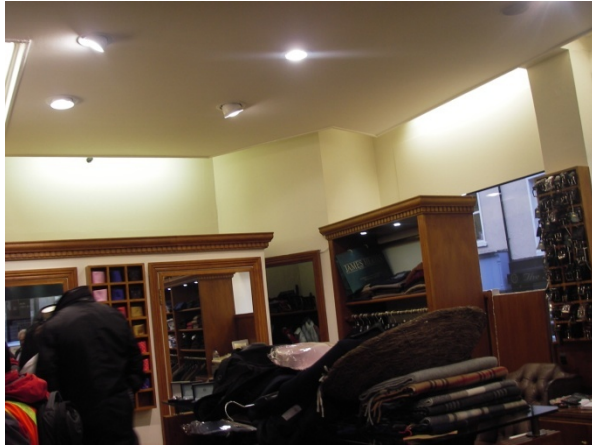
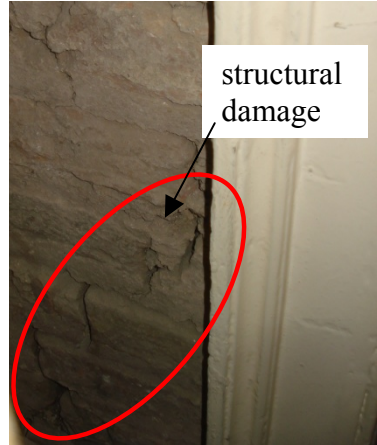
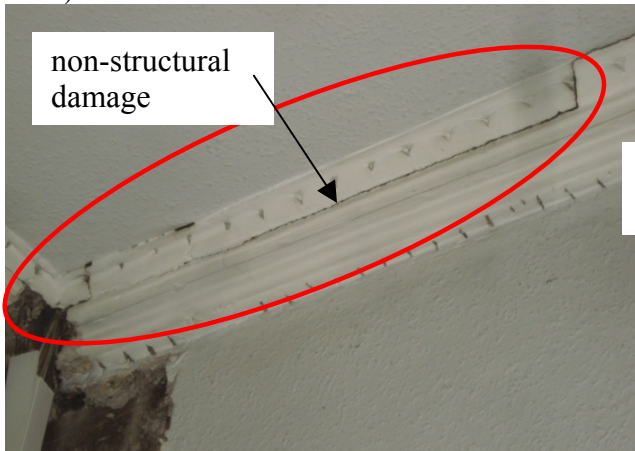
Figure 5. Type 1 (Building E) - interior views

a) Ground floor – retail unit

b) First floor – stockroom

c) Second floor – stock room

d) Second floor – stockroom

Two distinct building types were identified as part of this study. The first, herein called Type 1, consisted of a highly maintained ground floor retail unit. This unit contained large amounts of shelving and display units. As a result, the majority of the interior walls were concealed, thereby making defects difficult to detect. The remaining storeys were generally used for storage and employee facilities and, thus, remained out of view of the public. The state of dilapidation for these storeys was significantly worse than that of the ground storey; numerous defects were visible, and in many instances these areas appeared poorly maintained compared to publicly visible areas.

Buildings A, B, C and E are examples of Type 1. In Building E (Figure 5), structural and non-structural damage was evident in the upper stories; with cracking of up to 10mm in width propagating through brick and mortar (Figure 5b), as well as separation of walls at junction points (see Figure 5d). Non-structural damage was also present in many rooms in the form of cracked plaster on walls, corners, and coving (Figure 5c-d). However, the ground floor consisted of no defects whatsoever (Figure 5a), thus highlighting the potential disparity in damage across storeys within a single building.

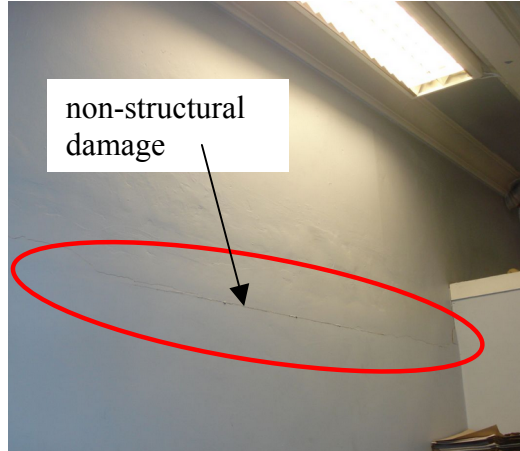
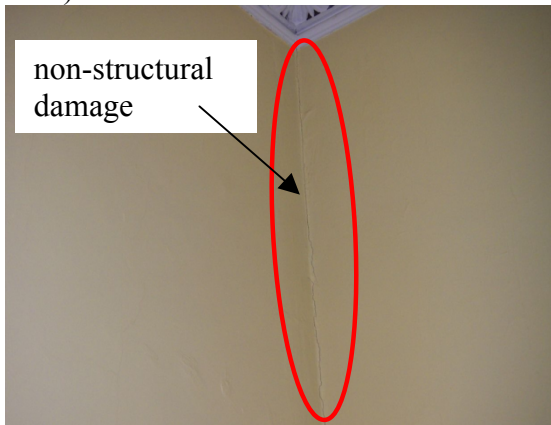
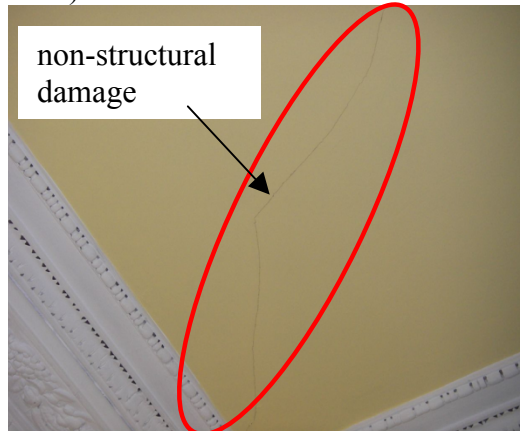
Figure 6. Type 2 (Building F) - interior views

a) Ground floor – retail unit

b) First floor – office

c) Second floor – office

d) Second floor – office

Buildings D and F provided examples of Type 2, where the building consists of highly maintained commercial units on all floor levels, with public access at the ground level and private offices in the upper storeys. Visible defects were mainly aesthetic in nature and limited to cracked plasterwork. Figure 6 illustrates the state of Building F's interior.

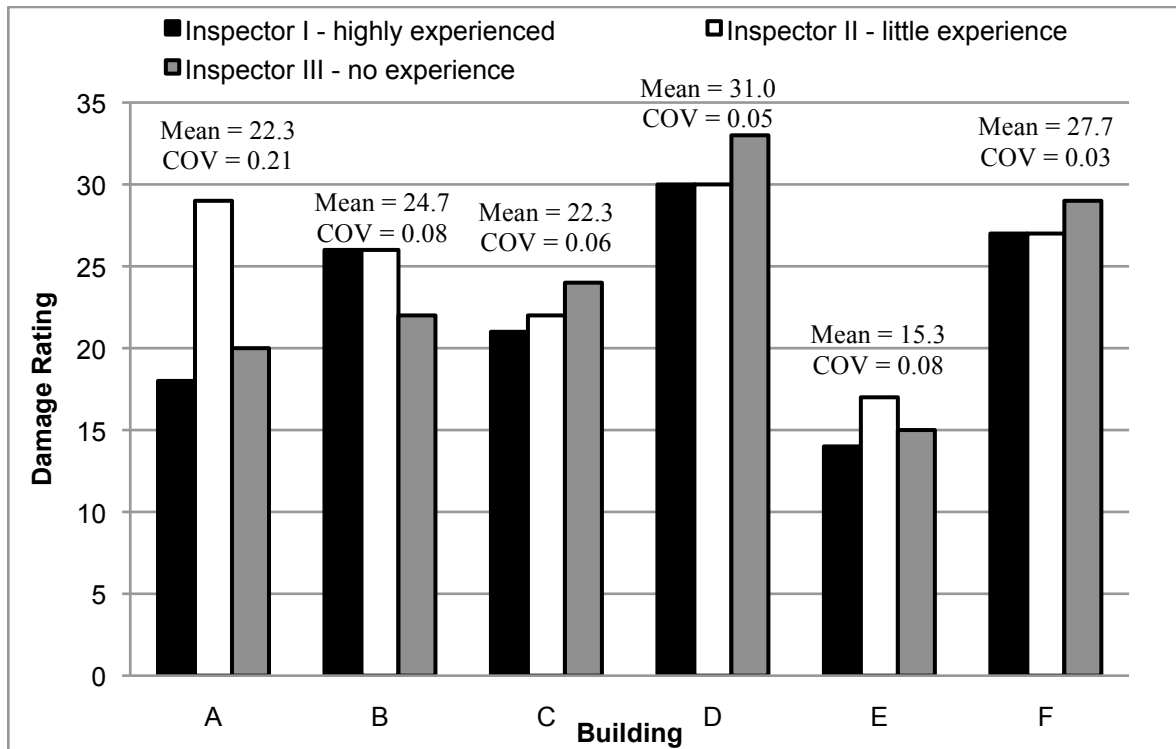
Figure 7. Survey results for the CEF System

The results of the CEF System are illustrated in Figure 7, in which a lower rating indicates increasing damage severity. Therefore according to the CEF System, Building D is in the best condition and Building E the worst. Damage ratings across the three inspectors were in good agreement, with a maximum coefficient of variance of 0.21 occurring in Building A and most variance in single digits. Notably, in two-thirds of the cases, greater experience correlated with improved agreement between inspectors.

The reliability of the CEF System, based on the coefficient of variance across inspectors, was generally higher than the UCDIM (Figure 7). This demonstrates a level of consistency in the application of the method irrespective of the inspector's level of experience. The higher discrepancies for Building A appear to be due to the fact that the CEF System does not account for cases where certain building elements were not included in the damage assessment. For example, in Building A Inspectors I and III did not rate ancillary items (e.g. shop fronts, architectural details). As scoring is cumulative and non-weighted, the overall score assigned by Inspector II was

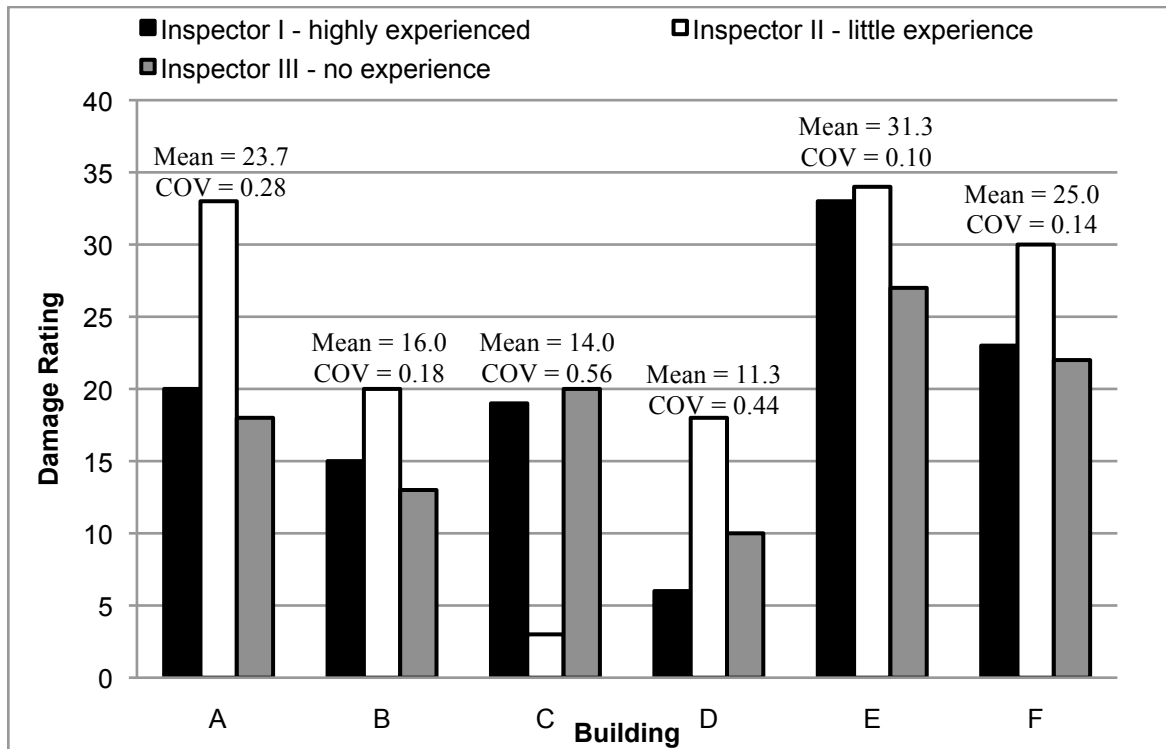
Figure 8. Survey results for the UCDIM

Figure 8 illustrates the damage ratings for each of the three inspectors for use of the UCDIM. Increasing damage classification is represented by the higher the numerical score. Therefore, in

agreement with the results of the CEF System, Building E is shown as the most damaged and Building D as the least.

significantly higher. Figure 8 shows a higher level of variance for the application of the UCDIM. None of the coefficients of variance were single digit, and the maximum was 0.56 for Building C, which consisted of a painted façade. This highlighted the difficulties of applying this method to painted structures. A similar scenario for structures consisting of rendered façades is likely. Nonetheless, all three inspectors identified Building E as the most dilapidated, with a coefficient of variance of 0.1 across the assigned damage ratings.

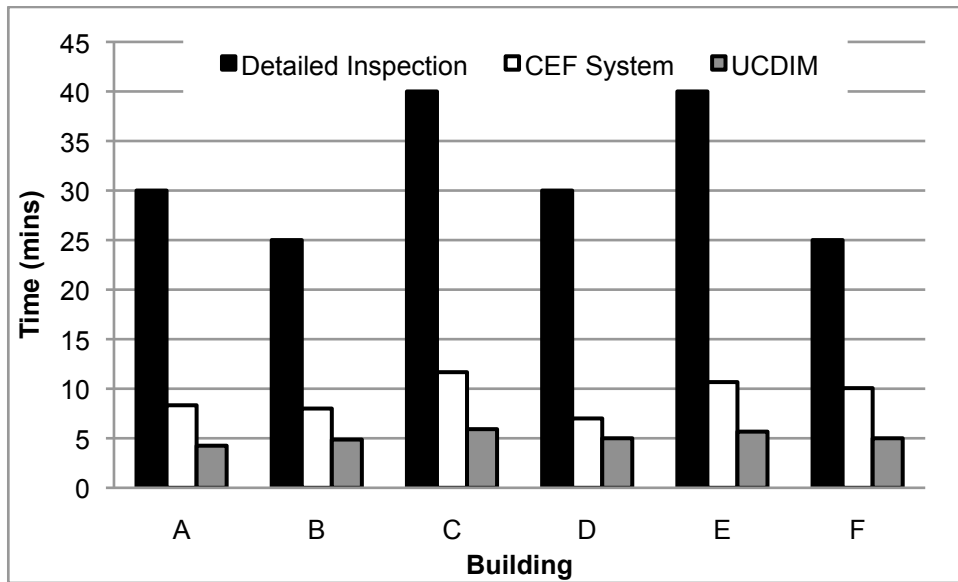
Figure 10. Average time required for each method
