AMERICAN JOURNAL OF AGRICULTURAL SCIENCE, ENGINEERING AND TECHNOLOGY (AJASET)

AN ANALYSIS OF THE MORPHOLOGICAL CHANGES OF SURMA RIVER IN SYLHET DISTRICT USING MULTITEMPORAL REMOTE SENSING IMAGESMd. Mueyed Hasan^{1*}, Md Bahuddin Sikder¹, Sushanta Gupta¹, Md Inzamul Haque¹, Md.Najmul Kabir¹, Minhaz Hasan Sujan¹, Sk Taufiqul Islam¹, M. Farhad Howladar²**DOI:** <https://doi.org/10.54536/ajaset.v5i2.122>**ABSTRACT**

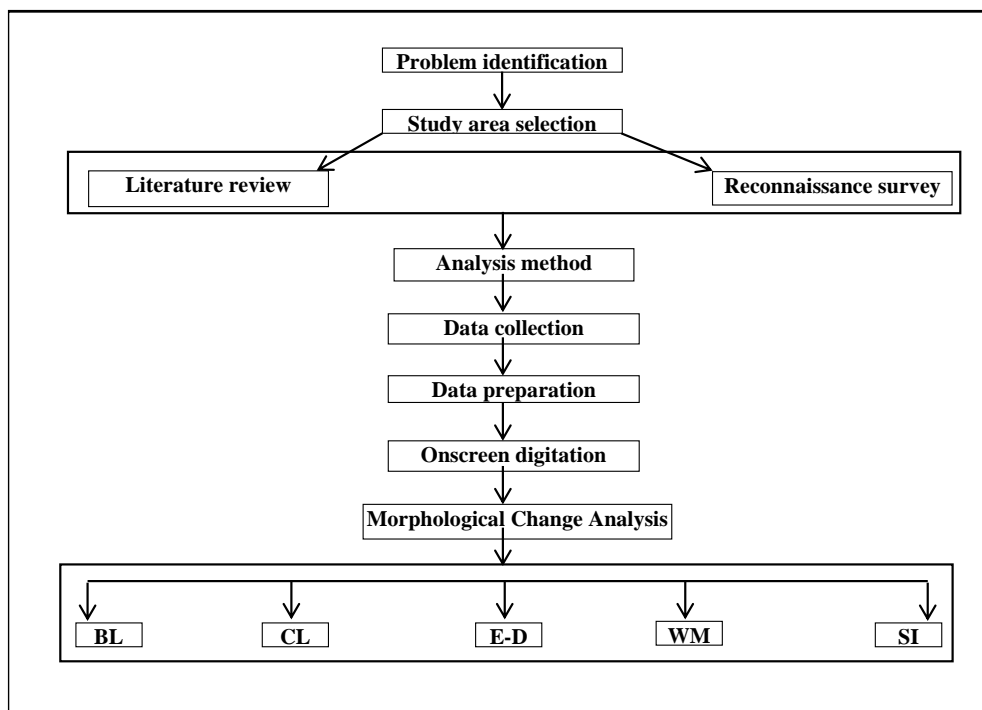
Figure 1: Chronological steps followed in this study. Here, BL= Bank line, CL= Central line, E-D= Erosion-Deposition, WM= Width measurement, SI= Sinuosity Index

The study area was selected after the identification of the problem, later a reconnaissance survey was conducted along the selected river reach, and relevant literature was reviewed. The analysis method was chosen based on the literature review and reconnaissance survey information and observation. Data collection and preparation were done by considering the method of analysis. Steps are shown in Figure 1.

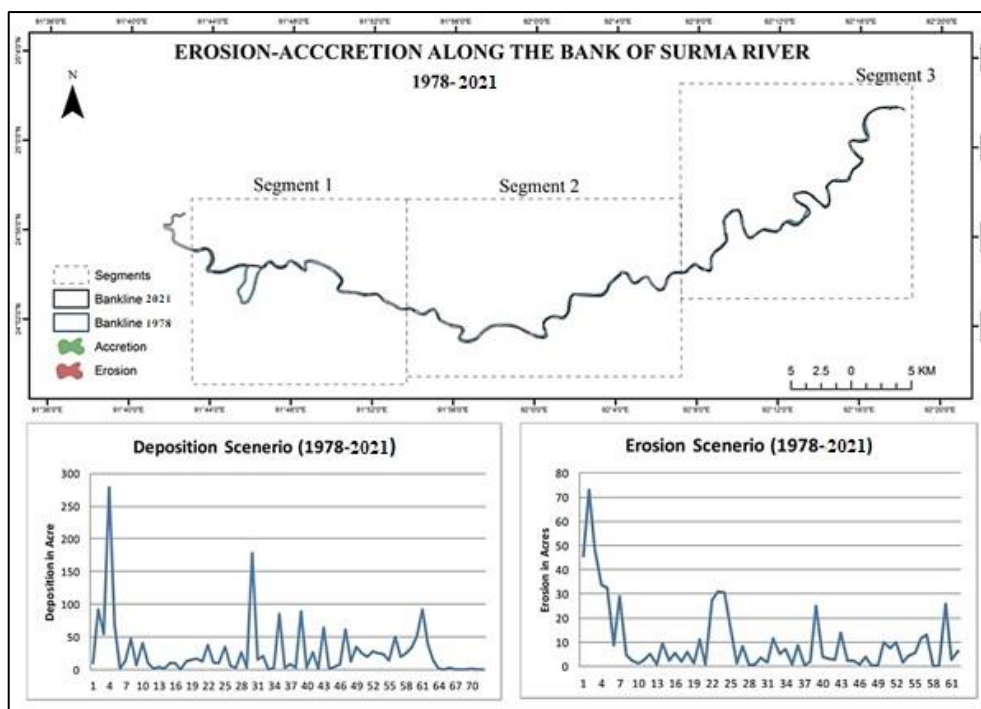
Figure 5: Erosion and Deposition along the Bank of River Surma from 1978 to 2021

The deposition rate was higher than the erosion rate from 1978 to 1989, which decreased drastically later. The erosion rate decreased from 1989 to 1999, and after it increased significantly from 1999 to 2011, it also more decreased in the time frame of 2011-2021. The overall erosion and deposition scenario in the three segments mentioned in the methodology section is illustrated in figure 6, 7, and 8, respectively. The net accretion was 3157.84 acres in 43 years, while net erosion was 1613.77, nearly half of the total accretion (Table 4 and 5). Overall, excessive sedimentation occurs along the bank of river Surma.

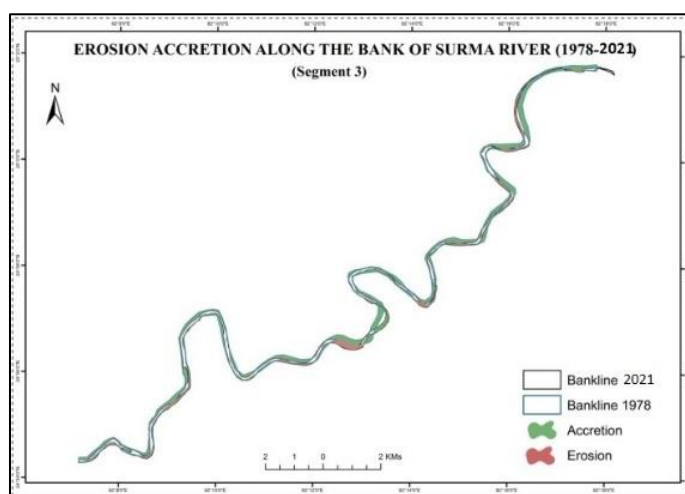
Figure 8: Erosion and Deposition in Segment 3

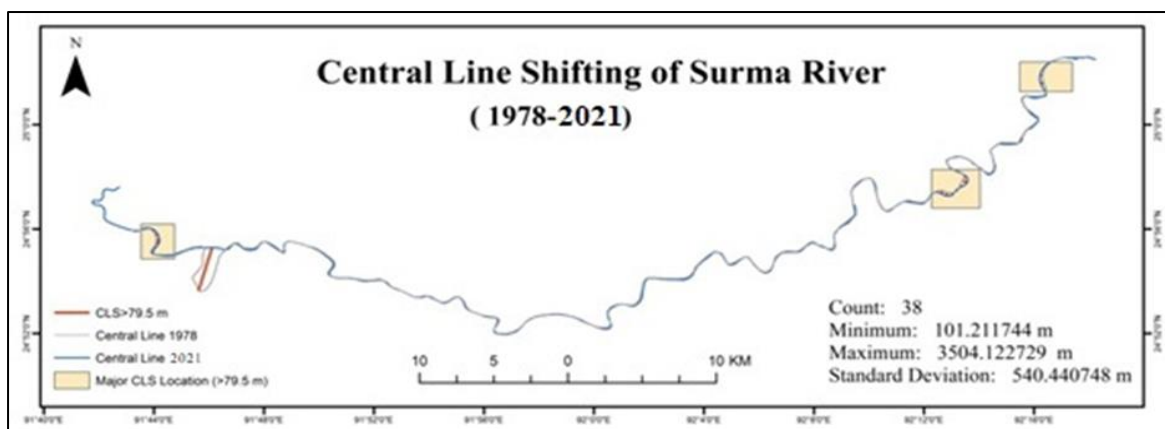
Figure 10: Three Bends where CL Shifted >79.5

At 200 points of 10 locations, the central line (CL) shifted more than 12 meters (Figure 9), and the average of CL shifting at 200 points was calculated 79.50 meters. It was found that more than 79.5 meters of CL shifting occurred at 38 points of three bends 1, 2, and 10 (Figure 10). Barahal (Kanaighat), South Banigram, and Lalargaon, respectively. Zoom-in view of the locations of Central Line Shifting is in Figure 11.

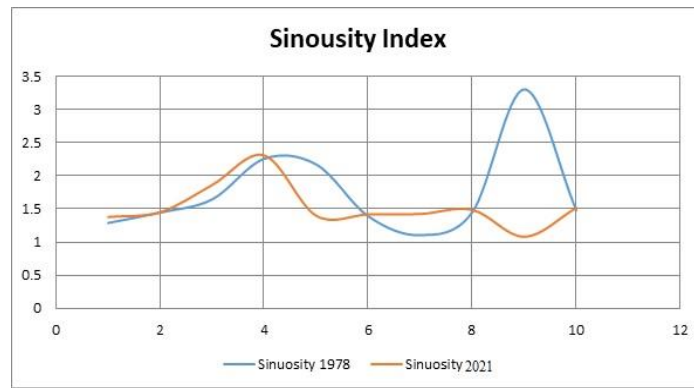
Figure 12: Change in Sinuosity Index along the River Bends

The sinuosity index varies from upstream to lower stream regions. Table 8 shows the calculated sinuosity index at different bends identified (Figure 12). The analysis finds that the maximum-minimum sinuosity index was 3.30 and 1.28 respectively in 1978, which decreased to 2.32 and 1.02 respectively in 2021. The river became straight from meander at only two positions (Bend five and Bend nine) as the change of the SI value was negative in those two positions. On the contrary, the change of SI value at all bends except these two bends was positive. In addition, the maximum positive change occurred at bend no three near Bardesh Bazar.
