Analysis of Leakage Mechanism of Shield Tunnel Segment

Fengyin Zhou^{1, a}, Dazhao Hou^{1, b, *}, Yu Zhang^{1, c}

¹College of Geoscience and Engineering, North China University of Water Resources and Electric Power, 450046, Zhengzhou, Henan, China
^a1225562087@qq.com (Z.F.); ^bCorresponding author: dazhaohou@163.com (H.D.); ^c1827916808@qq.com (Z.Y.)

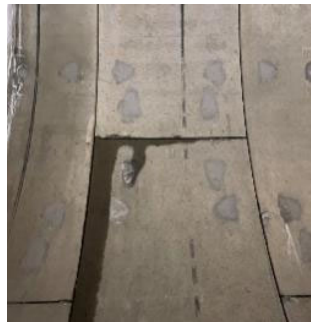
(a) Leakage in the longitudinal seam

Figure 1. Water leakage position diagram of shield tunnel

The common locations of water leakage in shield tunnels primarily include leakage at grouting holes, segmental joints,

and longitudinal joints. These typical leakage positions are illustrated in Fig. 1 below.

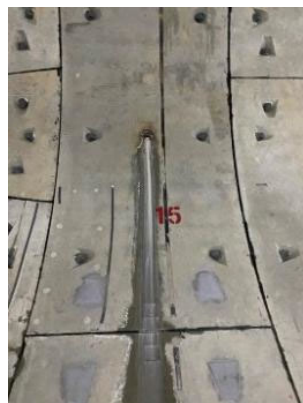
(b) Leakage of grouting holes

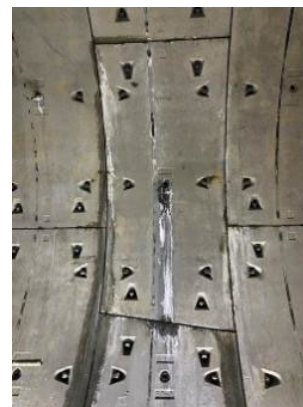
(c) Leakage in the ring joint

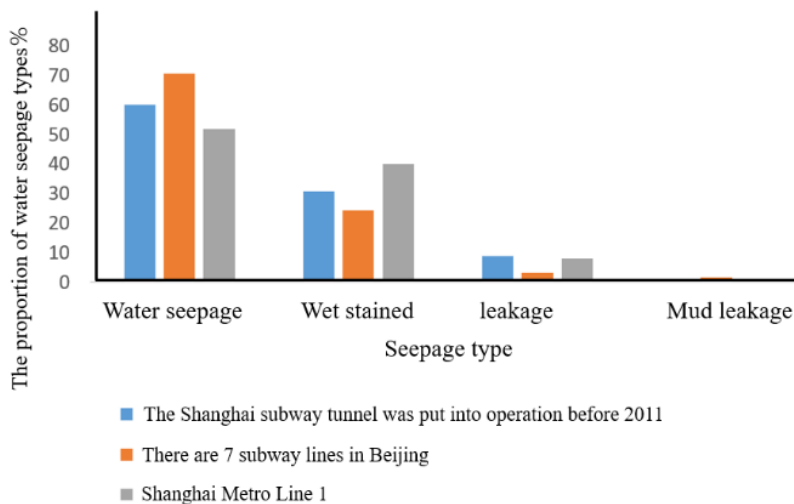
Figure 2. Survey results of seepage types of shield tunnel

Based on the analysis of survey results concerning water leakage types in shield tunnels, it can be concluded that among the four identified categories of leakage defects, seepage is the most prevalent, accounting for approximately 50% to 80% of all leakage cases. This is followed by damp marks, while dripping is relatively less common. Although sand leakage occurs less frequently, it poses a significant threat to tunnel safety. Due to the large volume of leakage associated with this defect type, it can easily carry soil particles and mud from behind the segment lining, resulting in substantial soil loss in the surrounding environment. In severe cases, this may lead to the formation of voids behind the segment lining, causing stress concentration in the lining structure. Therefore, effective countermeasures must be implemented to prevent the occurrence of mud/sand leakage defects.

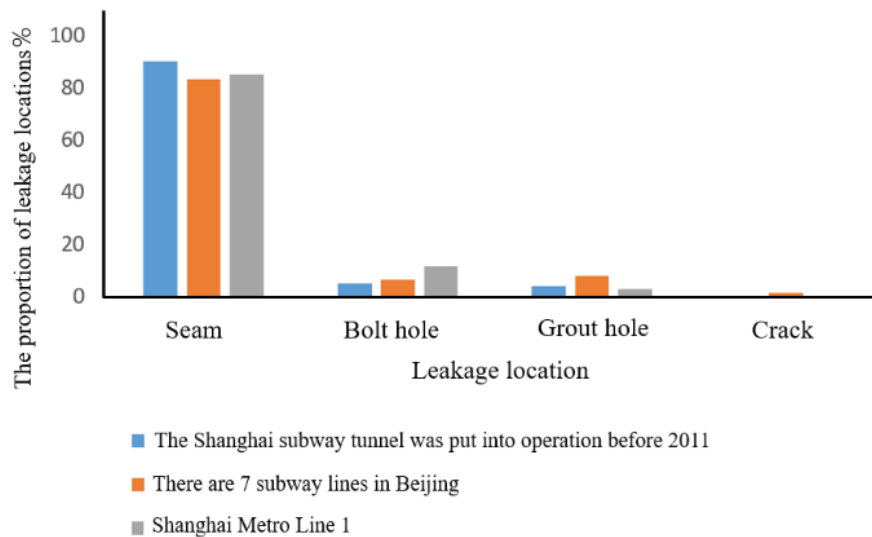
Figure 3. Survey results of leakage disease locations in different subway shield tunnels

Based on the statistical analysis of leakage locations in various metro shield tunnels, it can be concluded that the most common leakage sites are the segment joints, accounting for approximately 80% to 90% of all leakage cases. Among these, annular joint leakage is the most prevalent. Leakage at bolt holes and grouting holes occurs relatively infrequently, and leakage through bolt holes is often indirectly caused by water ingress at the joints. Leakage through segment cracks is the least common. Therefore, waterproofing at segment joints should be regarded as the primary focus in the waterproof design of shield tunnels.
