TRAFFIC ACCIDENT ANALYSIS USING EDR DATA: A CASE STUDY OF A MULTICOLLISION EVENT

DANIEL MIKYSKA

Brno University of Technology, Institute of Forensic Engineering, Purkyňova 464/118, 612 00 Brno, Czech Republic

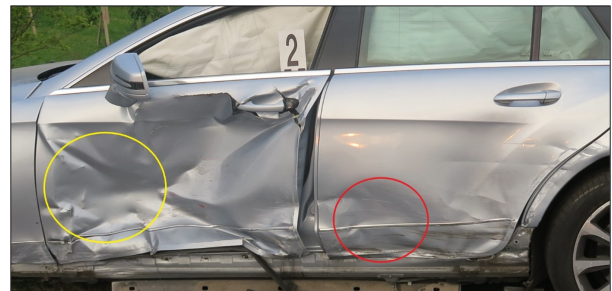
The second event related to the impact with the silver vehicle was recorded as a side collision and occurred 58 ms after the previous event. This time would correspond to the damage locations on the left side of the silver vehicle, see Figure 5, where the red color indicates the likely location of the first recording, i.e., TRG 1, and the yellow color indicates the stronger impact, i.e., the likely location of recording TRG 2.

In terms of the nature of the overall damage to the left side, it is clear that the red vehicle was not moving directly against the side of the silver vehicle but was moving at a small angle relative to its longitudinal axis. The collision therefore took place with a significant slip, but only to the point of greatest deformation, i.e. the point of the second entry marked in yellow in the figure. The intensity of the first impact was 16 km h^{-1} (Delta V).

FIGURE 5. Silver vehicle damage.

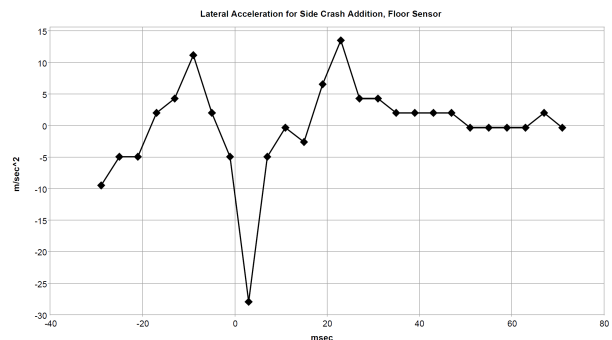
In the second event, only the lateral acceleration values were recorded using sensors located on the B-pillar, C-pillar, and floor of the vehicle. The graph of lateral acceleration recorded by the floor sensor is best illustrated at Figure 6. This is because it shows the overall pattern of acceleration changes over the recorded time. Positive values represent acceleration from left to right, negative values from right to left. Initially, a slight acceleration from right to left can be seen, which at time -20 ms switched to acceleration from left to right. When the vehicle hits the other, the sensor accelerates to the left, corresponding to the impact of the right front corner so intensity of the second impact was with lateral acceleration -27.6 m s^{-2} . Subsequently, this impact caused the red vehicle to turn. This then corresponds to the next graph progression, i.e. the acceleration of the right rotation of the vehicle. This has gradually decreased as a result of the vehicle being in a sled.

FIGURE 6. Graph of lateral acceleration of the vehicle (sensor on the vehicle floor).

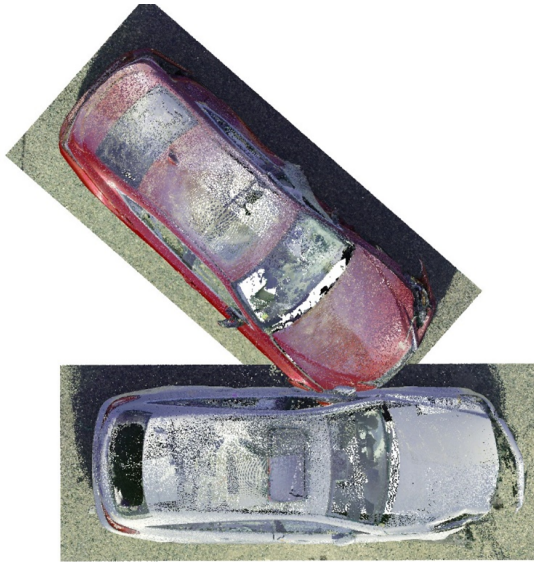
Figure 7 shows the probable corresponding collision position of the vehicles that triggered the recording of the second event (TRG 2).

FIGURE 7. Vehicle collision position TRG 2.

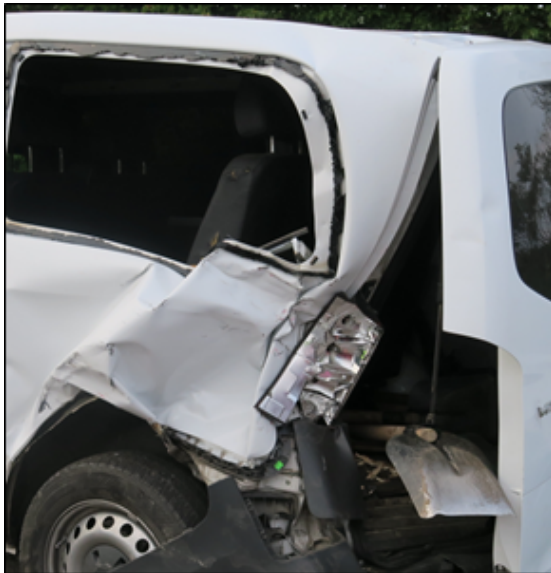
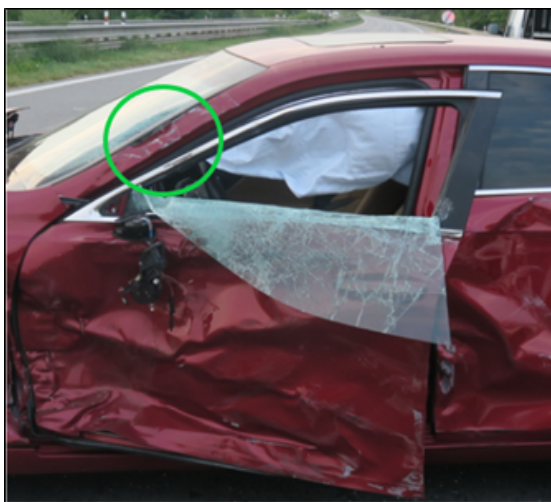
The red vehicle was hit by the left side, specifically the part at the level of the left rearview mirror. It hit the left rear corner of the van, see Figure 8, which also corresponds to the damage on the left A-pillar of the red vehicle, which can be seen marked in green in Figure 8. Figure 9 shows the probable corresponding collision position of the vehicles that triggered recording of TRG 3 and TRG 4

(A). Damage to the left rear corner of the van.

(B). Damage to the red vehicle on the left rearview mirror.

FIGURE 8. Damage of vehicles (TRG 3 and TRG 4).

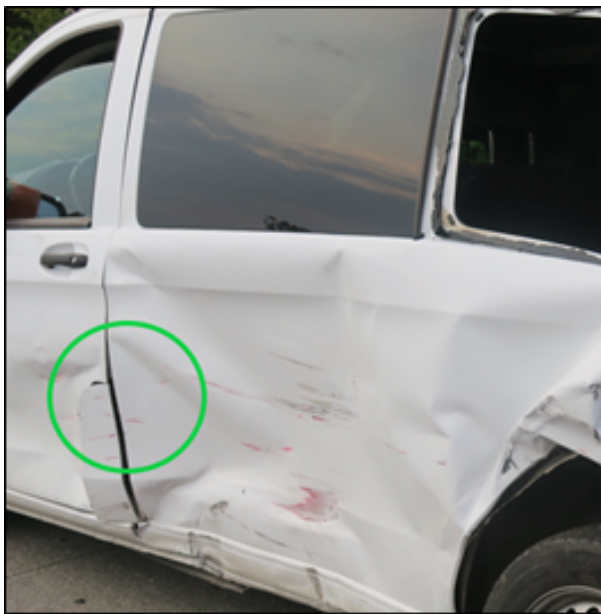
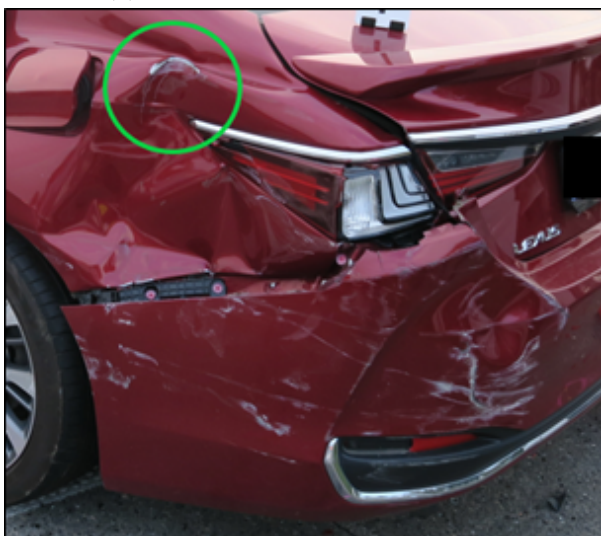
The last recorded event occurred 172.5 ms after the previous one and 1.6 seconds after the first one. It was recorded as a side impact that occurred as a result of the red vehicle rotating after striking the left side of the van. The corresponding vehicle damage that caused the recording can be seen in Figure 11.

In terms of the data itself, only the lateral acceleration values were recorded again. The values of all sensors showed an increasing and fluctuating lateral acceleration acting from left to right. Floor sensor for the lateral acceleration captured maximum value $36,8 \text{ m s}^{-2}$. Therefore, these were secondary impacts of the red vehicle on the van due to vehicle rotation.

(A). Damage to the left side of the van.

(B). Damage to the left rear of the red vehicle.

FIGURE 11. Damage of vehicle (TRG 5).
