Adaptive Reuse of Historic Dwellings into Cafés: Design Challenges and Planning Issues in Hebron

¹Assistant professor. Palestine Polytechnic University, Palestine

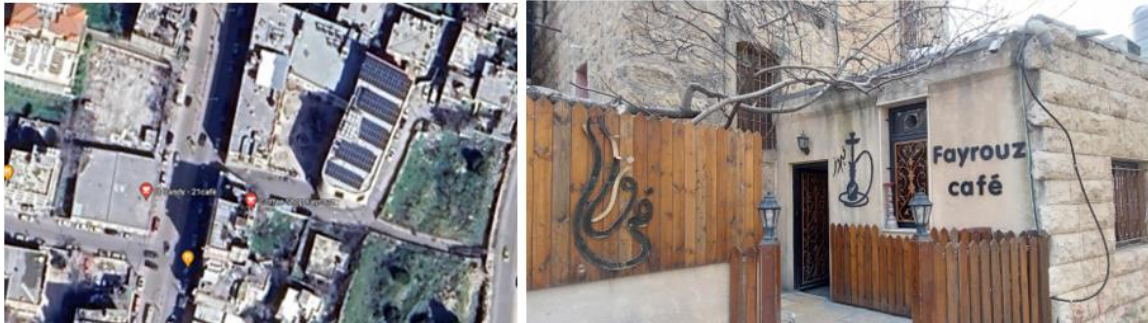
Figure 3 represents the location according to Google, including the front facade of Fairouz Café, Author, 2024

The current condition of the café, detailed in Table 2, reveals several challenges and features: it suffers from insufficient electrical capacity, limited balcony load-bearing, and minor maintenance needs in furniture and finishes. Despite storage limitations and its sensitive proximity to the municipality, the café maintains strong architectural integrity and provides a comfortable layout for 64 visitors.

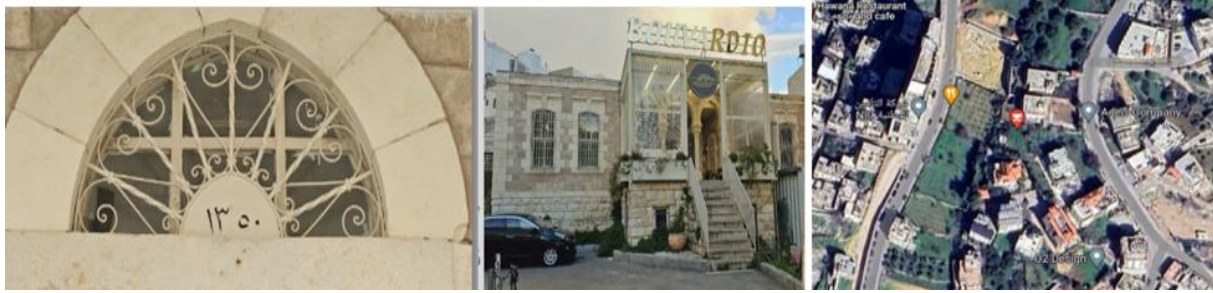
Figure 4 shows the main façade of the Bouvardio Café, with its location confirmed via Google Maps (Author, 2024).

Table 4 summarizes the renovation and design features, highlighting the project’s goal to transform the historic building into a vibrant, functional space. Traditional elements were preserved and enhanced—for example, original geometric tiles were replaced with new ones that replicate traditional patterns. The ceiling was structurally reinforced and finished with plaster for both aesthetic appeal and moisture resistance. Exterior walls were treated for dampness with insulating layers and finished using classical plaster designs, elevating the building’s visual charm.

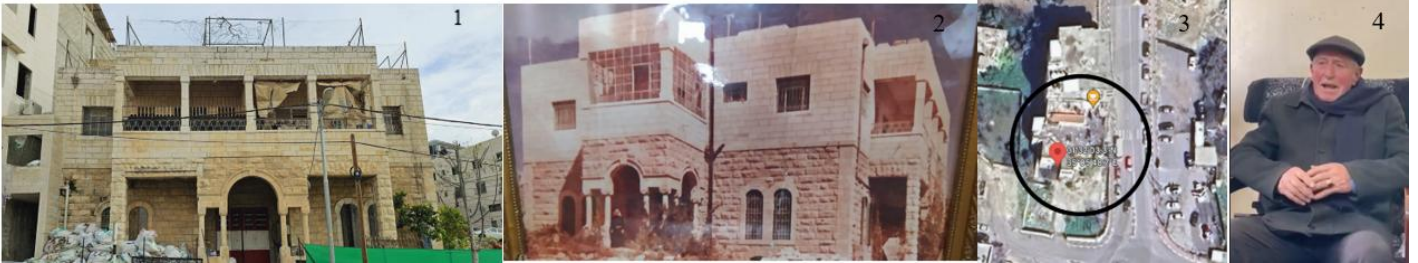
Figure 5 presents key images highlighting the architectural and historical significance of Al-Zaru House, including its current façade, a 1960 archival photo featuring Abu Talib Al-Zaru, an aerial view from Google Maps, and a portrait of Talib Al-Zaru, the second grandfather. (Sources: Author documentation and Google Maps, 2024)

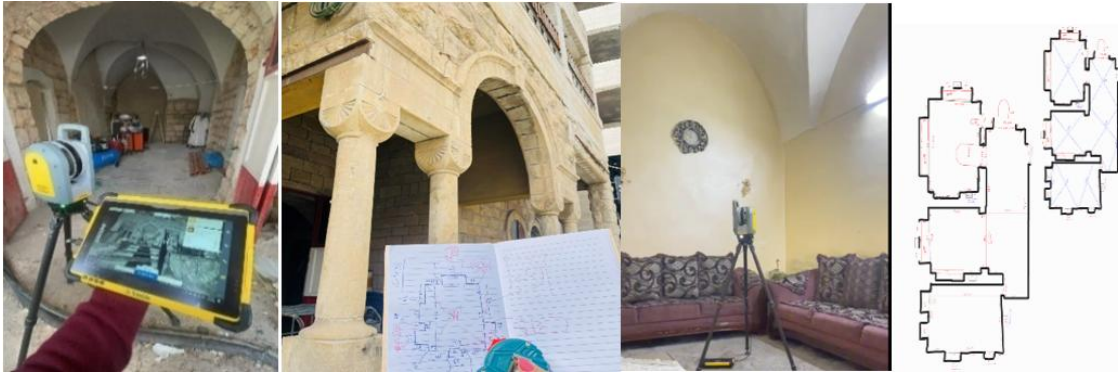
Figure 6 represents the stages of taking measurements, documenting, and drawing plans of the Zaroo House.
(Author, 2024)

To assess the physical condition of the structure, several engineering consultations were held with the Hebron Rehabilitation Committee. A 3D laser scan of the building was carried out using the Tx5 Laser Scanner in collaboration with the Palestine Polytechnic University lab. The data collected was processed into two-dimensional and three-dimensional digital plans. These analyses revealed the architectural layout and condition of all interior and exterior spaces, providing a detailed understanding necessary for rehabilitation planning. Figure 6 represents the stages of taking measurements, documenting, and drawing plans of the Zaroo House

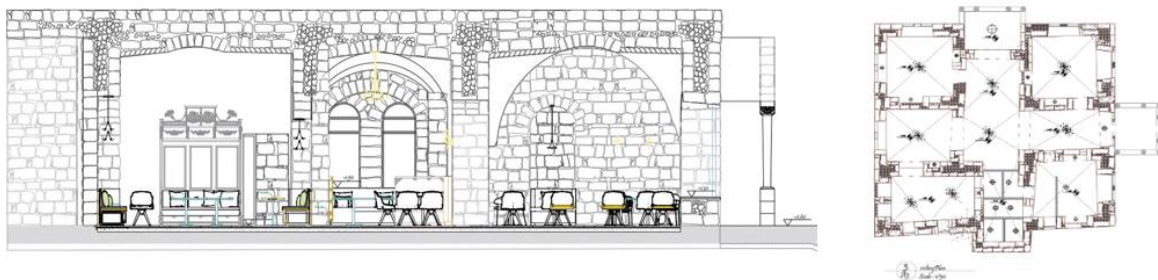
Figure 9 Interior Architecture and Ornamentation Analysis: the ceiling plan, interior elevations, and vertical sections in the Zaroo House. Source: (Author, 2024)

The design process incorporated: **Analysis of decorative elements**, such as arches and domed ceilings, integrating them into the interior layout. Designing the ceiling plan about plaster details and hidden infrastructure like electrical wiring. Creating **interior elevations and vertical sections** to demonstrate spatial relationships, furniture placement, and decorative treatments. Figure 9 presents a detailed study of the Zaroo House’s interior architecture and ornamentation, focusing on the ceiling plan, interior elevations, and vertical sections.

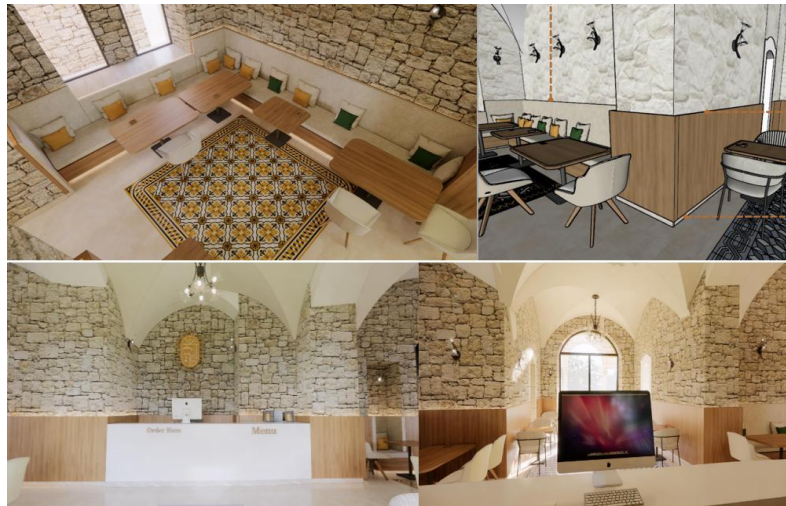
Figure 12 represents models of the proposed designs for the Al-Zaru Café, before and after. Source: Author, 2024

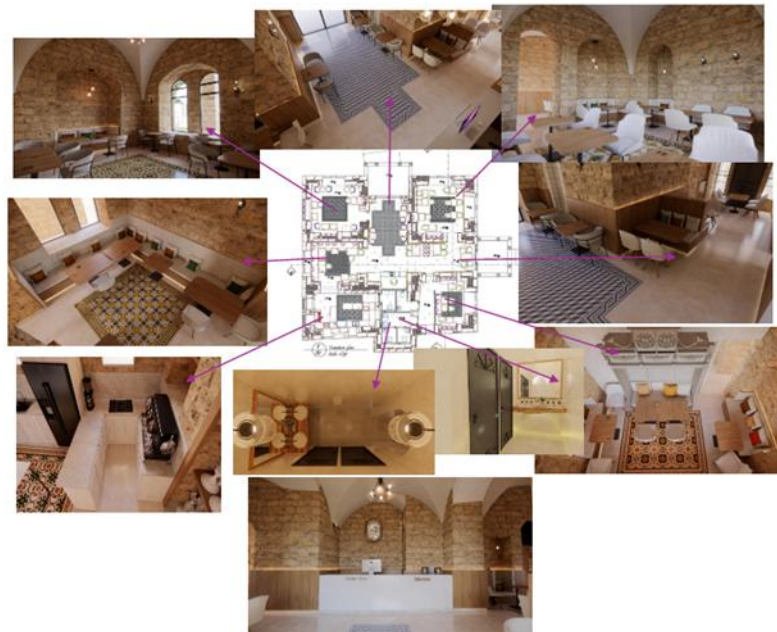
Figure 13 represents the proposed designs for the Al-Zaru Café before and after the redesign. Source: Author, 2024

Table 12 presents design and practical recommendations derived from the study’s findings. Figure 13 represents the proposed designs for the Al-Zaru Café before and after the redesign. (Source: Author, 2024)
