OBJECTS OF INVESTIGATIONS

The powerfulness of the developed approach by using CRFP coupons of cross-ply stacking sequence $[0/90/]_{6s}$ and dimensions of $180 \times 30 \times 4.8$ mm has been firstly demonstrated in work [1]. Present paper concerns enlarging data collection by obtaining residual stress values for more thick specimens of the same stacking sequence and plane dimensions. The elements of this collection include, firstly, the magnitudes and distributions of the principal residual stress components, which are obtained, as in a thin sample, by static indentation of a steel sphere with a diameter of 16 mm with a force of 3.0 kN. Secondly, data were obtained on the values and distributions of the principal residual stress components

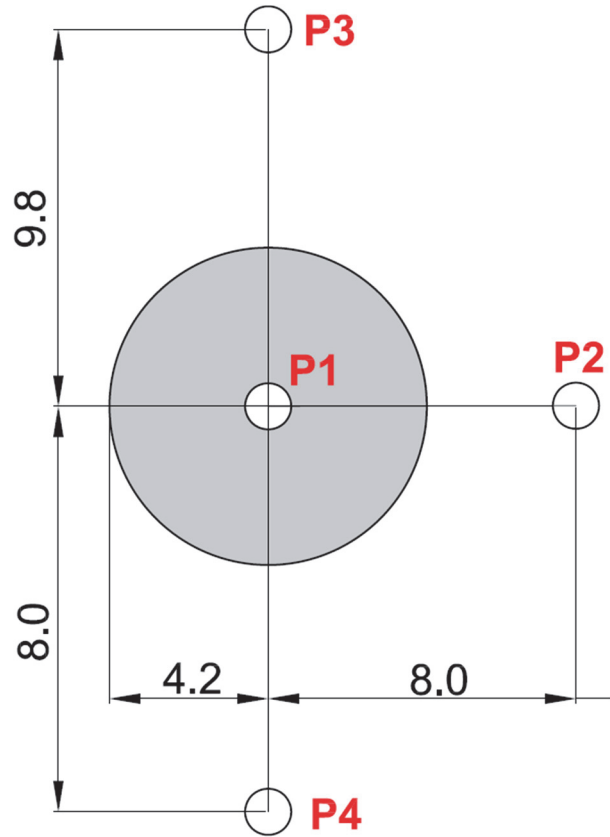
(a) Real image

(b) Scheme

Figure 4: Mutual location of contact dimple border and probe hole edges in CP_D-25 coupon.

Mutual location of contact dimple borders and probe hole contours is shown in Fig. 2, 3 and 4. Fig. 2b depicts local coordinate system used (y –axis coincides with the vertical symmetry axis of each individual probe hole). Through holes, essential for residual stress deriving, are of 2.0 mm diameter. Hole number increase corresponds to the drilling order. The impact of 20 mm hemispherical tip (CP_D-20 coupon) leads to revealing the image of the dimple contour due to visible surface layers damages as it is shown in Fig. 3a.

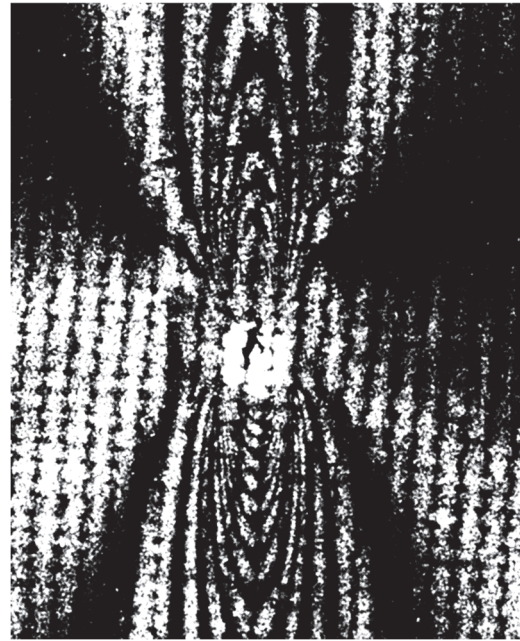
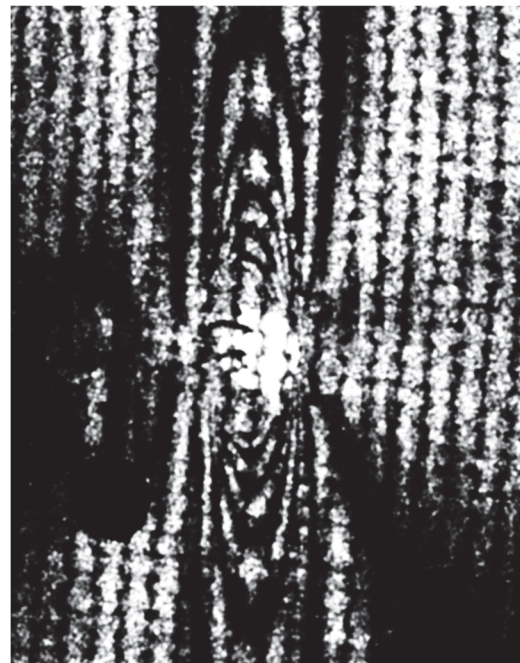
(a) Component u , $\Delta N^u = -13.5$

(b) Component v , $\Delta N^v = +7.5$

(c) Component u , $\Delta N^u = +27.0$

(d) Component v , $\Delta N^v = -20.5$

(e) Component u , $\Delta N^u = -23.0$

(f) Component v , $\Delta N^v = +15.0$

Figure 6: Specimen CP_S. Interferograms referred to point 2 (a), (b); point 4 (c), (d) and point 5 (e), (f).

Interferograms marked by letters (a) and (b), which are obtained for point located relatively far from the dimple edge, demonstrate high quality, which provides reliable resolution of fringes over the hole edge. Interference images, obtained for points 4 (Fig. 6(c, d)) and 5 (Fig. 6(e, f)), reveal quite high quality, which provides reliable resolution of high-density fringes over the hole edge. Centers of probe holes drilled at point 4 and point 5 are located very close to contact dimple border. This is a reason of high-density fringe arising in both horizontal and vertical direction. Maximal value of absolute fringe order difference, which is counted in horizontal direction for point 4, equals to $\Delta N^u = +27.0$ fringes. This value, related to the hole of 2.0 mm diameter, is close to the resolution limit of ESPI technique.

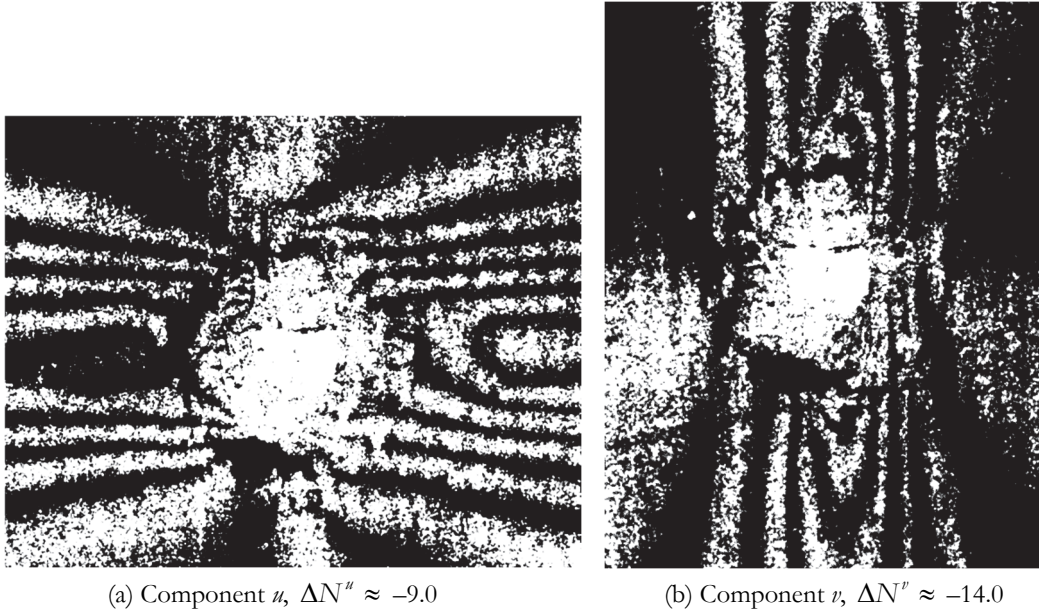
Figure 7: Specimen CP_D-20. Interferograms referred to point 1.

The size of the hemispherical impactor and the impact energy were chosen so as to obtain a contact dimple with a diameter that is close in magnitude to that of a static indentation of a steel ball with diameter of 16 mm. Interference images visualized after probe hole drilling at point 1 of CP_D-20 coupon are presented in Fig. 7. The quality of the fringes leaves much to be desired, due to the significant degree of damage to the surface layers of the material. Thus, values of absolute fringe order differences can be only approximately counted as it is illustrated in Fig. 7. Note, however, that these differences have a negative physical sign as it takes place in statically induced case (see Fig. 5).

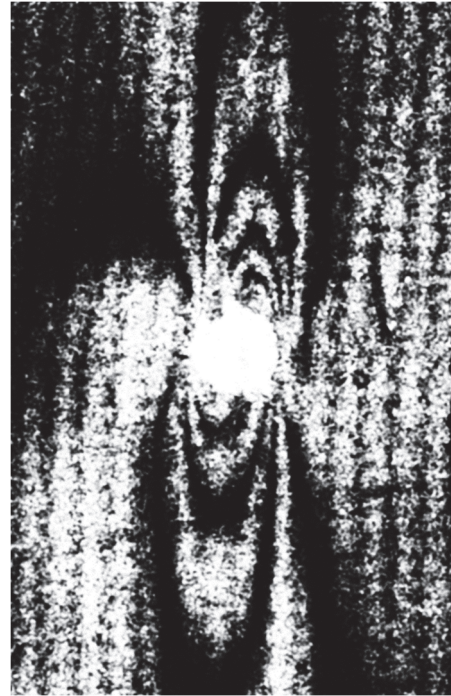
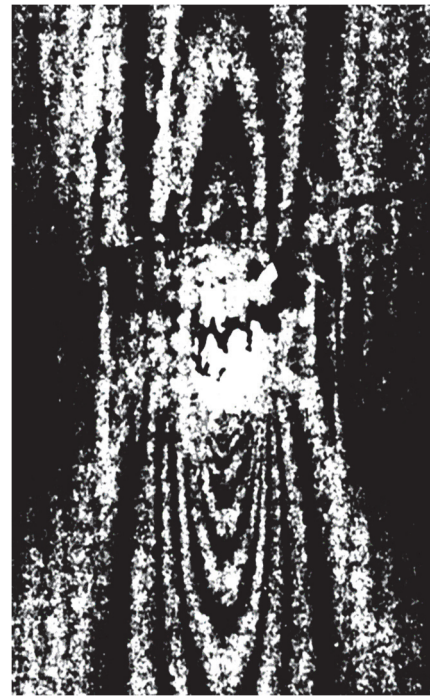
(c) Component u , $\Delta N^u = -10.0$

(d) Component v , $\Delta N^v = +8.5$

(e) Component u , $\Delta N^u = +20.0$

(f) Component v , $\Delta N^v = -12.5$

Figure 8: Specimen CP_D-20. Interferograms referred to point 2 (a), (b); point 8 (c), (d) and point 5 (e), (f).

Involved points are located both close to the contour of the dimple and some distance from its boundary. Figs. 8(a, b) and 8(c, d) include interference fringe patterns inherent in point 2 and point 8, respectively, which are located out of contact dimple area. This fact considerably increases the fringe quality comparing with images presented in Fig. 7. The quality of the fringes visualized at point 5 (Fig 8(e, f)) is quite satisfactory for quantitative processing, despite the fact that the probe hole partially overlaps the damaged contour of the contact dimple.

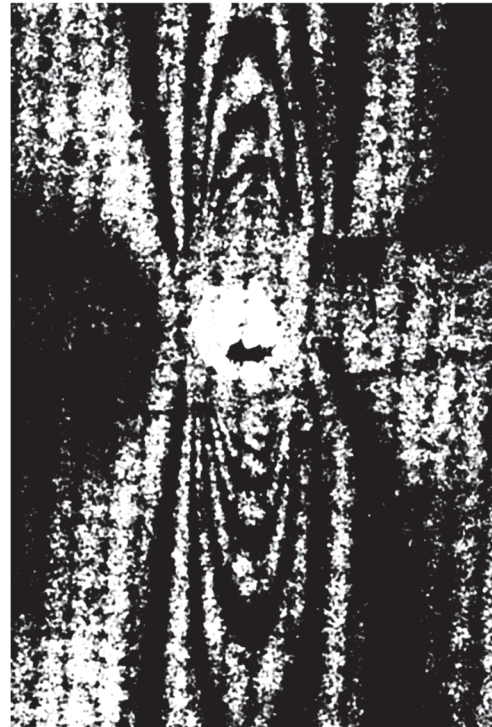
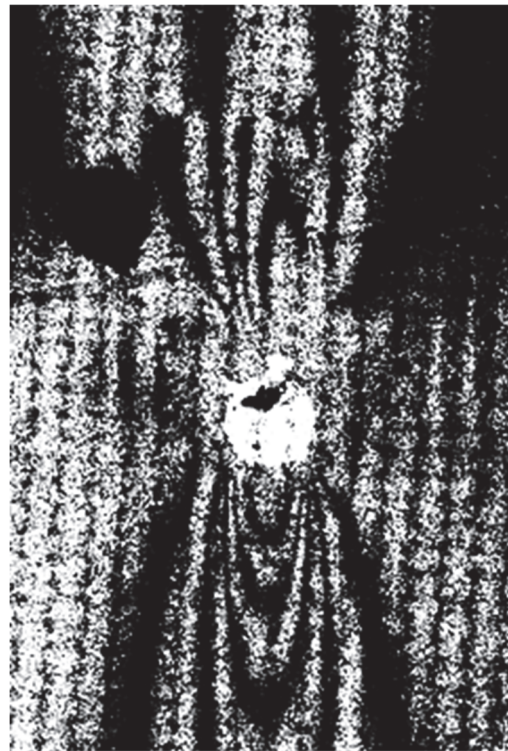
(a) Component u , $\Delta N^u = -11.0$

(b) Component v , $\Delta N^v = +19.5$

(c) Component u , $\Delta N^u = +27.0$

(d) Component v , $\Delta N^v = -9.0$

Figure 10: Specimen CP_D-25. Interferograms referred to point 5 (a), (b) and point 6 (c), (d).

Interference fringe patterns, a source of which is deformation response to through hole drilling at the vicinity of contact dimple at point 5 and point 6 caused by impact influence on CP_D-25 coupon, are shown in Fig. 10. These interferograms reveal quite high quality, which provides reliable resolution of high-density fringes over the hole edge. Centers of probe holes drilled at point 5 and point 6 are located very close to contact dimple border. This is a reason of high-density fringes arising in both horizontal (point 6) and vertical (point 5) direction. Maximal value of absolute fringe order difference, which is counted in horizontal direction for point 6, equals to $\Delta N'' = +27.0$ fringes. Note again that this value, related to the hole of 2.0 mm diameter, is close to the resolution limit of ESPI technique.

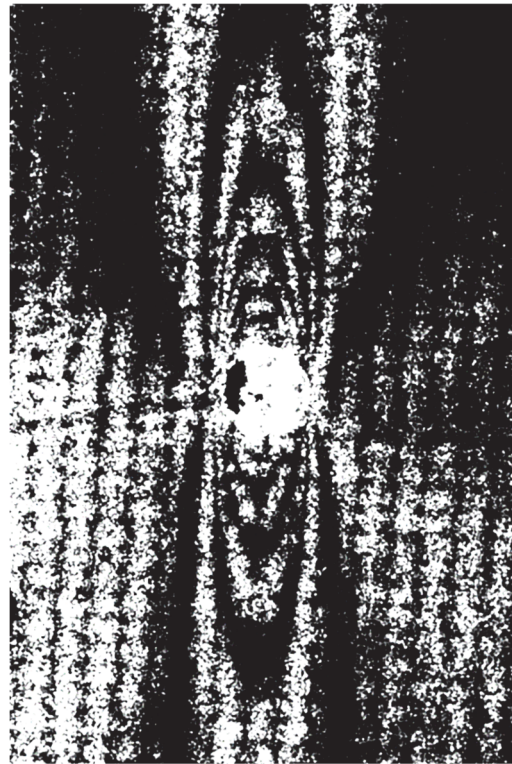
(a) Component u , $\Delta N^u = +20.0$

(b) Component v , $\Delta N^v = -11.0$

(c) Component u , $\Delta N^u = -5.0$

(d) Component v , $\Delta N^v = +10.0$

Figure 11: Specimen CP_D-25. Interferograms referred to point 4 (a), (b) and point 7 (c), (d).

Interference fringe patterns, a source of which is deformation response to through hole drilling at the vicinity of contact dimple at point 4 and point 7 caused by impact influence on CP_D-25 coupon, are shown in Fig. 11. The fact that probe holes are located out of contact dimple area provides very good fringe quality.
