# Multidisciplinary characterisation, weathering patterns, and durability assessment of stone blocks for the conservation of Tamentfoust fort (ex. Rusguniae) in Algiers

**KEYWORDS:** Stone building heritage, Conservation, chemical, Physical and mechanical characterisation, Durability and weathering mapping.

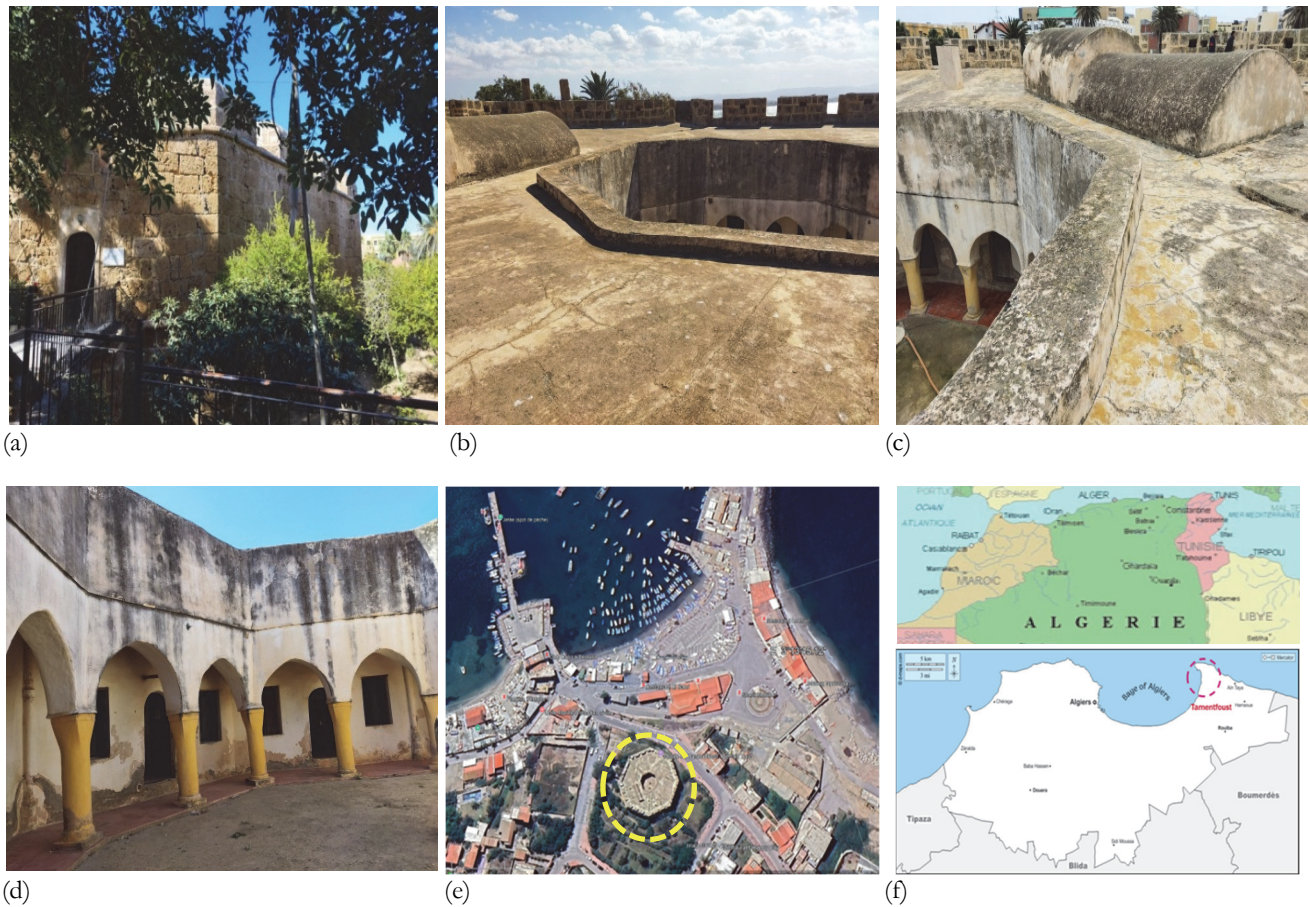
Figure 1: (a) external view (b, c) terrace (d) internal courtyard (e) aerial view (f) geographical location

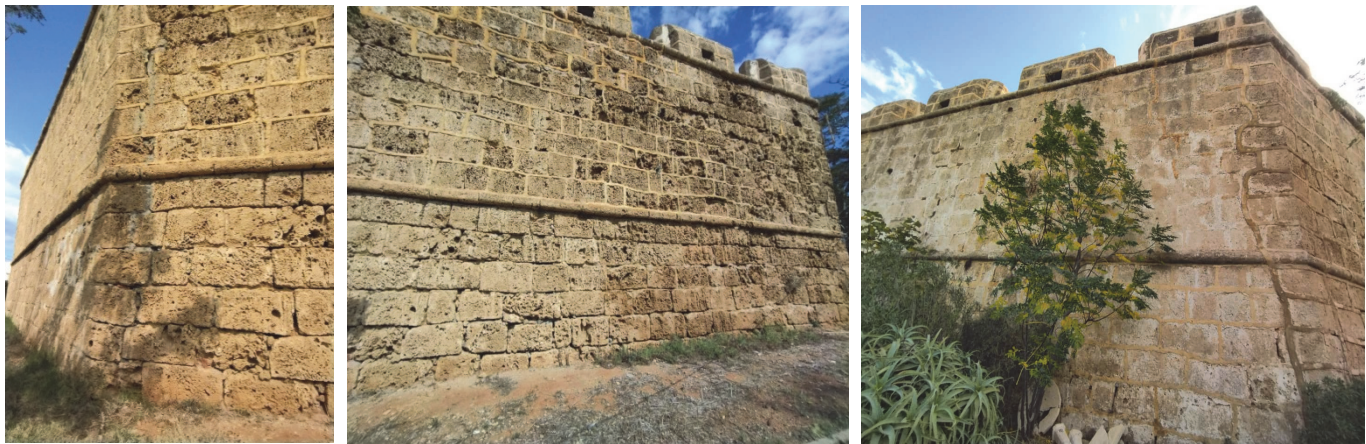
Figure 2: Main fort facades.

records confirm Rusguniae was founded as a Roman colony by Augustus in 30 Before Common Era (BCE), later thriving as a Byzantine urban center [10]; [11]. Its orthogonal urban layout, covering 19 hectares, included two gateways (Fig. 2), with a north-eastern portal connecting to the Icosium-Tipasa trade route.

courtyard, which houses functional spaces (kitchen, prayer hall, prison, hammam, and armory), accessible via a lateral staircase (Fig. 2). The 1992 restoration campaign identified multiple forms of deterioration, including: exfoliation, fissures, fractures, alveolar erosion, stone detachment, delamination, and rain-induced deposits, particularly in areas exposed to meteorological stressors such as solar radiation, saline aerosols, and humidity. Subsequent interventions in 2012 used cement-based mortars for façade repointing, a method criticized for its incompatibility with the fort's historical stone substrates.

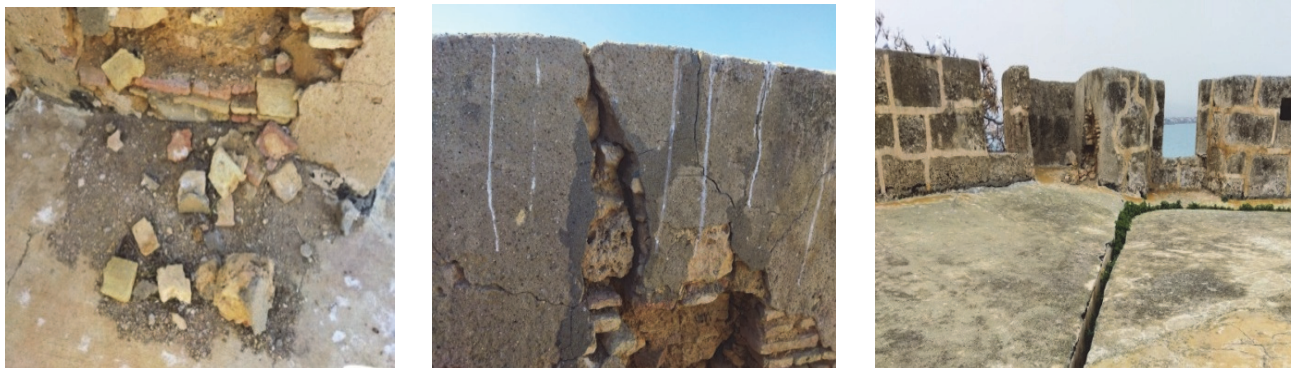
Figure 3: Damaged masonry walls on the terrace where the stone block samples were taken.

Four stone blocks (E1, E3) as type T1 and (E2, E4) as type T2 with dimensions approximately of  $17 \times 37 \times 15$  cm, collected from the immediate surroundings of the fort, belong to the damaged masonry wall on the fort's terrace (Fig. 3). The blocks were cut into parallelepipedical specimens  $30 \times 5 \times 5$  cm, and cylindrical specimens via core drilling 50 mm bit (Fig. 5), (Fig. 6). For microscopic studies, thin sections were also prepared from the two blocks (Fig. 4). Stone samples were selected for their historical texture, avoiding contemporary materials to focus on the early construction phase, due to monument restorations in the 1992s and 2012. Below, are listed all the tests carried out, summarized in Tab. 1, with reference to the tested specimens.

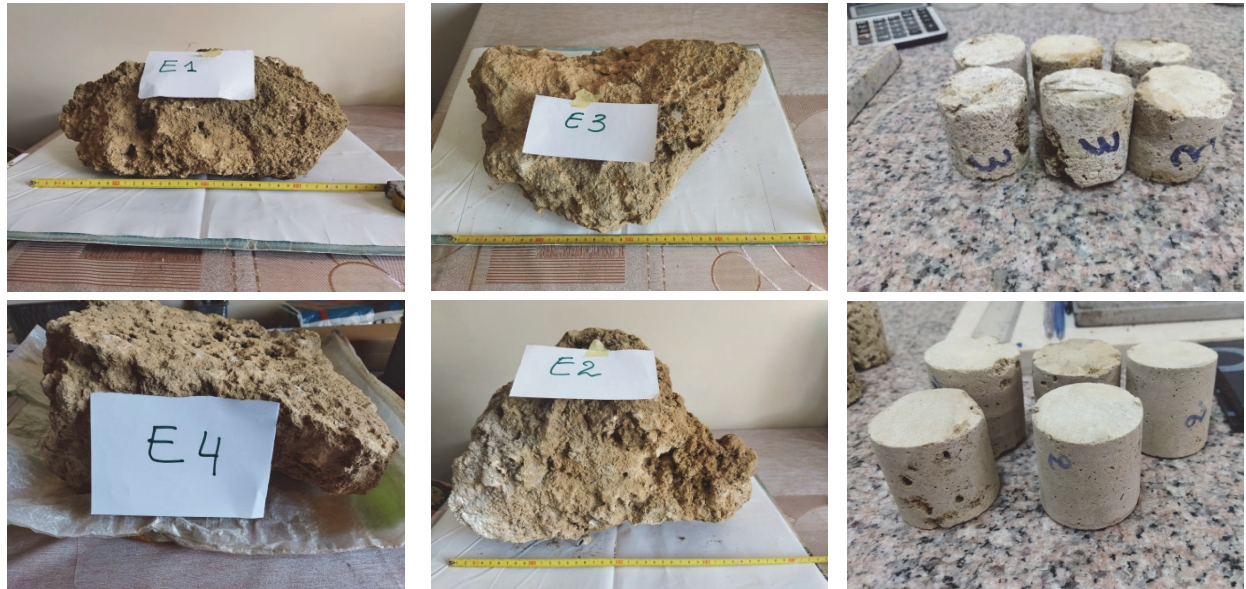
Figure 5: Stone samples and extracted cylindrical specimens.

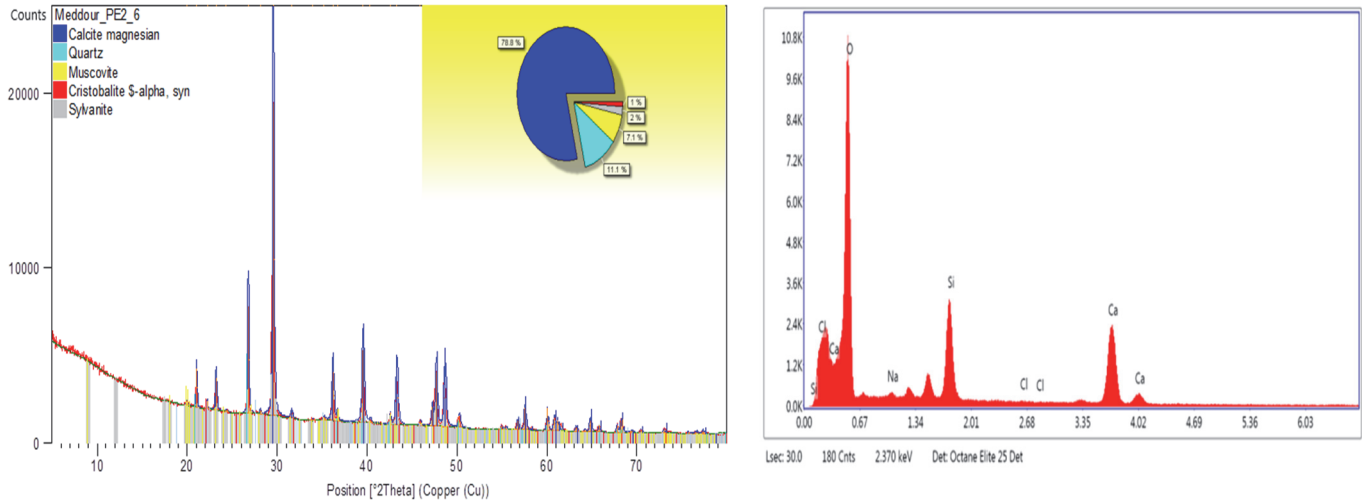
Figure 12: XRD and EDX analysis of sample PE2-6 (T2).

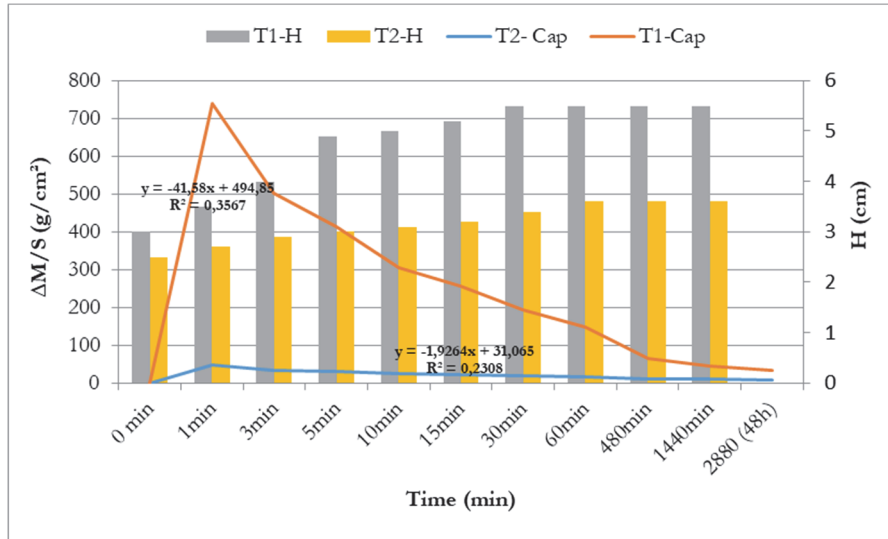
Figure 18: Capillary water absorption, measured as mass uptake per unit area ( $\Delta M/S$ ) and the displacement  $H$  of the capillary front along the height of the two types (T1) and (T2) cylindrical sample, in relation to the square root of elapsed time ( $t$ ).

T2's capillary absorption ( $C$ ) exceeds atmospheric absorption ( $A_b$ ) (Fig. 17, Fig. 18), indicating interconnected pores and microcracks, worsened by clays (muscovite, chlorite), elongate grains (quartz, plagioclase), and hygroscopic clay properties, raising chemical deterioration risks per ISRM (ASTM C880/C880M Standard Test Method for Flexural Strength of Dimension Stone). Furthermore, T2's uniaxial compressive strength ( $\sigma_c$ :  $27.57 \pm 0.03\ \text{MPa}$ ) (Fig. 19) is rated "medium strength" per ISRM, limited by 35% fossils and 0.172% phosphorus as weak points, restricting it to non-load-bearing uses per ASTM C170. T2's flexural strength ( $\sigma_f$ :  $1.93 \pm 0.03\ \text{MPa}$ , maximum 3.73 MPa) falls below the 8 MPa threshold for dimension stone per ASTM C880, driven by its 8.59% porosity and its mineralogical composition: 35% fossils, 0.805% Fe, and clays (1% chlorite, muscovite), with brittle tensile failure resulting from stress concentration at fossil voids and crack propagation.

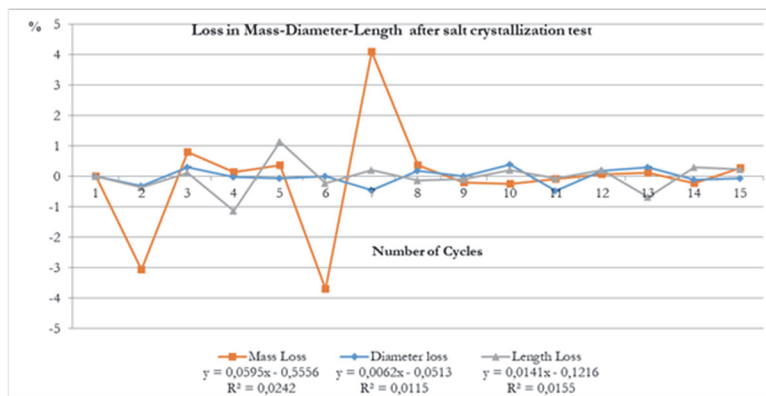
Figure 22: Loss in mass, diameter and length after salt crystallization of the T1 type block sample.

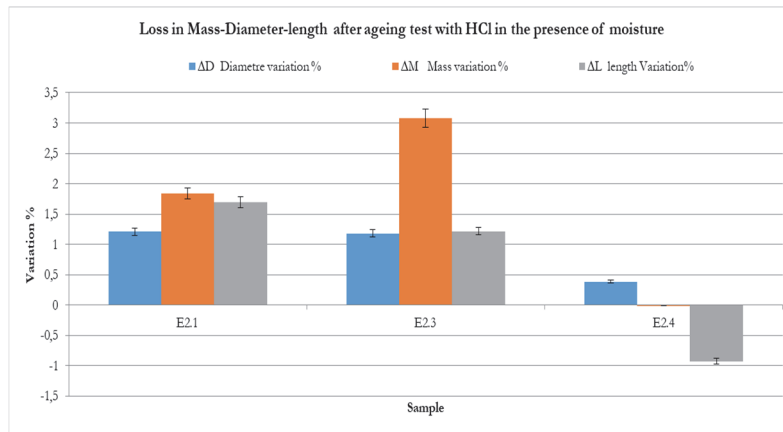
Figure 24: Loss in mass, diameter and length after ageing test with HCl in the presence of moisture.

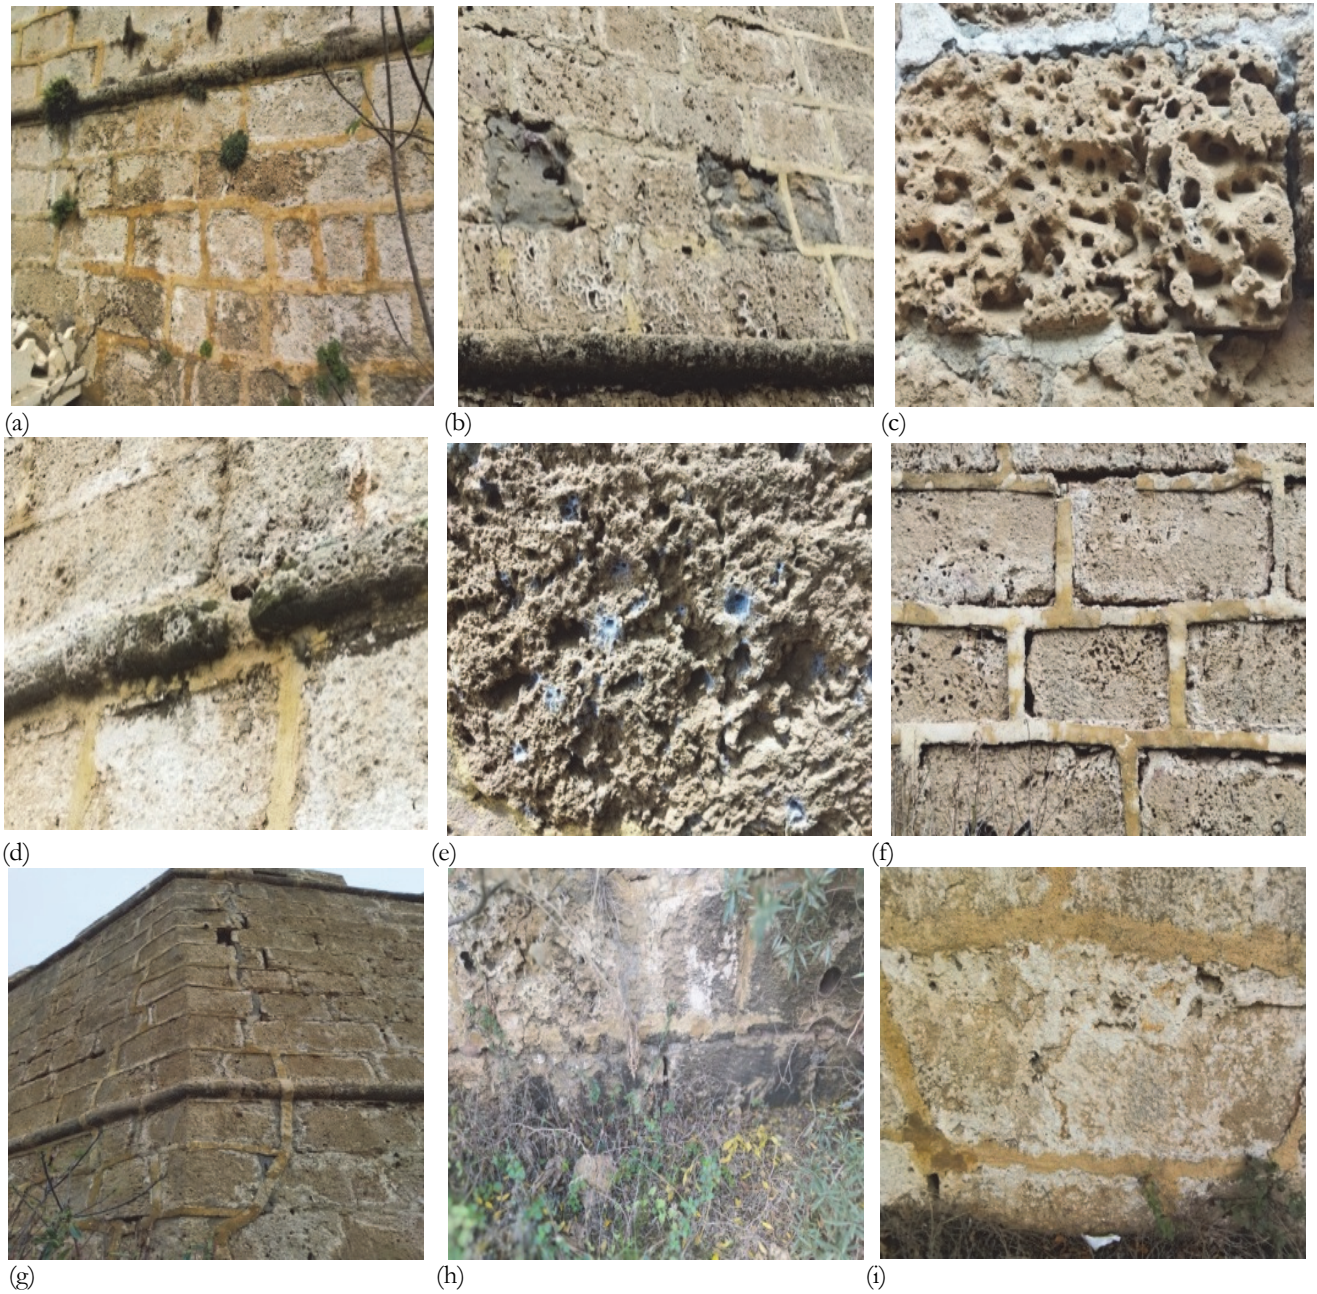
Figure 26: Southern fort façade type of damage (a) biological colonization, (b) scaling, (c) alveolization, (d) disaggregation and lichen colonization, (e) special biological colonization by a spider web, (f) erosion, (g)cracking, (h) black crust ,(i) effloresce.

The south façade exhibits extensive degradation, characterized by multiple mechanisms (Fig. 26). Efflorescence, manifesting as whitish deposits from salt crystallization (chlorides from marine air, sulphates from mortar or pollutants), is prominent in central and upper blocks, intensified by capillary rise and rapid evaporation, which promote subflorescence and disintegration. Disintegration, observed as granular fragmentation in mid-height and lower blocks, results from wetting-drying cycles, thermal stress, and low stone resilience, worsened by efflorescence and biological colonization. Vegetation (mosses, higher plants) in joints and blocks, alongside dark microbial stains, indicates moisture retention and acid-induced mineral dissolution, amplifying cracking. White, web-like patches, likely spider webs or salt efflorescence (possibly with calcium carbonate deposits), reflect coastal influences and high porosity. Micro-cracks, predominantly near colonized areas, arise from thermal expansion, root pressure, and salt crystallization, facilitating further water ingress. Erosion, marked by smoothed upper blocks and alveolar cavities, results from runoff and wind, exacerbated by disintegration. Staining (brownish, dark) from pollution, chemical reactions, or lichens, along with gypsum crusts, adds subsurface pressure.

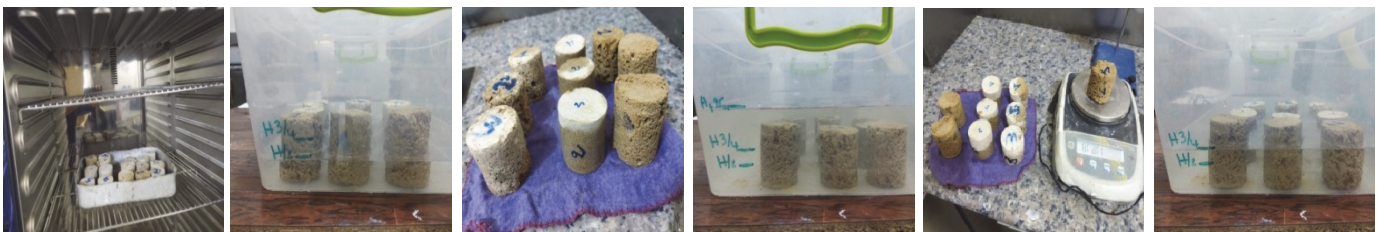
Figure A2-6: Different steps of the water absorption by atmospheric pressure

- **Objective:** The water absorption by atmospheric pressure testing was employed to determine the water absorption, expressed as a percentage, calculated as the ratio of the saturated sample mass (ms, obtained at constant mass) to the dry sample mass (md).

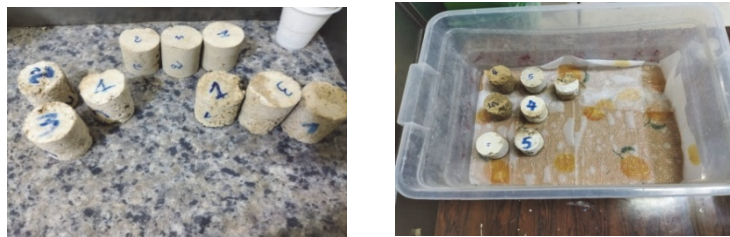
Figure A2-7: Water absorption by capillarity test.

- **Tools and software used:** For the capillary absorption measurement, the procedure involved drying samples at  $70 \pm 5$  °C to constant mass (Md), followed by immersion in water at a depth of  $3 \pm 1$  mm. Water absorption ( $\text{g}/\text{m}^2$ ) was measured at intervals from 1 to 4320 minutes, with the test concluding when the difference between consecutive measurements was less than 1% of the total absorbed water.
- **Objective:** The capillary absorption measurement was employed to calculate the mean capillary absorption coefficients ( $C$ ,  $\text{mg}/\text{cm}^2 \text{ s}^{-1/2}$ ) from the slope of absorption versus  $t^{1/2}$ , as presented in Fig. A2-7.

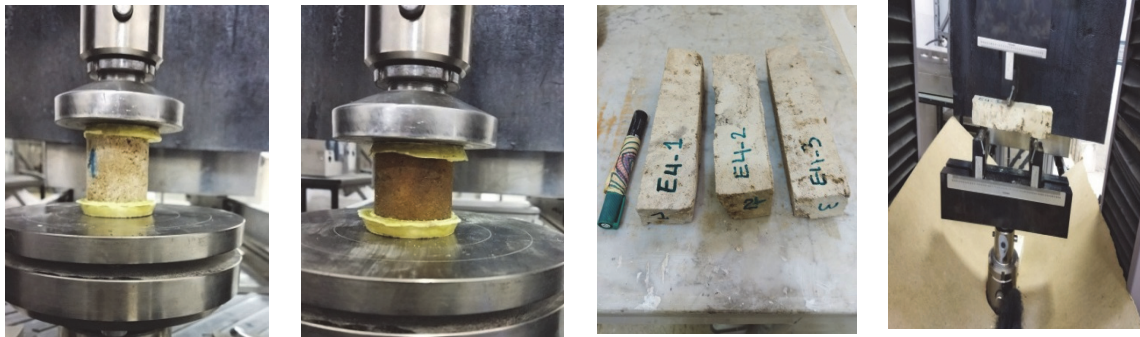
Figure A2-13: Mechanical tests

- **Tools and software used:** For the flexural strength testing, the procedure involved conducting tests under a centered load at  $0.3$  kN/s and a stress rate of  $0.25 \pm 0.05$  MPa/s until failure, using symmetrically dried samples.
- **Objective:** The flexural strength testing was employed to determine the flexural strength of stone samples under centered loading conditions until failure as presented in Fig. A2-13 .

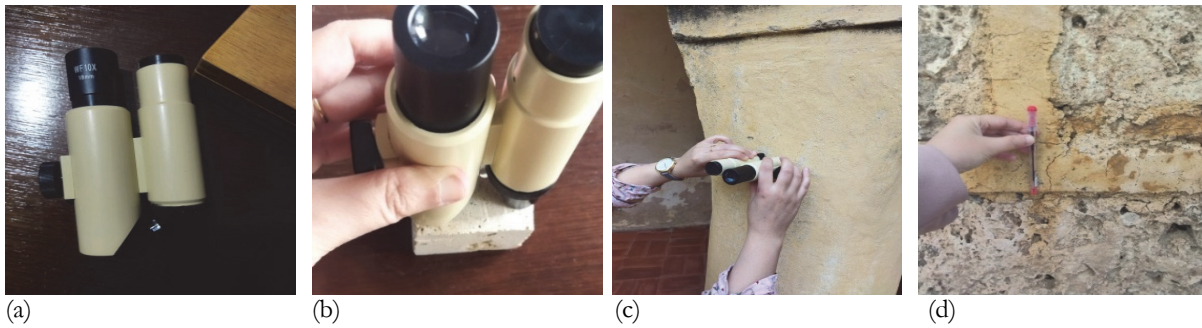
Figure A2-14: (a) the crackmeter from MATEST, (b) tested samples, before and after durability tests (c, d) the use of the crackmeter in the measurement of cracks development in the gallery support and the jointing mortar.

- **Tools and software used:** For the crack measurement and microstructural analysis, the procedure involved using a MATEST portable crackmeter (STDMC399) with a  $360^\circ$  rotatable eyepiece scale to measure cracks. Microstructural changes in four stone samples were analysed before and after aging durability tests.
- **Objective:** The crack measurement and microstructural analysis was employed to assess surface alterations due to mineralogical reactions in stone samples, as presented in Fig. A2-14.
