An experimental study on the rehabilitation performance of CFRP-strengthened bubble deck slabs: effects of void size and preloading levels

KEYWORDS. Rehabilitation, Damaged, Two-way slab, CFRP sheets, Bubbled slab

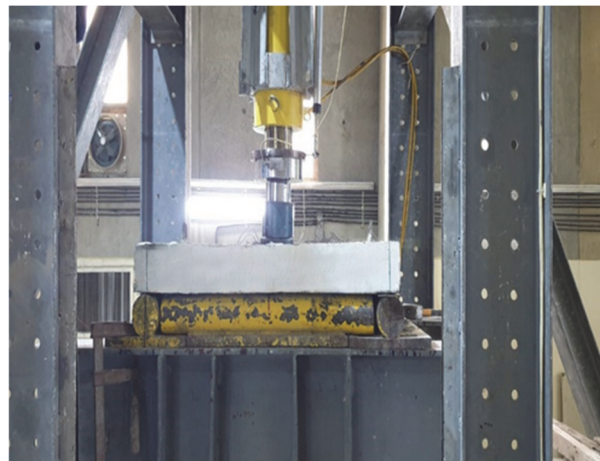
Figure 2: Schematic illustration of the experimental test setup.

All specimens were subjected to monotonic central loading with four-edge supported conditions to simulate two-way flexural behavior. The burden was uniformly transferred by placing a rigid steel loading plate (100 mm × 100 mm) at the center of the slab, directly above the cast-in column stub. The support system comprised steel rollers to prevent restraining moments and facilitate unfettered rotation. Three linear variable differential transformers (LVDTs) were employed to measure deflections: one at midspan and two at opposite supports. An automated data acquisition system was employed to record data perpetually. Loading was performed in a universal testing machine with a capacity of 200 tons, with displacement control. The initial loading rate was 0.5 kN/min to capture the first cracking and elastic behavior precisely. A controlled failure was achieved by increasing the rate to 1.0 kN/min after considerable cracking was developed, typically beyond 40% of the ultimate load. This protocol guaranteed that the test conditions were consistent and reproducible for all specimens.

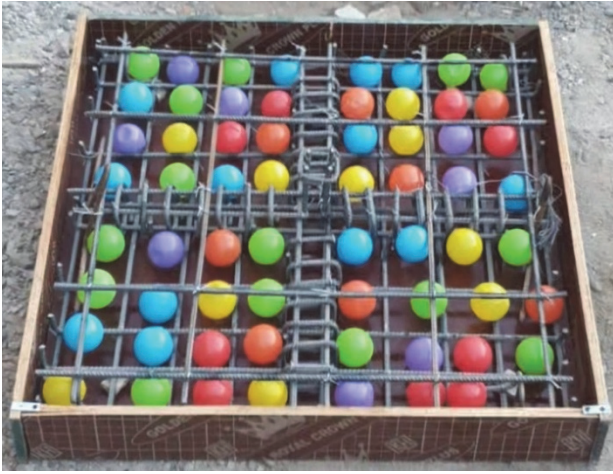
Figure 3: Casting of slabs.

The formworks were constructed from 15 mm flat plywood and utilized for concrete casting. The forms have a thickness of 125 mm and dimensions of 1000 x 1000 mm. The materials (cement, gravel, and sand) were weighed and packaged; refer to Fig. 2. The steel bar reinforcements were subsequently inserted after the interior faces of the formwork were lubricated. A steel rod manually vibrated the concrete mix, and the form's exterior faces were hammered with a rubber hammer after the concrete was cast inside the form. A manual trowel was employed to level and smooth the concrete surface. After washing and lubricating the forms, three cubes of the dimensions (150x150x150) mm are cast in steel cube molds during concrete casting. After one day of casting, the cubes were demolded and subjected to the same conditions as the samples. Fig. 3 illustrates that concrete curing commenced one day after casting, with a moist canvas utilized for 28 days. A universal testing equipment with a maximum capacity of 200 tons was employed to test all slab specimens under monotonic central loading. The slabs were supported along their four edges, which simulated bidirectional deformation. The slab is four-edge simply supported on rollers, with a central column stub (100 mm × 100 mm). Load is applied through a 100 mm × 100 mm steel plate aligned with the column. LVDTs are positioned at midspan and supports to measure vertical deflection, as shown in Fig. 4. Failure modes were also precisely identified using crack patterns and ultimate failure mechanisms (i.e., flexural, punch shear, or mixed shear and flexural failure). The observations of the reconstituted CFRP slabs were similar, and the performance of the reinforcement work was also observed in terms of crack reduction and increased stiffness.

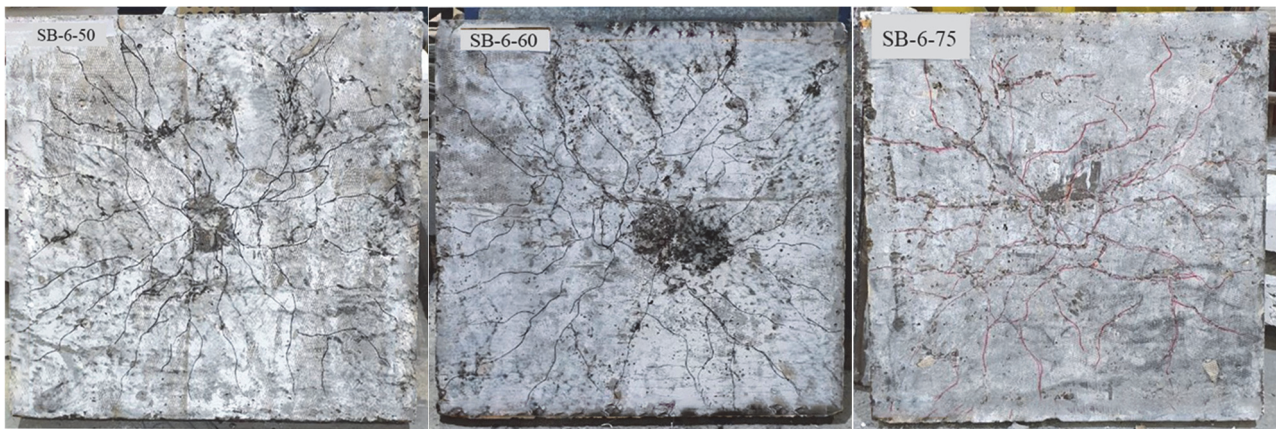
Figure 12: Crack patterns in 60 mm void bubble slabs after CFRP rehabilitation and re-testing to failure: (a) SB-6-50, (b) SB-6-60, (c) SB-6-75.

Bubble slabs with voids measuring 60 mm in diameter comprised group 2. In the unreinforced specimen, the ultimate load was approximately 13% lower than the solid specimen's, even though its deflection was slightly higher. This may be attributed to the lower strength but similar failure toughness. The structural performance of all reconstructed specimens (loaded at 50%, 60%, and 75%) exhibited some or significant signs of recovery after the CFRP reinforcement was completed. Depending on the severity of pre-existing damage, the ultimate burden increased by 5 to 9% compared to the unreinforced slab. Adding layers reduced deflection, as evidenced by the substantial effect of preloading: slabs lacking preloading experienced deflection decreases of up to 20%. Group B responded favorably to CFRP rehabilitation; however, Group 2 recovered a lesser percentage of its original strength than Group 1 when the damage was more severe, as illustrated in Tab. 2 and Figs. 10, 11, and 12. As with all specimens, the predominant failure type for the Group 2 panels was a mixed flexural-delamination failure. The SB-6-0 specimen experienced the development of typical downward-curving fractures in the central region, which subsequently spread. The specimen's top bowed, and the concrete in that area fractured extensively, indicating a classic flexural failure. In the SB-6-50 specimen, the widest cracks were smaller and concentrated in a single location, suggesting that the CFRP laminates assisted in slowing the fracture process and making it more localized. The CFRP enabled controlled fissure growth and maintained failure stability, even though the fracture zone in the SB-6-60 was denser. The SB-6-75 failure was characterized by the partial detachment of the CFRP reinforcement layer and early cracking in the upper layer. The energy absorption and the bond between the fibers and the resin were substantially shorter, even though they were not yet considered a buckling failure. The toughened panels outperformed SB-6-0 regarding fracture size and growth at moderate damage. The post-cracking resilience of CFRP panels was enhanced due to delayed surface expansion and delamination. We observed a decrease in the reliability of damage recovery in the 60% to 75% damage range, which suggests that the CFRP panels are less effective and that the components are deteriorating more rapidly. This confirms that CFRP panel repair is more effective for moderate damage and that fissure control is crucial for optimal post-repair performance.
