# BEACH NOURISHMENT AND SEDIMENT MANAGEMENT FRAMEWORK FOR HATTERAS ISLAND, NORTH CAROLINA, USA

Haiqing Liu Kaczkowski<sup>1</sup>, PhD, PE and Stephen Kaczkowski<sup>2</sup>, PhD

*Keywords: Hatteras Island, North Carolina, Dare County, NPS, NC Highway 12, Sediment Management, Beach Nourishment, STWAVE, GenCade*

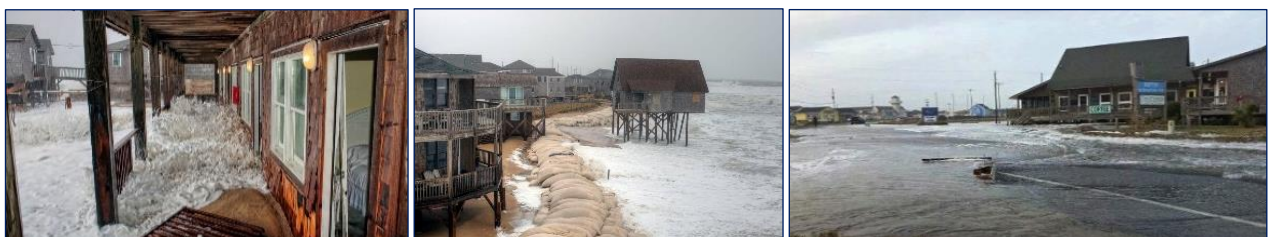
**Figure 2. Flooding of NC 12 and damaging waves along the Buxton oceanfront properties during a northeaster on 8 December 2014 (NPS/USACE 2015).**

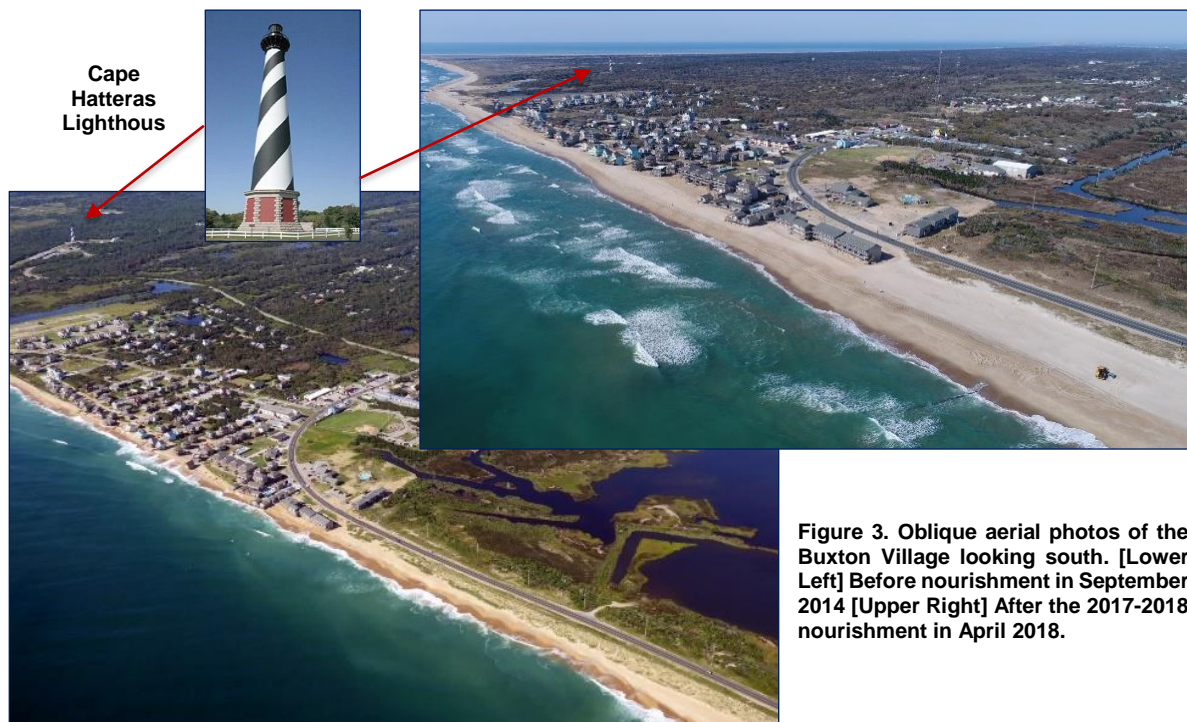
**Figure 3. Oblique aerial photos of the Buxton Village looking south. [Lower Left] Before nourishment in September 2014 [Upper Right] After the 2017-2018 nourishment in April 2018.**

Despite the delays, the project was successfully completed without any sea turtle fatalities or other environmental incidents. Nourishment in front of the narrow isthmus of NC Highway 12 was completed, and the highly vulnerable section of the road was protected (Figure 3). The Buxton project offers valuable insights for future renourishment efforts. Without the allowance for summer dredging, construction could have taken even longer, potentially leaving the road vulnerable to breaches during hurricanes and storms.

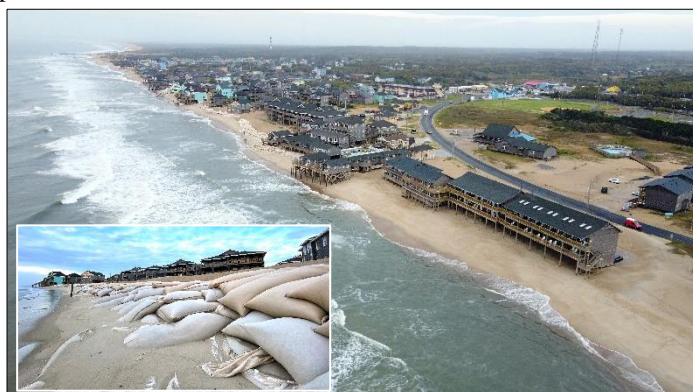
**Figure 5. Ground and aerial images taken on 15 April 2021 – looking south. The Village of Buxton north limit is located approximately at the end of the northernmost building shown near the bottom of the photo. Three years after the initial 2017–2018 beach restoration project, almost all nourishment sand was lost outside of the project limits beyond the depth of closure (USACE 2021a).**

Between February 2018 and August 2020, the annual erosion rate in the Buxton project area was approximately 500,000 m<sup>3</sup>/year, significantly exceeding the historical average of 88,000 m<sup>3</sup>/year used in the design of the 2017–2018 project. Similarly, in recent years high erosion rates have been observed at Nags Head, which is located about 70 km northeast of Buxton in the northern Outer Banks. The unusually high erosion rate in the Buxton area during the first three years post-completion (2018–2020) can be attributed to several factors, including increased storm activity, the deteriorating condition of sand-retaining structures (e.g., groins) at the southern end of the project area reducing their sand-trapping effectiveness, and the migration of sand offshore beyond the depth of closure, influenced by the presence of a nearshore deep trough. Oblique aerial photos taken on April 15, 2021 (Figure 5), reveal a minimal dry-sand beach remaining along the Village of Buxton. Some previously buried sandbags have been re-exposed due to erosion, and new sandbags have been installed by property owners along the oceanfront as a temporary measure for shoreline protection. The loss of the dry beach has once again left NC Highway 12 vulnerable to flooding and potential breaches.

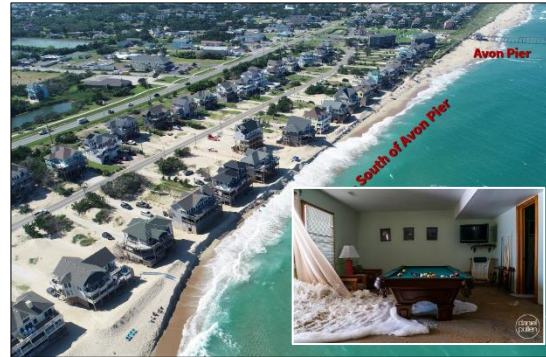
**Figure 6. Aerial photo taken on 15 July 2020 looking north, showing the highly eroded section of Avon south of the pier. The ground photo was taken by Daniel Pullen on 20 September 2020 during Hurricane *Teddy*. NC Highway 12 was closed for 5 consecutive days due to overwash caused by ocean swell generated by *Teddy* (USACE 2021b).**

In 2020, the NC Division of Coastal Management (NCDCM) reported official erosion rates for Avon ranging from 0.6 m/year in an area north of the Avon Pier to 1.8 m/year along an approximately 1,200 m (4,000 ft) stretch of beach south of the pier. Erosion rates decrease to 1 m/year at the southern edge of the village. Based on these official erosion rates and beach condition surveys in 2020 and 2021, the long-term historical erosion rate for the 4 km (13,200 ft) Avon project area is estimated at 108,000 m<sup>3</sup>/yr (140,000 cy/yr). Restoring the project area for five years under normal weather conditions, would require approximately 764,500 m<sup>3</sup> (1 million cubic yards) of sand (USACE 2021b).

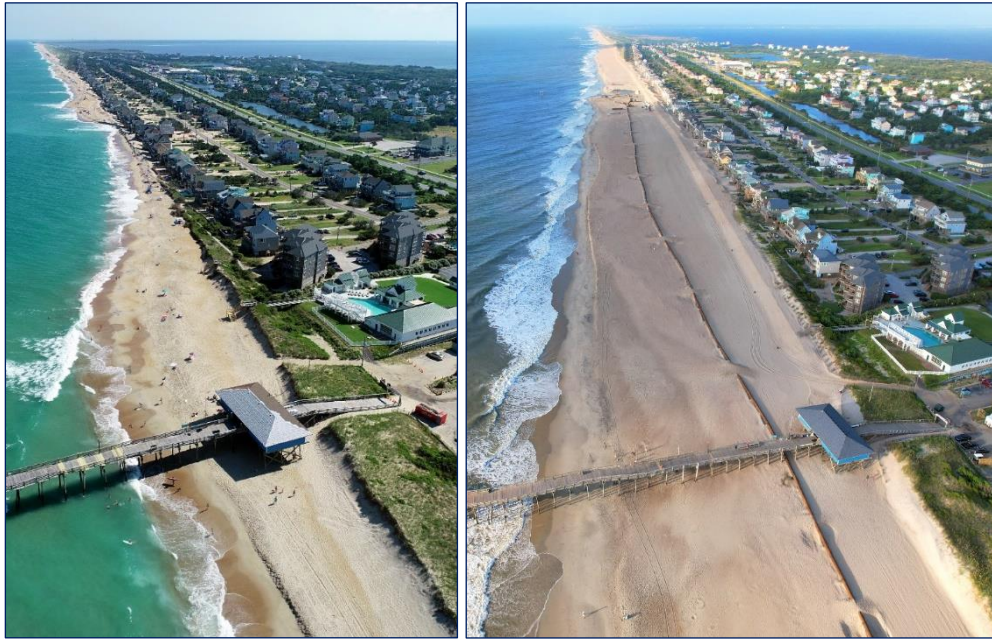
Figure 8. Oblique aerial images looking south showing the beach conditions before and after the 2022 Avon beach nourishment project. [Left] Before nourishment on 15 July 2020 [Right] During nourishment on 26 July 2022

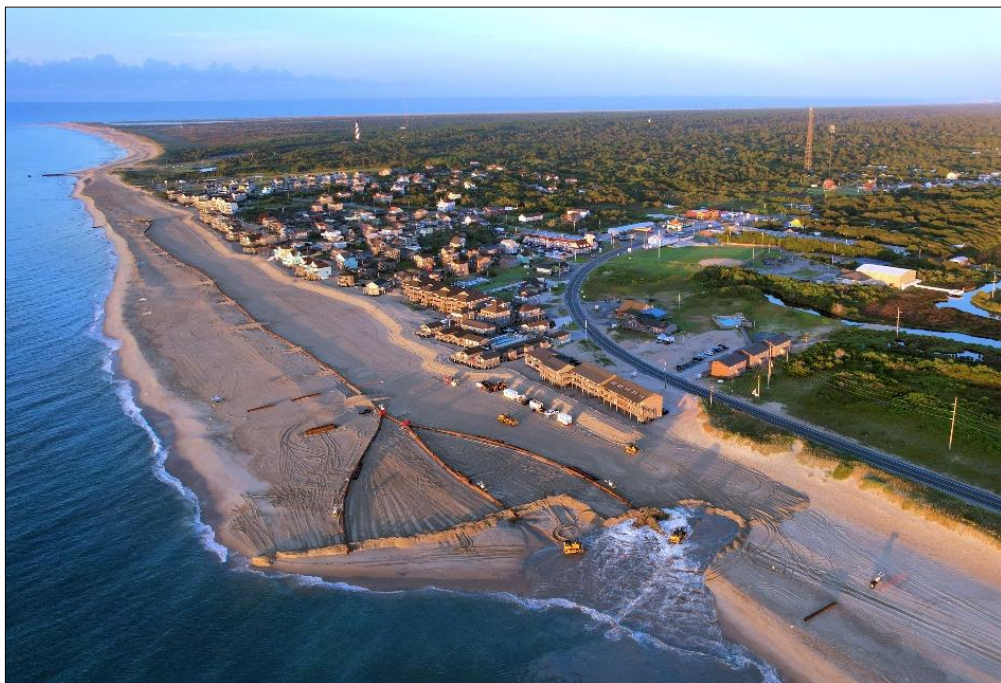
Figure 9. Oblique aerial images on 5 August 2022 during construction of the 2022 Buxton beach renourishment project.
