# SYSTEMATIC TESTING OF A NOVEL BREAKWATER ARMOUR TOE SOLUTION: THE ACCROBERM™ I

Fernando Roca<sup>1</sup>, Alberto Gutierrez<sup>2</sup>, Pauline Berte<sup>3</sup>, Yoann Bonte<sup>4</sup>, Iman Safari<sup>5</sup> and Cyril Giraudel<sup>6</sup>

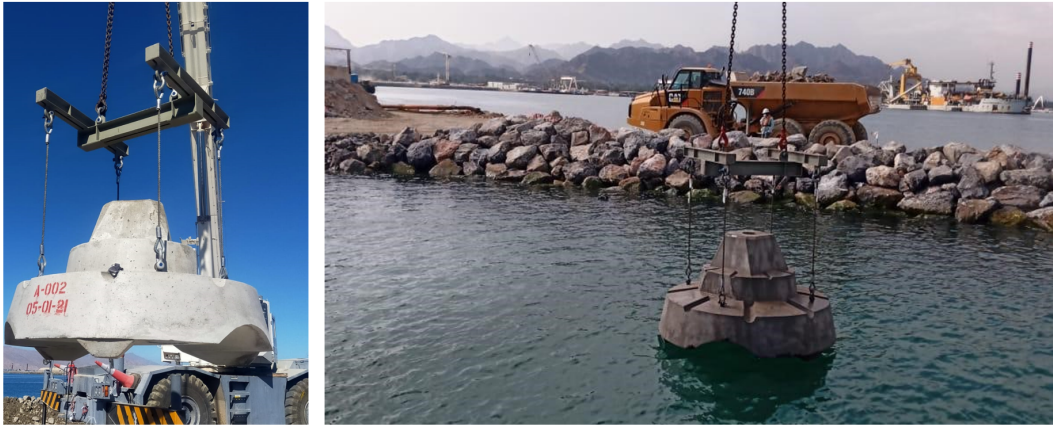
Figure 3. ACCROBERM™ I units installed on a project site in 2019

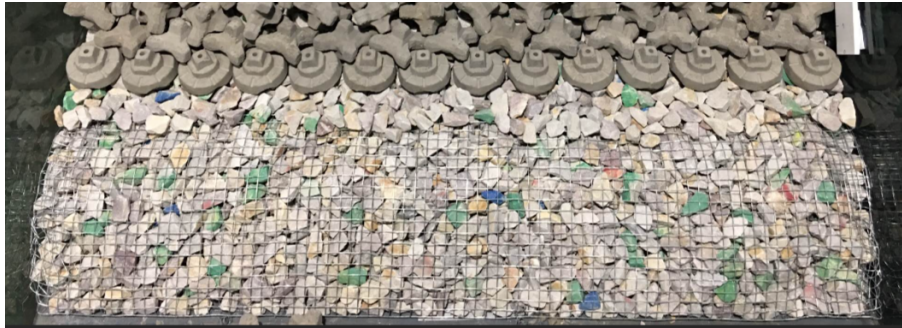
Figure 5. Rigid wire mesh applied to the rock berm supporting the ACCROBERM™ I units

Model dimensions as well as the hydraulic conditions have been defined according to a Froude scaling of  $E = 1/31$  (model to prototype). The equivalents of a 0.3 – 0.7 tonnes nature-size underlayer and a 1 – 300 kg quarry-run permeable core have been implemented in both models. The material of the toe berm is the same of the underlayer. In model cross-section n°2, a rigid wired mesh was installed on top of the rock berm to ensure that its geometry was not modified during the tests, which could impact the stability of the ACCROBERM™ I units on top of it. The opening size of the mesh (12 mm) has been chosen as to impede the extraction of berm rocks, while allowing for imbrication with an un-confined layer of rock placed between the berm and the ACCROBERM™ I units (Figure 5).

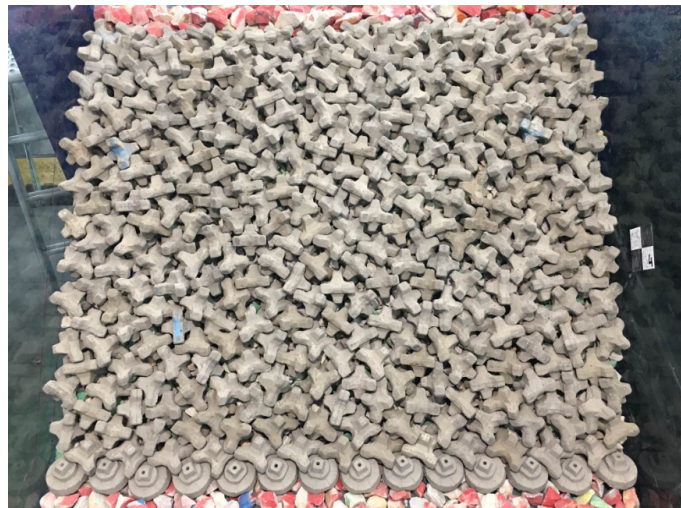
Figure 6. Detail of the ACCROPODE™ II armour placement

The ACCROPODE™ II and ACCROBERM™ I model units are made of densified mortar ( $\rho_{\text{mortar}} = 2316 \text{ kg/m}^3$ ). They represent  $2\text{m}^3$  prototype units with a Hudson stability scaling and considering the densities of concrete and sea water to be  $\rho_{\text{concrete}} = 2350 \text{ kg/m}^3$  and  $\rho_{\text{sw}} = 1025 \text{ kg/m}^3$ . Following the indications given in (CLI 2023), the ACCROPODE™ II armour units were placed to a density of  $\phi = 0.635$  (Figure 6). The first row of armour units on the slope were installed regularly with the same orientation between ACCROBERM™ I units by ensuring three points of contact: one with each ACCROBERM™ I and one with the underlayer on the slope. Such positioning shall allow the first row of ACCROPODE™ II units to quickly reach an equilibrium position, with three points of contact, if an ACCROBERM™ I is extracted during the execution of the tests.

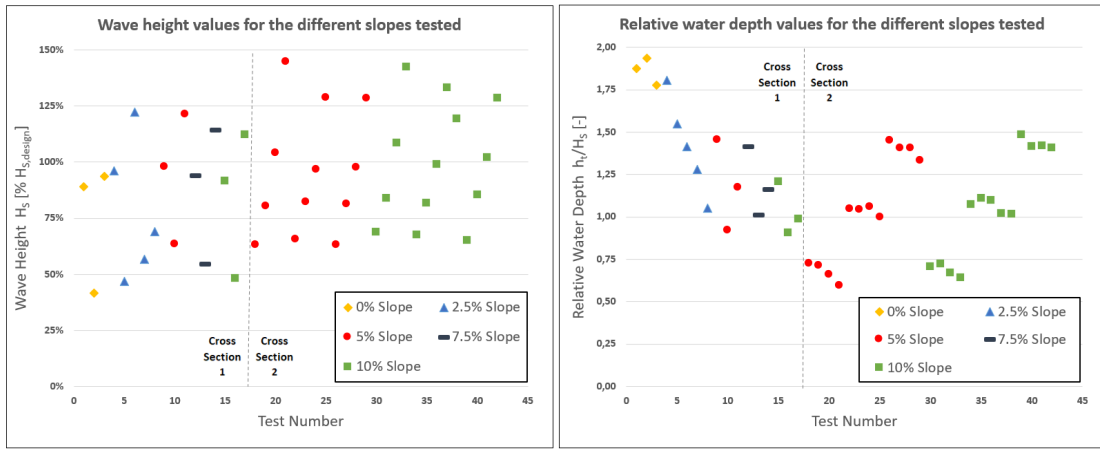
Figure 7. Ranges of values considered for the wave height (H<sub>s</sub>) and the relative water height (h<sub>i</sub>/H<sub>s</sub>)

A total of 7 test series with different combinations of the above parameters have been executed for this study; the last two series having three separate test sequences each (refer to Figure 7 for details). Within each particular sequence, 3 to 5 tests have been performed with an increasing value of the incident wave height. The duration of all the tests was 3h (prototype) which allowed for the number of waves to be always slightly over 1000.

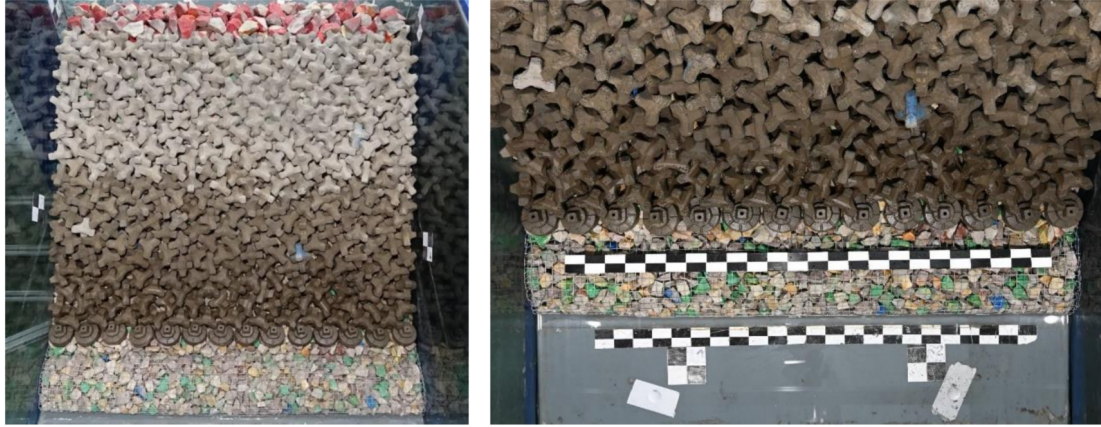
Figure 8. Example of perpendicular photo of the armour layer (left) and vertical photo of the toe berm (right)

In line with previous literature (e.g., (Etemad-Shahidi et al. 2021), (Safari, et al. 2018)), neither the armour nor the toe of the structure were repaired after the execution of each test within a particular sequence. This allowed to determine the cumulative damage along the sequence. Two photos (see example in Figure 8) were taken before and after the execution of each test: one general shot, perpendicular to the slope; and a second picture, vertical, focused on the ACCROBERM™ I units. The first permitted qualifying the settlement of the armour layer, while the latter allowed quantifying the displacements of toe units. This is made by superimposing the photos, which were always taken in the same way, and calculating the displacement of the centres of gravity. A fixed camera remained on the same support during the tests, with the same focal length setting.

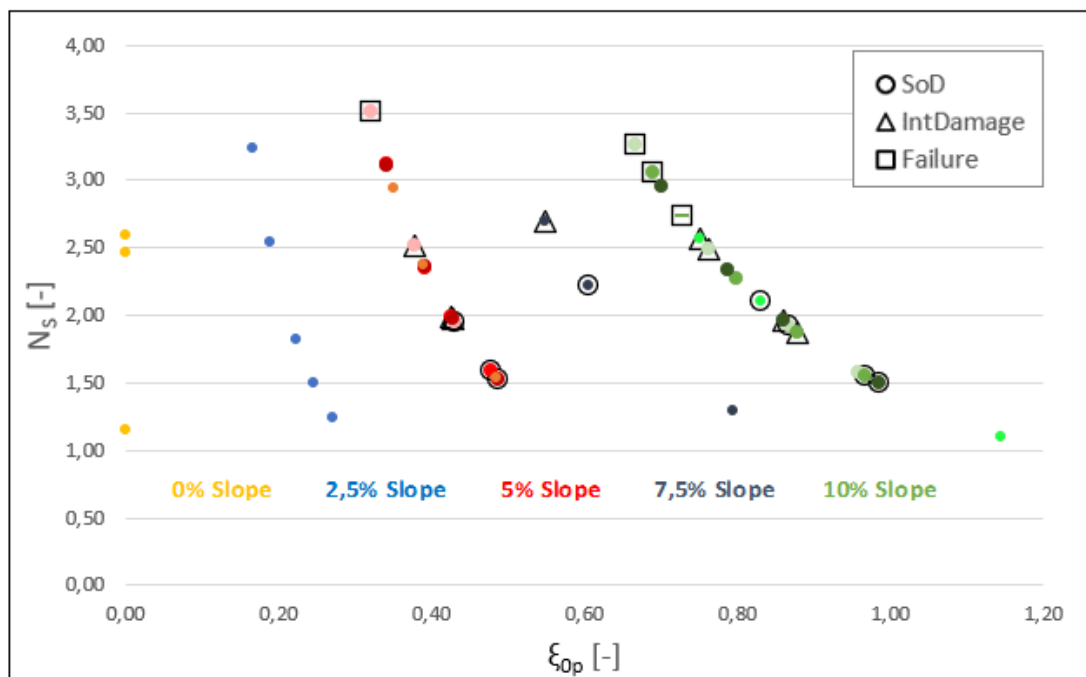
Figure 9. Stability number ( $N_s$ ) versus the Iribarren number ( $\xi_{0p}$ )

Hydraulic stability is one of the key design parameters to be considered when designing a breakwater toe. In this regard, the hydraulic stability of the ACCROBERM™ I unit can be analysed from Figure 9, where the stability number  $N_s$  is plotted against the Iribarren number for all the tests of the study. In the figure, the different foreshore slopes are identified by a change in colour. The fact that, for a given slope,  $H_s$  is the only variable parameter present in both  $N_s$  and  $\xi_{0p}$ , derives in a correlation of the points corresponding to tests done on the same foreshore slope.

The three levels of damage discussed before are indicated by means of a circle (Start of Damage), a triangle (Intermediate Damage) and a square (Failure) for the tests where these levels have been reached. It is to be noted that for the two gentler slopes (0% and 2.5%) no test led to damage on the toe.

Start of Damage and Intermediate Damage were found in several tests on the slopes 5%, 7.5% and 10%; while Failure only happened in four cases; three on the 10% slope and one on the 5% slope. Failure was reached at values of  $N_s$  between 2.7 and 3.3 for the slope of 10%; while at  $N_s = 3.5$  for the slope of 5%. It is worth to be noted that these values should not be directly compared to those of a rock toe berm, since in the levels of damage are defined differently, and the acceptable damage for rock toes is higher.

Preliminary conclusions on the effect of the foreshore slope  $\tan \alpha$  on the hydrodynamic performance of the ACCROBERM™ I unit can be drawn from Figure 9 and Figure 11 already presented. Not only the slope of 10% cumulated most of the failure events, for different  $h_i/H_s$  ratios, but they also happened earlier (i.e., at a lower value of  $N_s$ ) than for a gentler slope of 5%. The toe remained stable even if subject to some damage for all other combinations of slope and relative water depth, except for a case with a 5% slope and a low value of  $h_i/H_s$ . Therefore, it could be concluded for the ACCROBERM™ I, that an increase in the foreshore slope decreases the stability of the toe, which is in line with previous literature for other types of toe berms. Moreover, a 10% slope appears to induce instabilities for a wider range of values of  $h_i/H_s$ . Hence, a conservative design criterion could be established to limit the application of such technique to cases where the foreshore slope is milder than 10%. The afore shall not impede the proposal of particular designs exceeding such criterion which could be validated through detailed physical modelling.
