ASSESSMENT OF COASTAL PROTECTION PROVIDED BY SEAGRASS BEACH CAST DEPOSITS: LABORATORY EXPERIMENTS

Joan Pau Sierra^{1,2}, Vicente Gracia^{1,2}, Carlos Astudillo^{1,2}, Ivan Cáceres^{1,2}, Cesar Mösso^{1,2} and Agustín Sánchez-Arcilla^{1,2},

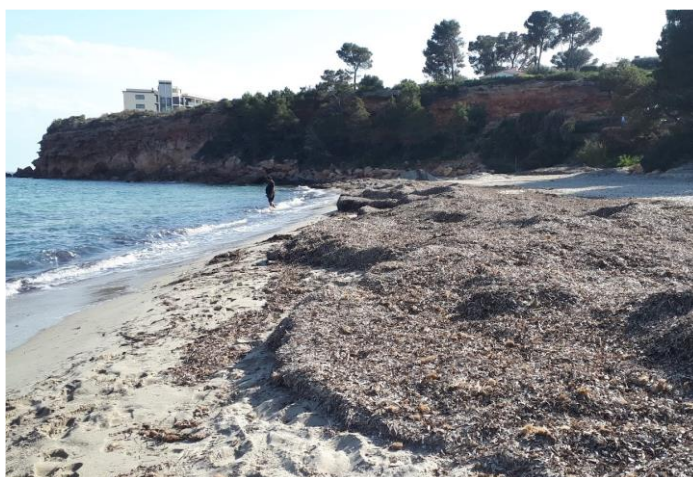
Figure 1. Image of a seagrass beach cast on a beach in Catalonia (Spain).

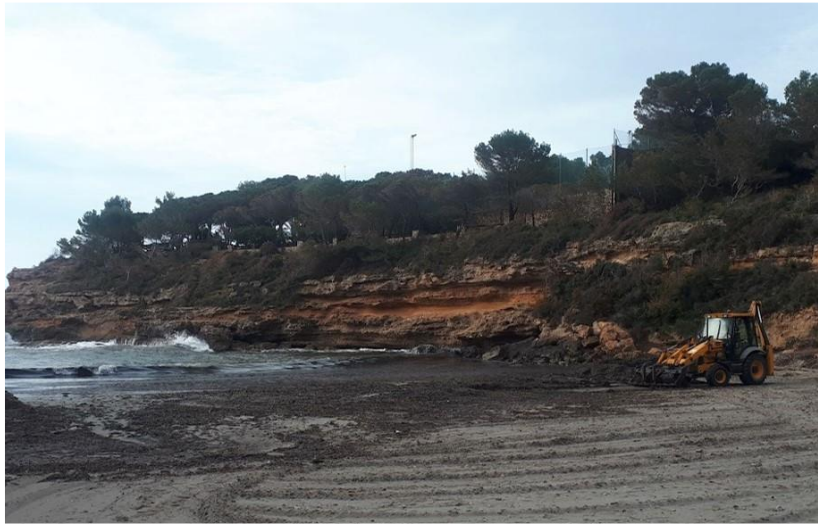
Figure 2. Image of seagrass wrack being removed from a beach.

Some authors (e.g. Simeone and De Falco, 2012, Passarella et al., 2020) pointed out that banquettes play a protection role on beaches from winter storms and favor foredune development by providing nutrients for vegetation growth (Joyce et al., 2022; Menicagli et al., 2024). Despite this, the perception of these plant accumulations by users is often negative and banquettes are removed (Figure 2) to allow beach exploitation for tourist activities (Duarte, 2004).

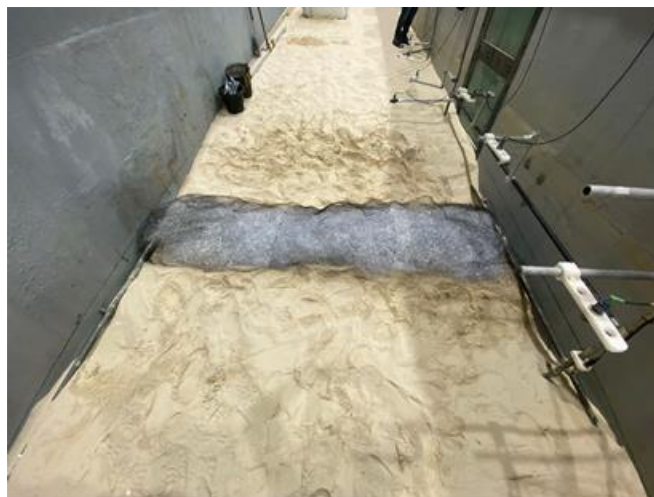
On the other hand, the leaves should be placed within a plastic mesh, as shown in Figure 3, for several reasons: i) to prevent potential interference of loose leaves with sensors; ii) to protect the wave generation system; iii) to facilitate changes of configuration; and iv) to reduce cleaning cost and time.

Figure 3. Image of a banquette being prepared for the experiments.

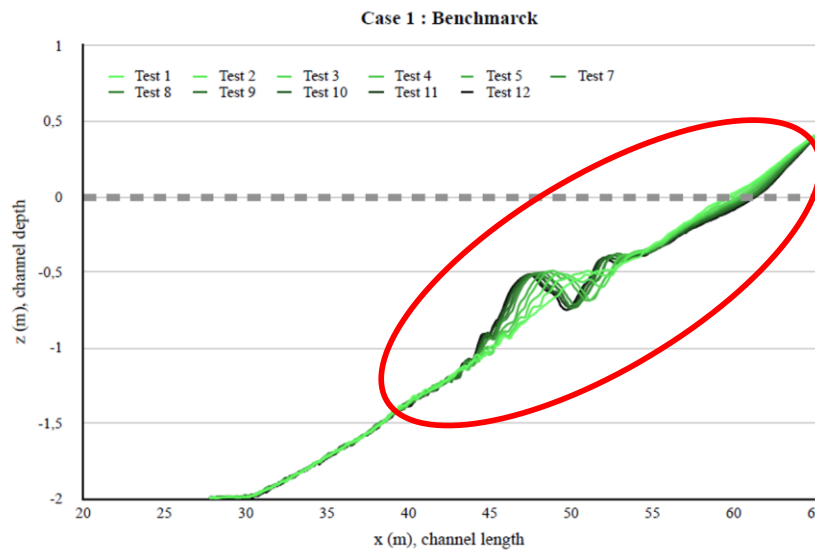
In Figure 5, the evolution of the beach profile after each test, for the benchmark case, is shown. The lower part of the profile does not show significant morphodynamic changes during the tests. In contrast, in the upper part of the beach, noticeable changes in the beach profile can be detected. Therefore, the

study of the evolution of the profile will focus on this upper part, where the morphodynamic activity is concentrated.

Figure 5. Evolution of the beach profile in the benchmark case. The area marked in red is where the significant morphodynamic changes take place.

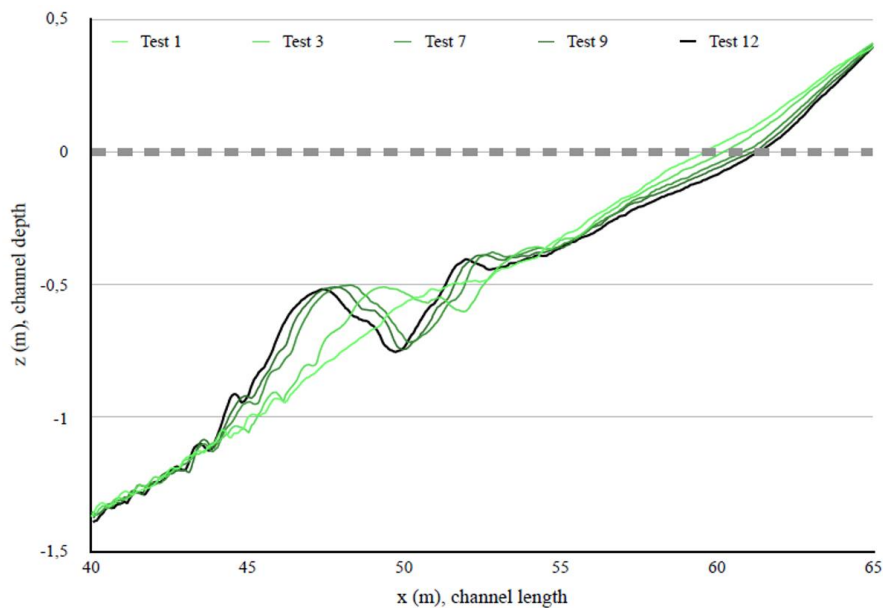
Figure 6 shows the upper part of the beach profiles in the benchmark case after the tests. To facilitate the visualisation of the results, only 5 of the 12 tests have been plotted. It can be seen that the profile is erosive, with progressive loss of sand around the shoreline, sand that is used to feed two bars, one rather small and one larger located further offshore. These bars are moving offshore with time, as the erosion around the shoreline increases.

Figure 6. Evolution of the upper part of the beach profile in the benchmark case.

The maximum erosion reached around the shoreline is -26 cm and occurs (in the last test) just before the shoreline, where the breaking waves have their maximum erosive power. From this point and in offshore direction, the magnitude of the erosion decreases, although the profile of the beach remains

below the initial one, until the first bar, which reaches a maximum level of 10 cm above the initial profile. Between this bar and the one located further offshore there is a trough with a minimum of up to -8 cm below the initial profile, while the large bar reaches a level 33 cm above it.

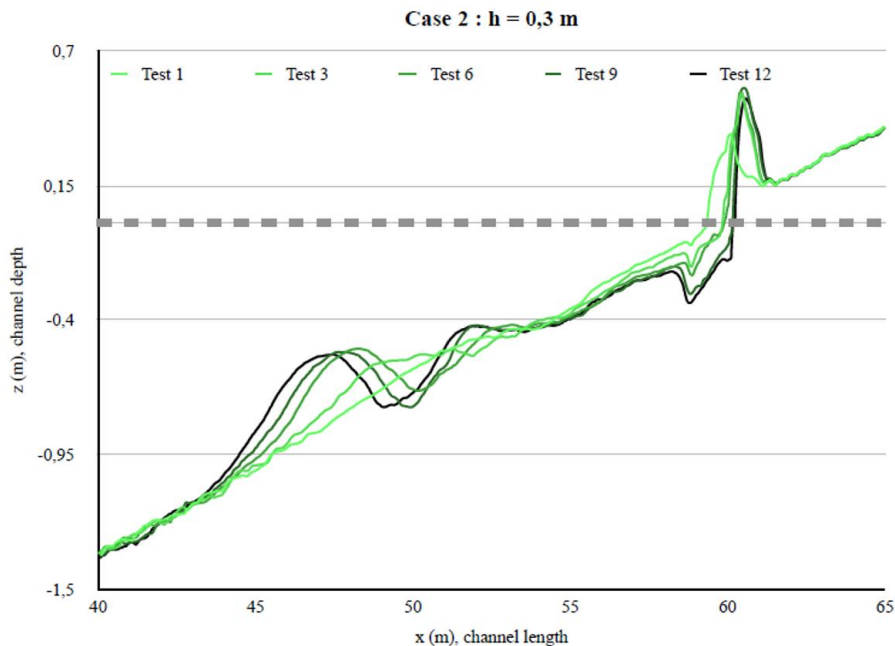
In Figure 7 the profile evolution for the case LB is presented. This corresponds to a long and high emerged banquette (2.25 x 0.30 m) placed on the shoreline. In this case, the profile behaves differently from the previous case. In the backshore, behind the banquette, the beach profile does not change, showing the protective role of the banquette. In front of the banquette, there is a pronounced and progressive erosion, similar to the scouring at the toe of a seawall-type hard structure. The minimum value measured in this trough with respect to the initial profile is -36 cm, and occurs after test 12. From this scour area extending offshore, the beach profile remains lower than the initial one, with maximum differences of up to -10 cm, particularly after test 12. The sand removed in this area feeds two bars similar to those of the previous case, with maximum heights of 10 cm and 32 cm respectively and with a trough of up to -4cm between them.

Lastly, changes in the banquette shape are also very remarkable. Waves push the leaves which tend to accumulate in a narrower and therefore higher space, as they are constrained by the plastic mesh.

Figure 7. Evolution of the upper part of the beach profile in case 2 (long and high emerged banquette).

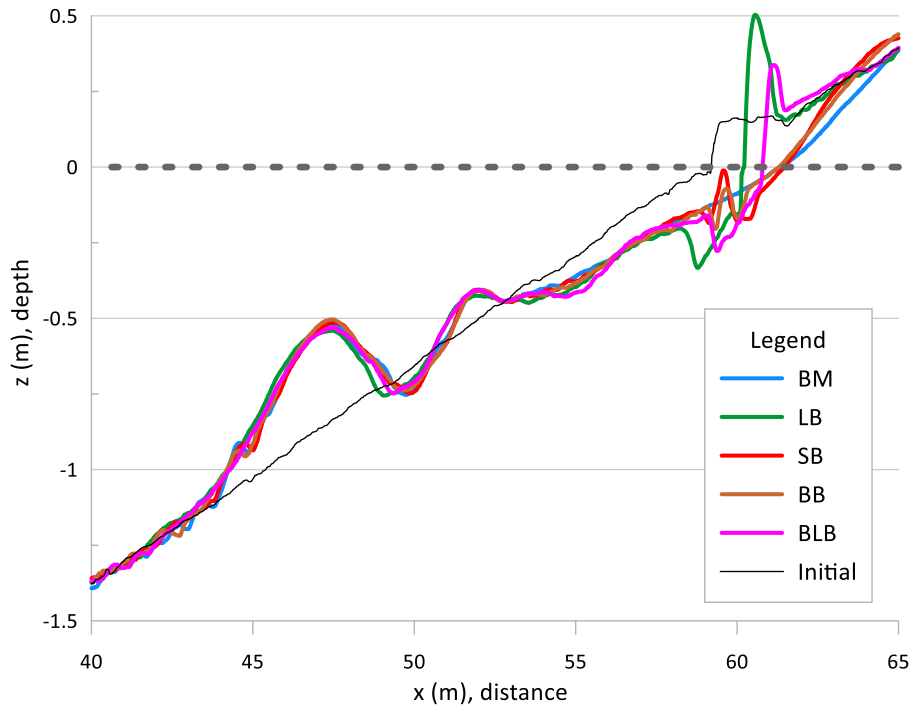
Figure 9 summarizes these three types of beach profile evolution. In this figure, the final profiles (after test 12) of each experiment are shown, together with the initial profile (before the experiments). There, the large erosion produced in the swash zone and the upper shoreface, in the benchmark case, can be observed. This sediment loss has been estimated at 1.29 m^3 per unit width, 8% of which forms the inner bar and 81% the outer bar. This eroded zone extends over a length of approximately 12 m from the swash zone to a depth of 44 cm.

Figure 9. Initial beach profile compared with beach profiles after test 12 in the five experiments.

When long banquettes are placed on the dry beach (cases 2 and 5), two significantly different features are observed with respect to the benchmark. The first is that, behind the banquette, the profile of the beach is maintained without erosion. This indicates that the presence of the banquette limits wave action in the swash zone by increasing coastal roughness, although it does not completely prevent the passage of the waves, as during the experiments it was visually verified that some individual waves overtopped the banquette. However, the action and number of these individual waves were not sufficient to change the profile in this area.

The second remarkable feature of both cases is that in front of the banquette a strong erosion occurs, similar to the scouring generated by a hard coastal protection structure such as a seawall. This is probably due to the fact that, although the banquette is relatively permeable and some waves are partially transmitted through it, part of the wave energy is reflected by the banquette structure, as observed visually in the experiments. Furthermore, when analyzing the wave gauge data, higher wave heights were measured in front of these long banquettes than in the other cases, indicating that this additional wave

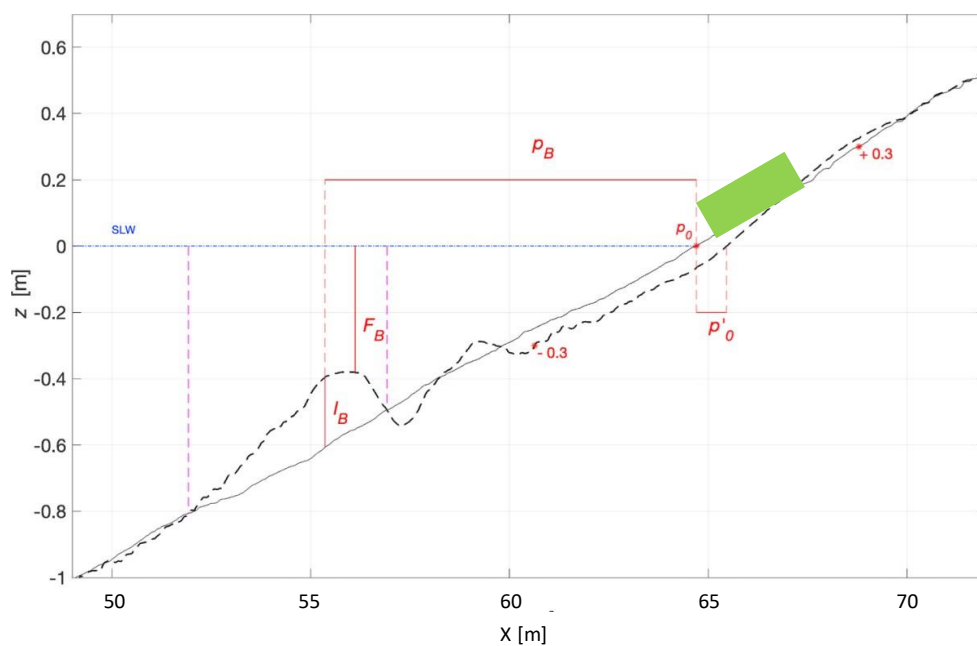
Figure 12. Morphodynamic parameters considered to assess beach profile evolution.

Another way to analyze the response of the beach to different banquette configurations is to study the evolution of some parameters during the tests. The parameters of interest are shown in Figure 12. These parameters are: bar freeboard (F_B), bar height (l_B), bar crest distance to the shoreline (p_B), initial shoreline position (p_0), shoreline retreat/advance of p_0 (p'_0), which is computed at the levels $z = 0$ m and $z = 0.3$ m.
