# IMPROVING TRANSITIONS AT GRASS COVERED DIKE SLOPES USING THE WAVE OVERTOPPING SIMULATOR

Jentsje van der Meer<sup>1</sup>, Bianca Hardeman<sup>2</sup>, Jan Valk<sup>3</sup>, Stanley Versteeg<sup>4</sup>, Martijn Huis in't Veld<sup>5</sup>, Werner Halter<sup>6</sup>, André van Hoven<sup>7</sup> and Roy Mom<sup>8</sup>

*Keywords: wave overtopping simulator, grass cover erosion, clay erosion, dike transitions, dike breach*

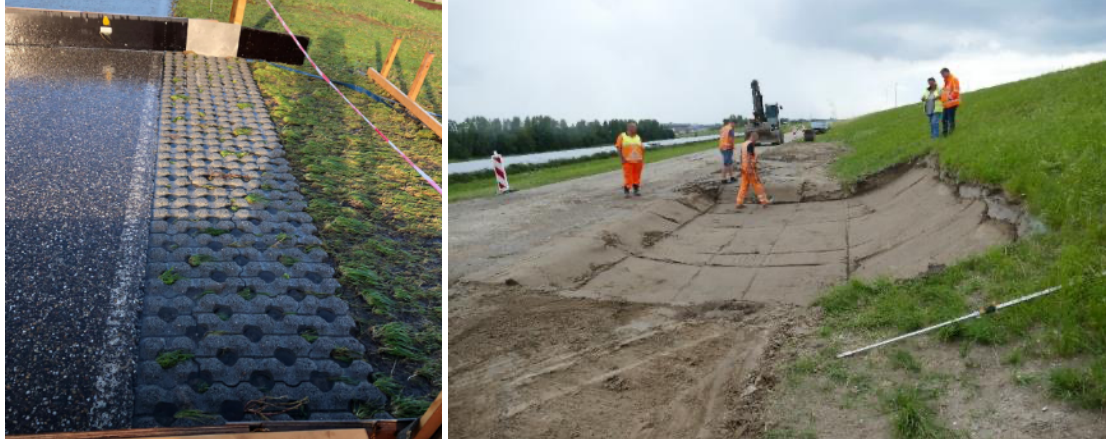
Figure 3. Concrete tiles with roughness in order to cancel the roughness effect at the location of the grass transition (left). Mixed-in-place solution at the geometrical transition (right).

from the asphalt road to about 4 m on the upper slope, see Fig 3 right picture. This solution replaced a possible underlayer of clay. The grass cover of 0.2 m was not replaced and the structure was tested directly. In order to stop any head cut erosion at the asphalt-grass transition, this transition was improved by a block - made of the same material as the improved geometrical transition – of about 0.6 m wide and 0.8 m deep, see Fig. 4 left picture.

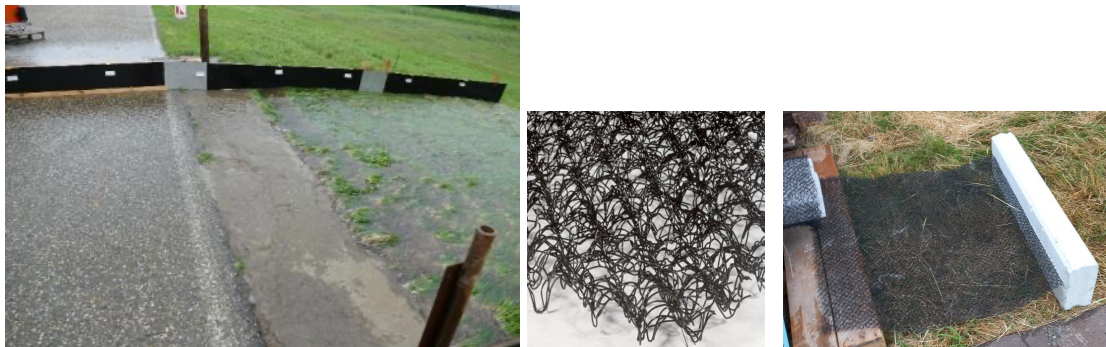
Figure 4. A block of Mixed-in-place of 0.6 m by 0.8 m to prevent failure at this transition (left). A concrete block with geogrid connected to give the grass a stronger connection (middle and right).

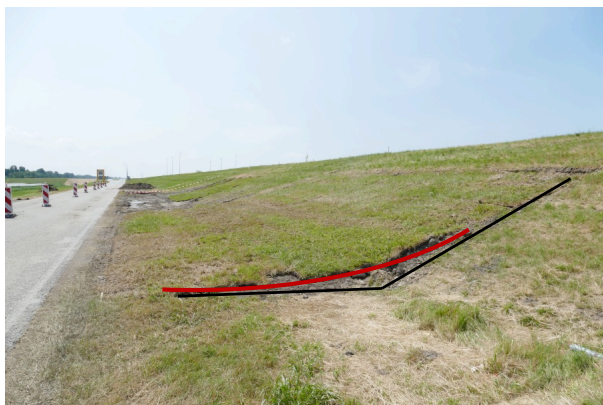
Figure 5. A rounded geometrical transition.

- The geometrical transition was made as a gentle curve and not as a sharp transition from slope to berm, see Fig. 5, in order to spread the change in flow direction over a larger area. The asphalt-grass transition was improved by a concrete border with a poured in geogrid extending in the zone of the grass roots, to strengthen the grass cover and connection at the transition, see Fig. 3 middle and right picture. An overall view of the sections on the dike is shown in Fig. 6.

The rounded geometrical transition (Fig. 5) was covered with transplanted grass, which did not have the full strength of a grass cover. It was eroded quite easily (Fig. 11), but still the test was useful. When the 5 cm thick transplanted grass cover had been removed by overtopping waves, the underlying clay eroded more or less similar over the full width and length of the rounded geometrical transition. From this it might be concluded that the hydraulic loads on the rounded transition were not concentrated any longer, but spread over the full transition. This also appeared from the front velocities over the transition: the front velocities decreased as much as for the sharp geometrical transition (Fig. 9), but it took two times more distance along the berm to reduce.

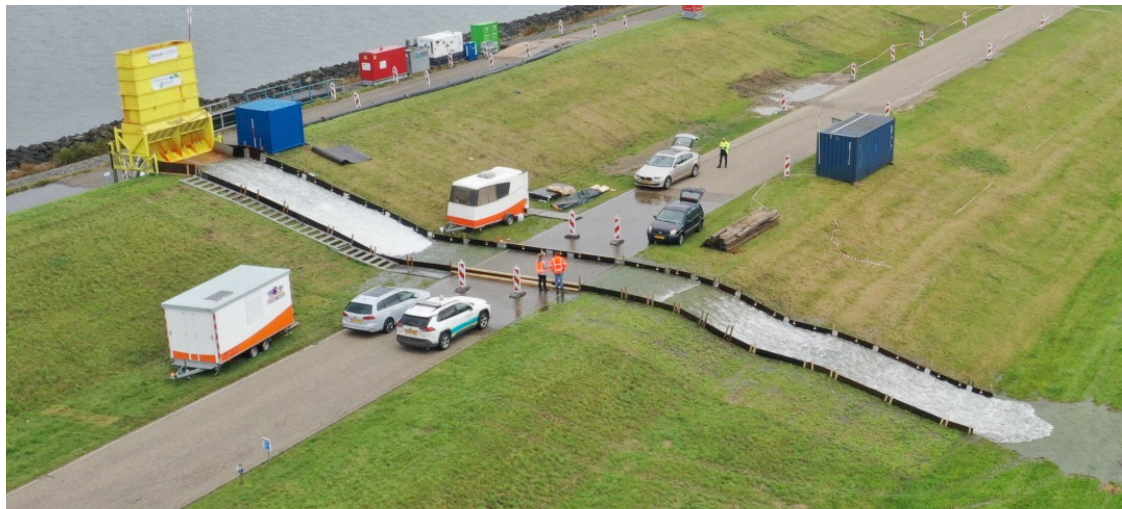
Figure 7. Test set-up at the dike with a wide berm and an asphalt road 3 m below the crest.

The Wave Overtopping Simulator that had been developed for tests in Singapore (Van der Meer et al. 2020) was used to perform the wave overtopping tests at a dike along the IJsselmeer. The simulator was placed just on the seaward side of the crest, see Fig. 8. Fresh water from the IJsselmeer (a large lake) was pumped into the simulator with a preset discharge. Guide walls 4 m apart kept the water flow within a constant width.

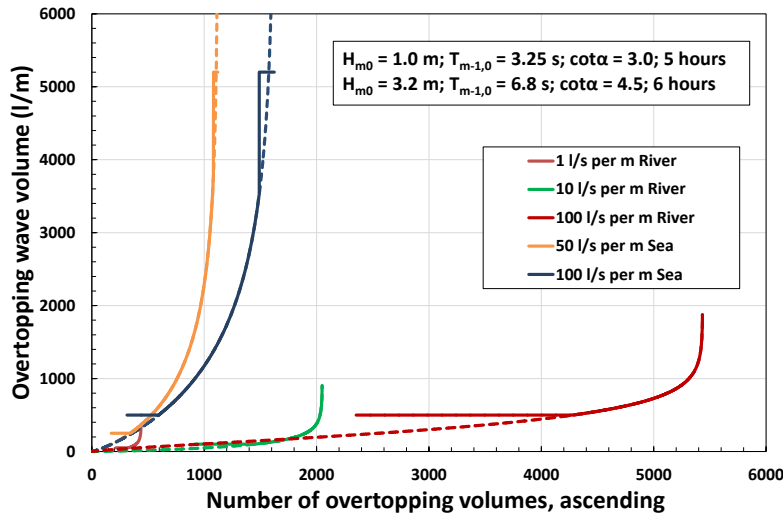
Figure 8. Distribution of overtopping wave volumes in ascending order for tests with a river and a sea regime.

Fig. 8 shows the large difference between the river and sea regime. When the wave height is only 1 m a large number of waves overtop the dike with relatively small overtopping volumes. With the sea regime, however, much less waves overtop, but the overtopping volume per overtopping wave is much larger. The dotted lines in the graph show the theoretical distributions, the solid lines indicate the released volumes. Very small volumes cannot be released as it takes time to open and close the valve and the simulator has a maximum content of 5300 l/m, which limits the maximum volume that can be released.

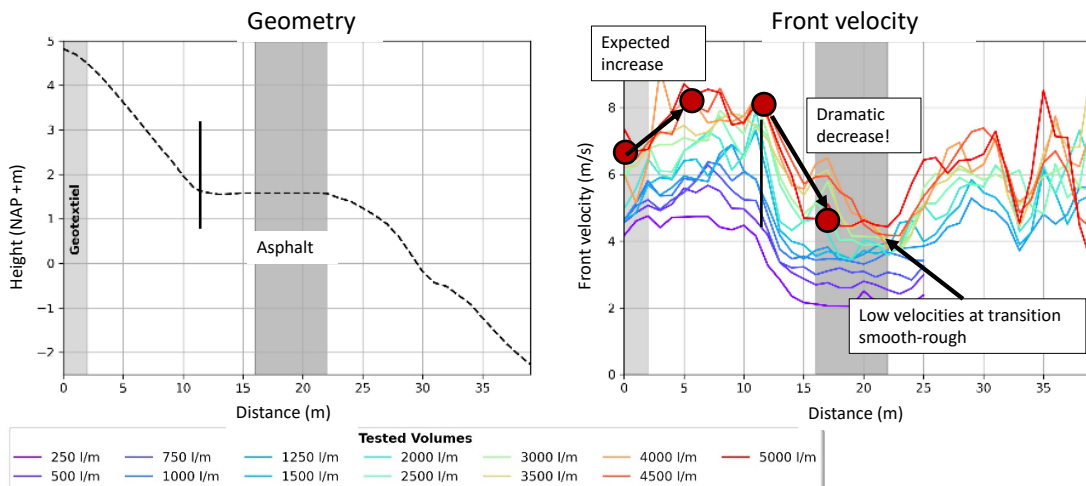
Figure 9. Geometry of the surface of the dike with the asphalt road in grey (left). Measured front velocities over the dike for specific wave volumes (right). The velocity increases over the upper slope, but reduces significantly after the transition to the horizontal berm.

Almost all wave overtopping tests on a dike so far have been performed with a constant and often long slope up to the toe of the dike. The tested dike here has a horizontal berm 3 m below the crest, followed by a second lower slope. This situation resulted in unexpected fast front velocity decreases over the dike geometry! Fig. 9 shows the measurements for distinct overtopping wave volumes from 250 l/m up to 5000 l/m. The left graph gives the geometry of the dike with the berm and asphalt road (indicated in grey). The vertical line gives the transition from slope to horizontal berm and is also given in the right graph of Fig. 9. This right graph shows the development of the front velocities.

From the crest to about 6-10 m from the crest the front velocities increase with approximately 40 % to a kind of maximum, as also expected from earlier tests. But in the 2-5 m after the transition to horizontal (starting from 12 m in the graphs), the front velocity decreases sharply to values that are lower than at the crest! They remain more or less constant over the horizontal part and increase again on the lower slope. There is again a decrease in front velocity at the small berm half way down the slope (around 30-33 m).

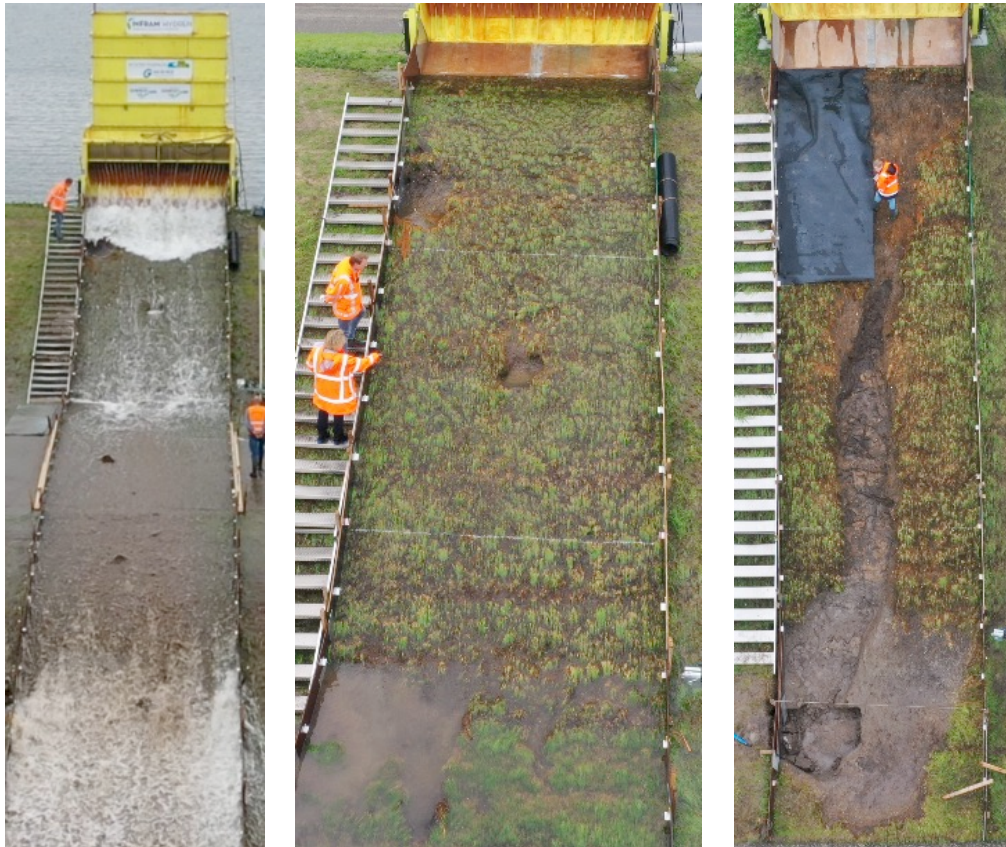
Figure 10. Instant development of initial damage half way the upper slope by one wave. The remains of the grass cover and clay sediment is visible on berm and down slope (left). Situation of failed grass cover (a hole in de middle of the test section with a depth of about 0.3 m) after 4 hours of 50 l/s per m with the sea/lake regime (middle). Failure of the geometrical transition (lower part of the picture) after the full test with the sea/lake regime and gully development in the boulder clay underlayer on the slope (right).

The grass cover on the upper slope of the actual dike section showed sudden initial damage caused by one wave in the 100 l/s per m river regime. The left picture of Fig. 10 shows the situation after this wave and before the next wave reached the hole. The damage occurred in the middle of the slope. The picture was taken from a drone video and shows the hole as well as the remains of the grass cover on the berm and downslope and some clay sediment. This was all removed by the next wave.

The hole gradually widened and deepened and after 4 hours of the next test with 50 l/s per m of the sea/lake regime the depth was almost 0.3 m. This is presented in the middle picture of Fig. 10 and is regarded as the moment of failure of the cover layer. There is also damage on the picture even more

upwards on the slope and next to the guide wall. This was caused by a specific accident and was not seen as regular damage to the slope. The hole was covered by a geotextile in order not to disturb further testing, see the right picture in Fig. 10.

The middle picture of Fig. 10 shows that damage occurred over a wider area at the geometrical transition from slope to berm (the down part of the picture). Damage/failure of the grass cover at this transition occurred earlier than at the slope. From this a load factor of  $\alpha_M = 1.2$  could be established.

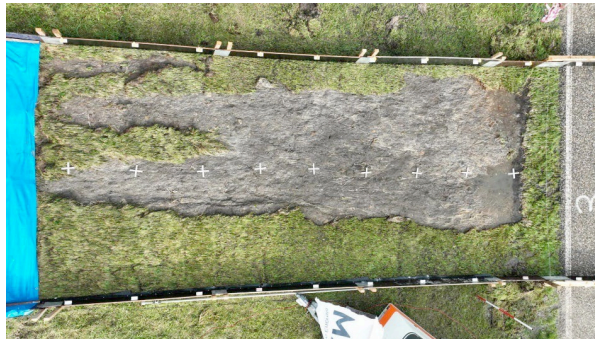
**Figure 11. Almost complete erosion of the transplanted grass sod (5 cm thick), but then similar erosion of the underlying clay of the rounded geometrical transition, showing similar loads over the transition.**

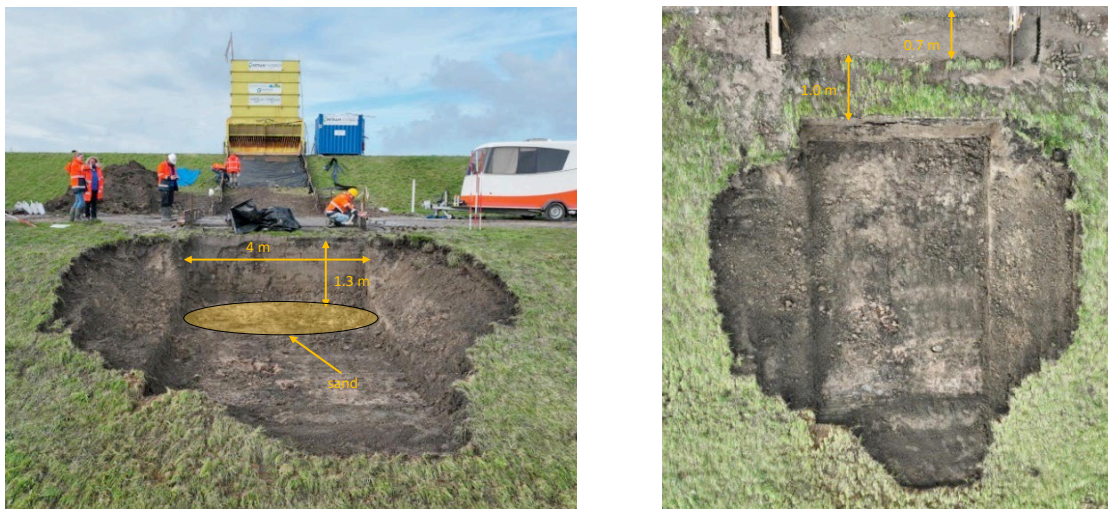
**Figure 12.** Creation of a cliff behind the asphalt road onto the sand core (left). Top view of the cliff erosion hole with the remains of 1 m grass cover with boulder clay underlayer and the 0.7 m wide Mixed-in-place block against the asphalt road (right).

A hole of 4 m wide and 1.3 m deep was made behind the asphalt road, see Figure 12. At a depth of 1.3 m the sand core was found that was also present underneath the road. From this depth a slope of 1:8 was made towards the downslope, through the boulder clay layer. Side slopes of about 45 degrees were made in order to avoid these side slopes falling into the hole. In this way a vertical cliff was created onto the sand core.

The test section with the Mixed-in-place block behind the asphalt road was used for this test. This block with a width of 0.7 m was left in place (see right picture of Fig. 12) as well as 1 m of grass cover with boulder clay underlayer. So, the test did not start directly at the asphalt road, but with real cliff

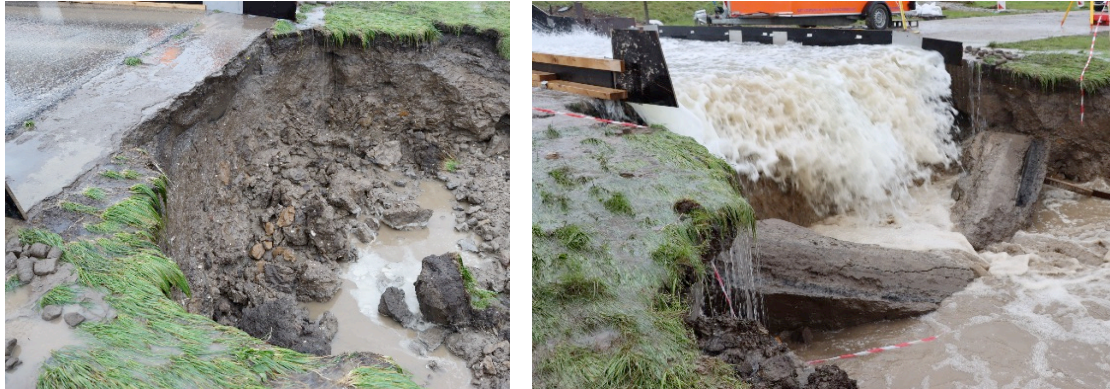
**Figure 13.** Cliff erosion test. The 1 m wide (boulder clay with grass cover) fails after 45 minutes (left). The 0.7 m wide Mixed-in-place block fails 30 minutes later (right).

Sand eroded from underneath the boulder clay and after 45 minutes with the 100 l/s per m river regime, the 1 m wide layer was fully eroded and fell into the hole (left picture of Fig. 13). Another 30 minutes later the Mixed-in-place block was undermined, broke and fell into the hole (right picture of Fig.13). Both cases give “cliff erosion speeds” of about 1.3-1.4 m/hour.

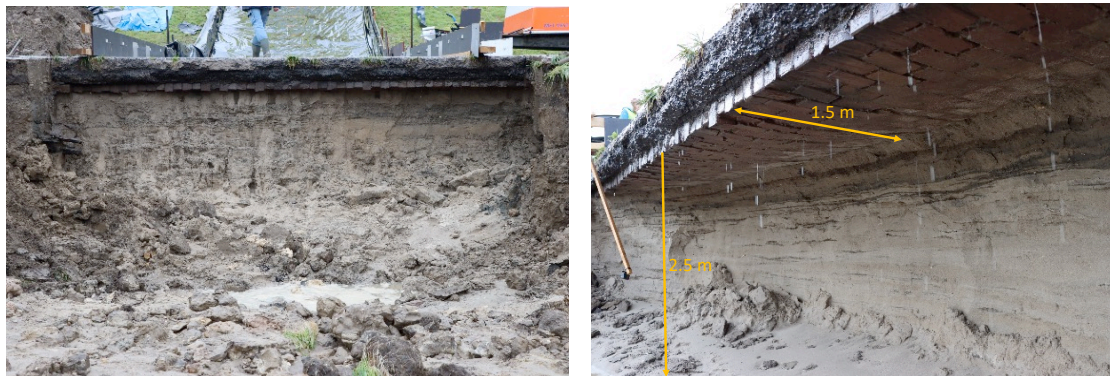
**Figure 14.** Start of cliff erosion at the asphalt road (left). Undermining 1.5 m after 5 hours of testing (right) and the erosion was almost terminated.

After removal of the Mixed-in-place block from the erosion hole, the cliff erosion test for the asphalt road could start (left picture in Fig. 14). Erosion of the core underneath the asphalt road started and revealed that the asphalt had been placed on top of the old brick road that was constructed in the seventies during construction of the dike (right picture of Fig. 14).

This picture also shows the vertical cliff of sand underneath the road and an undermining of 1.5 m that was reached after full testing with the river regime. At the foot of the cliff a sand slope was formed that went into the hole where the overtopping waves were falling. Overtopping wave volumes came with large velocities into the hole, plunging on the water that remained in this hole. Only small waves generated by the plunging volumes reflecting backwards reached the sand slope and sometimes also the vertical cliff underneath the asphalt road. In this way the cliff erosion decreased and in the second stage of the test with 100 l/s per m with the sea/lake regime, the total erosion increased by only 0.2 m to a final undermining of 1.7 m. After this the cliff erosion was terminated.

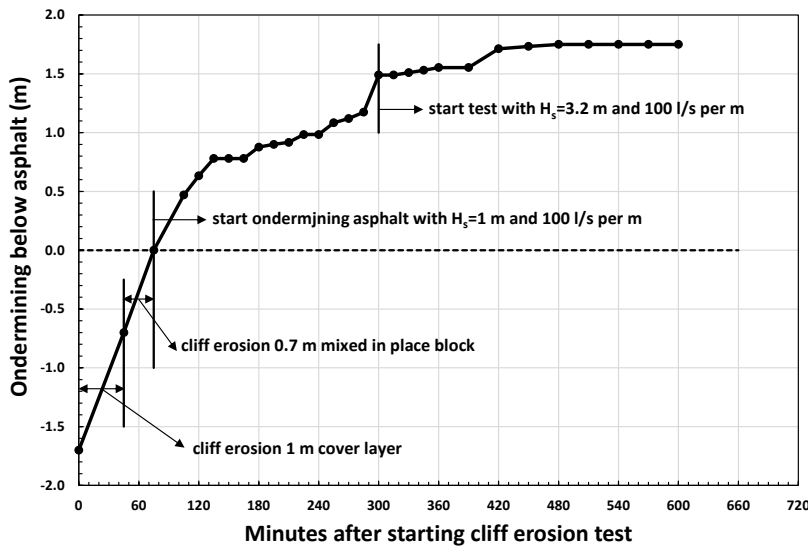
Figure 15. Development of cliff erosion (undermining) at the asphalt road in time.

Figure 15 shows the cliff erosion of the boulder clay cover layer and Mixed-in-place block in time, together with the undermining of the asphalt road. The actual cliff erosion went faster than the process of undermining the road. It is also clear that the undermining already terminated after half of the second stage of the test.

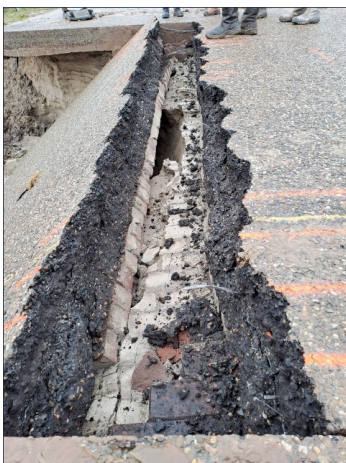
The test showed 1.7 m undermining.  
The asphalt failed at 2.9 m undermining by removing sand with a jet pipe.  
It was a classical mechanical failure.

Figure 16. Classical mechanical failure after forced undermining up to 2.9 m.

To find out, undermining was forced manually by a jet pipe. Sand was slowly eroded over the full width till the road collapsed, see Fig. 16. The asphalt slab broke over the full width by overturning due to its own weight when the undermining reached a depth of 2.9 m, almost half of the width of the road.

It is a classical mechanical failure and can calculation wise be reconstructed, using the properties of the asphalt material. It means that the failure of other roads that are less wide (cycle path) or less thick, or with another type of asphalt, can also be calculated. Of course, if the undermining becomes more than half of the width of the road, it will not mechanically fail, but can just overturn as a whole into the cliff erosion hole.
