NUMERICAL SIMULATION OF VOLCANOGENIC TSUNAMI WAVE INUNDATION IN TONGA

Keywords: volcanic-induced tsunami; numerical modelling; coastal structures; DualSPHysics

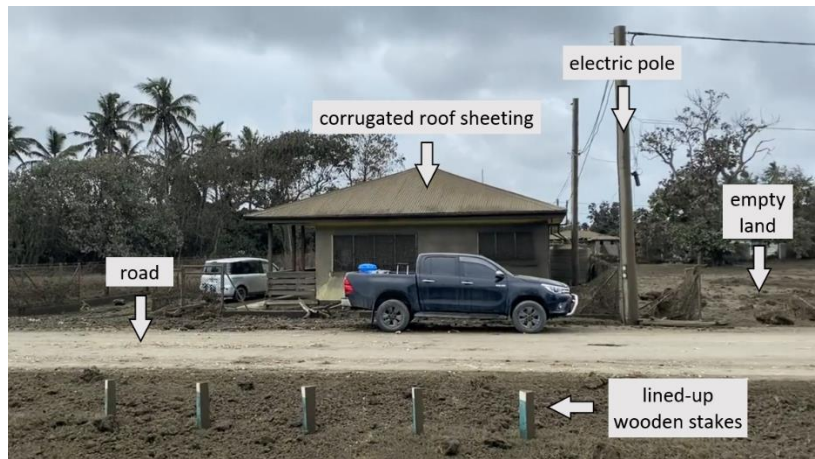
Figure 5. Post-tsunami condition of a house where tsunami video footage was recorded (image used with permission, Newsflare (2022))

Among the many photos and videos of the 2022 Tonga tsunami event available online, a careful examination was conducted of their content, focusing on specific details in the surrounding area and in the distance, as outlined in Step [4a]. In Step [6], the information obtained from Steps [2a], [2b], and [4a] was compared until a video was found on the social media platform X (formerly Twitter) that contained details matching the information from those steps. Thus, in Step [7], it was concluded that the targeted coastal area shown in the video from Step [2] had been identified. The conditions around the coastal area are depicted in Figures 4, 5, and 6.

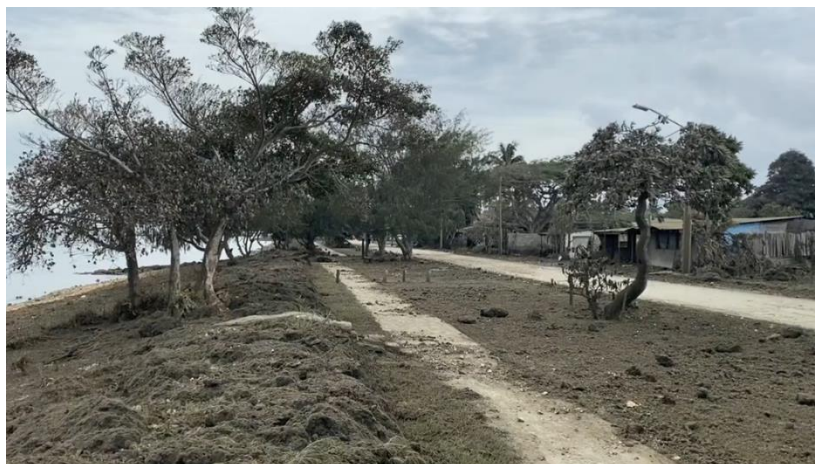
Figure 6. Post-tsunami condition at the identified location in Nuku'alofa coastal area (image used with permission, Newsflare (2022))

In this study, numerical modelling of tsunami waves was carried out using the open-source smoothed particle hydrodynamics (SPH) software DualSPHysics version 5.2.2. The numerical modelling began with the design of a boundary model that replicates the conditions along the shoreline at Nuku'alofa, as seen in the video footage and shown in Figure 7. Details of the coastal area, including the shape and dimensions of the rubble mound coastal defence and roads, were obtained from the Coastal Resilience Project-Tonga report (GoT, 2017), and are redrawn in Figure 8. To be precise, the length of the road was determined using the scale available in Google Satellite View, as depicted in Figure 6.

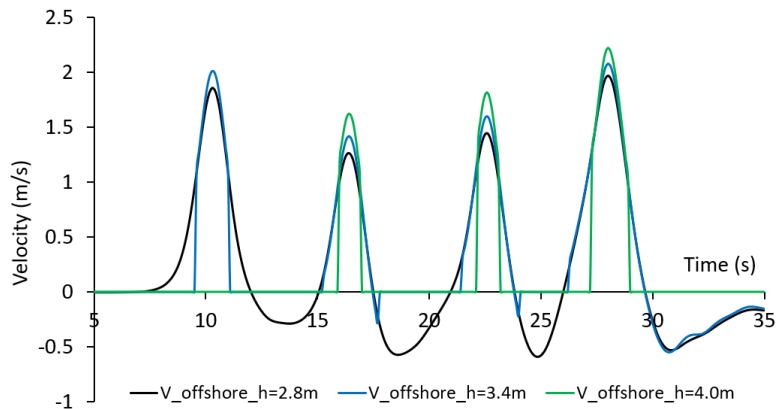
Figure 12. Offshore wave velocities

Figure 12 shows the offshore wave velocity measured at a location 5 meters seaward of the toe of the rubble mound, the same position as the WSE measurements. At this x -axis position, the plotted velocities were measured at three different heights: at the still water level, at half of the solitary wave

height, and at the top of the solitary wave height. Overall, each solitary wave has a different velocity history due to the dynamic movement of water particles around the sloping rubble mound. This dynamic is indicated by the negative velocity values as water particles move backward (in the negative x -direction).

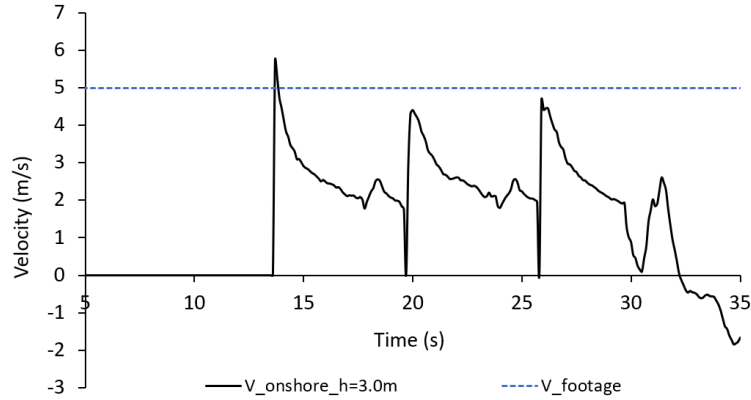
Figure 13. Onshore bore velocity

Following wave overtopping, the solitary waves transitioned into a bore. Figure 13 illustrates the onshore bore velocity measured 20 meters landward of the toe of the rubble mound. The sharp increase in bore velocity is contributed by the rapid movement of the bore tip, followed by a larger amount of water particles. The negative velocity values indicate that some water particles bounced back after impacting the wall at the right end of the boundary model. Numerical predictions of onshore tsunami bore velocities were comparable to the tsunami bore velocities observed in the video footage.

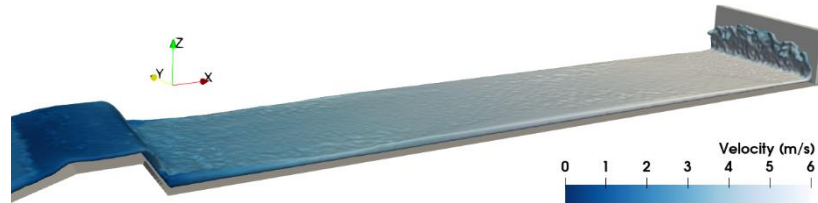
Figure 15. Bore first impact on the wall, at $t = 15.8$ sec.

The first bore impact was entirely caused by the leading tip of the bore (Figure 15), while the subsequent impacts were influenced by the oncoming leading bore interacting with the impounded water on the landward deck, as shown in Figure 16. This explains the irregularly increasing impact force depicted in Figure 14. The modelling also provided a bore pressure distribution as the bore hit the vertical wall, as illustrated in Figure 17, which is related to Figure 15. Figure 17 shows a random pattern of higher pressure, with the majority of the highest pressure occurring at the bottom part of the wall. Figure 17 was obtained by setting the wall to be transparent, with the view facing offshore.

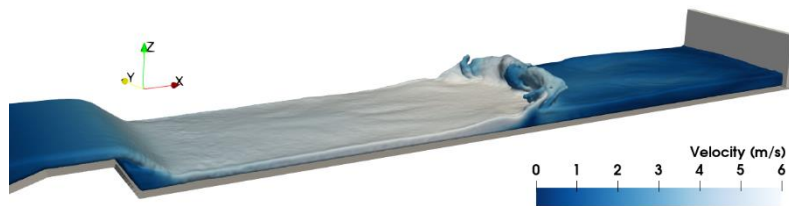
Figure 16. Interaction of second bore leading tip with impounded water, at $t = 21$ sec.

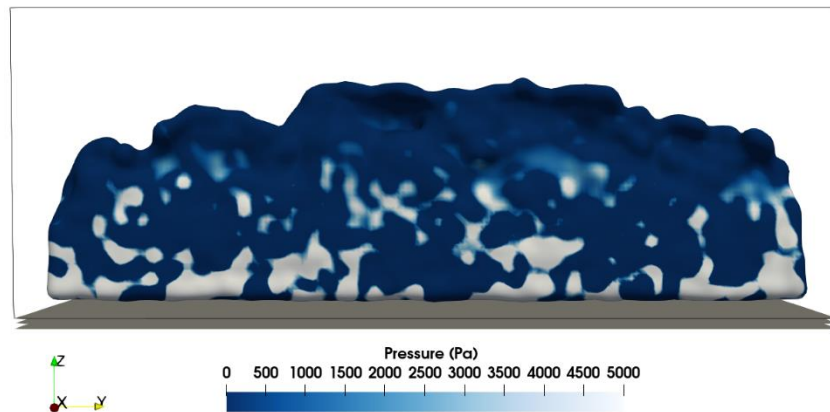
Figure 17. Tsunami bore pressure distribution on the wall's vertical surface, at $t = 15.8$ sec
