PROPOSAL OF IMAGE PROCESSING FOR RIP CURRENT VERIFICATION

Ryo Shimada¹ Toshinori Ishikawa¹ and Tsutomu Komine²

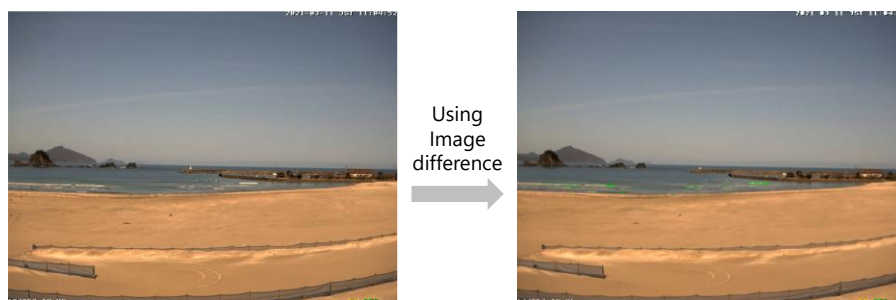
Figure 1. Example of average images.

There are from 2,000 to 3,000 rescues every summer at bathing beaches in Japan. 54 % of drowning accidents were caused by rip currents (Ishikawa, T. et al., 2014), therefore rip currents are the main cause of drowning accidents in Japan. As measures against drowning accidents, life savers inform beach users and put up flags and signboards. During the peak season, a single lifeguard is responsible for overseeing more than 1,000 beachgoers. Therefore, beachgoers themselves must pay attention to the rip current. However, there are problems such as the beachgoers cannot perceive the place of rip current occurrence and do not understand the risk of the rip current. According to the results of the questionnaire survey to one hundred beachgoers in Japan, there is a strong relationship between beachgoers perceiving the rip current area and swimming away from the rip current area (Endo, S. et al., 2022). Under these circumstances, the approach that focuses on visualization is progressing. For example, an AI system was created that detects rip currents and alerts beachgoers through the application (Ishikawa, T. et al., 2021). The application allows information to be provided to many people. Additionally, it always enables continuous monitoring. However, the system requires an initial investment, along with ongoing costs for installation, AI development, and maintenance during the season. Therefore, to analyze the rip current surveys, a method for visualizing rip currents with average images can be used. It is a method for visualizing currents by averaging consecutive images of the coast into a single image (Lippmann and Holman, 1989). The breaker zone is shown in the lighter-shaded area, and the current area is shown as the darker-shaded area. This method costs slightly as long as you have the image data, but it cannot be applied instantaneously in real-time. So, in this study, we suggest a new approach to visualize rip currents in real time using image differences to verify whether beachgoers can recognize rip currents easily using image processing in real-time (Figure 1).

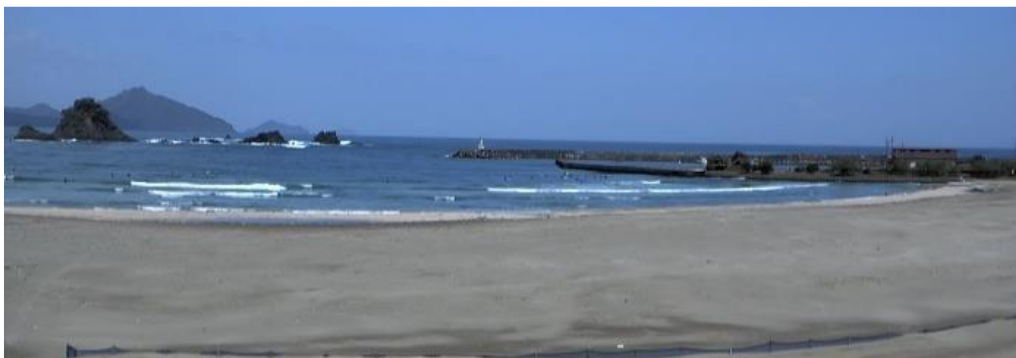
Figure 4. Example of image shooting from this camera.

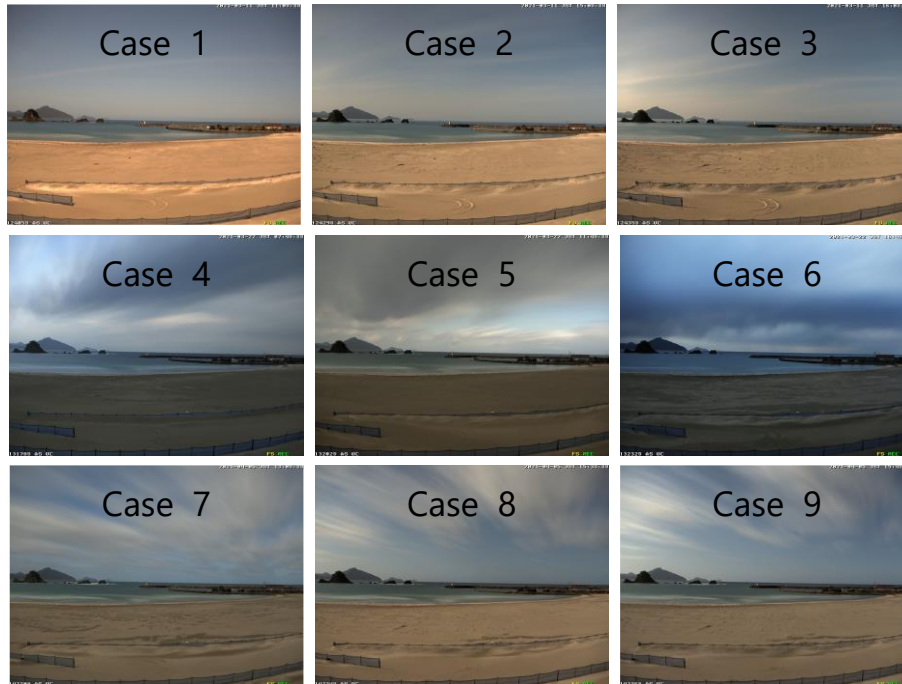
Figure 7. Result of the image averaging.

First, three experienced lifesavers reviewed 26 hours of footage of the beach to acquire images of the beach during the rip current. As a result, three videos were selected for each of the three days of 11 March 2021, 22 March 2021, and 5 April 2021, each lasting five minutes. Each video was designated as Case 1 to Case 9 (Figure 7). To verify the actual occurrence of rip currents, image averaging was applied to Cases 1 to 9, and the results are shown in Figure 7. The rip current was able to be seen in all cases. For example, the results of Case 1 (11th March 2021, 11:05-11:10) are shown in Figure 8. Image averaging is a method of visualizing the flow by averaging a series of images of the shore into a single image. The following steps are used to create an average image. First, prepare consecutive images to be averaged. Note that the images must be consecutive to perform averaging. Second, obtain the pixel value of each pixel in the first image. Each pixel stores three values called pixel values as shown in Figure 9. Pixel values represent red, green, and blue, respectively, which have a maximum of 255 and a minimum of 0. If the number of vertical pixels in the image is h , the number of horizontal pixels is w , the red pixel value is r , the green pixel value is g , and the blue pixel value is b , then an image is given by:

$$I_{ave} = \frac{\sum_{k=1}^n I_k}{n} \quad (2)$$

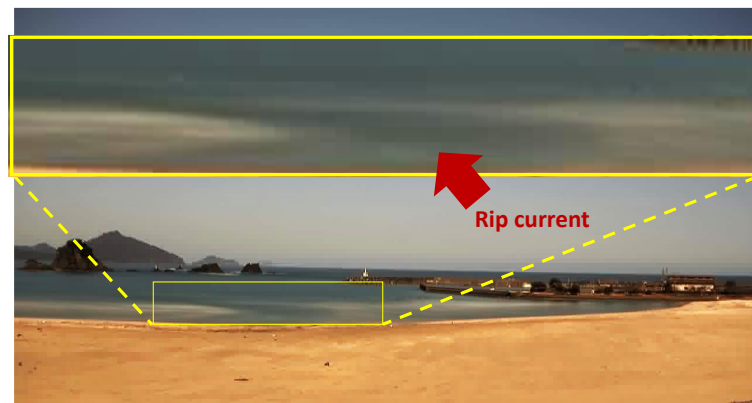
Figure 8. Example of average images (Case 1, 11th March 2021, 11:05-11:10).

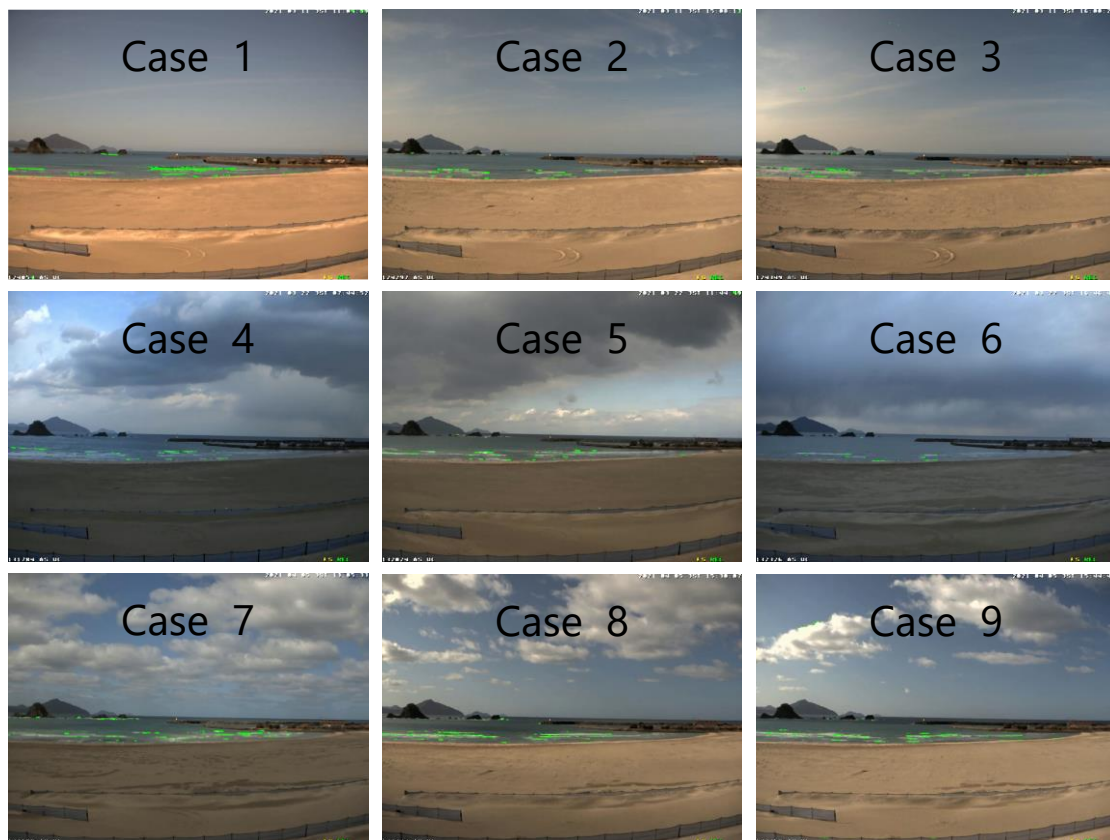
Figure 10. Result of the image processing using different consecutive images.

For Cases 1 to 9, the proposed analysis method using the difference between consecutive images was applied (Figure 10). It was considered that the use of image differencing would make the movement of waves clearer and make it easier to recognize areas of unbroken waves, which is a feature of rip currents. In detail, the analysis was conducted in the following steps. It was conducted using the programming language Python's image analysis module, pillow, and OpenCV.

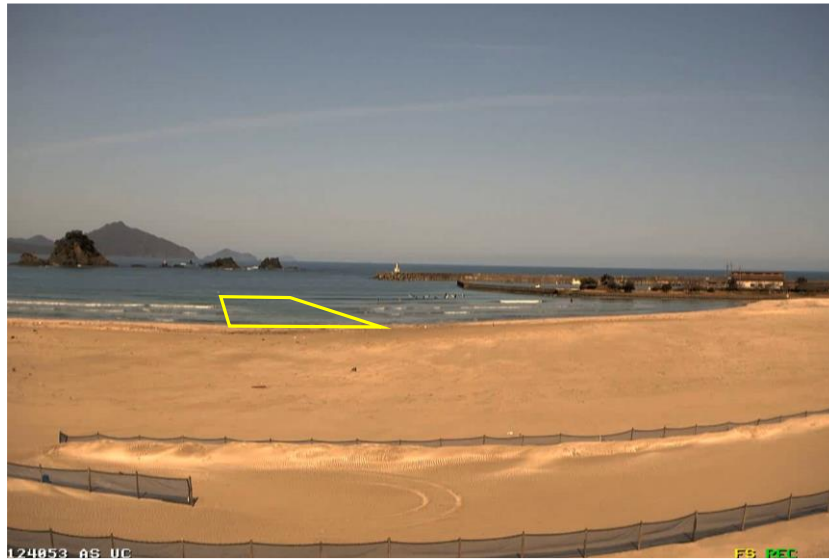
Figure 14. Example of specified areas where the rip currents occurred by experienced lifesavers.

Image analysis was performed on the videos from Case 1 to 9, and three experienced lifesavers specified the areas where the rip currents were occurring in polygons, as shown in Figure 14. The areas covered by the area were considered the correct areas where the rip currents were flowing. Next, a total of 18 videos of Case 1 to 9 were prepared, including the original video without image analysis and the video with image analysis, and were viewed randomly by 20 subjects. After viewing the videos, the subjects designated areas where they thought the rip currents had occurred using polygons (Figure 15) and compared them with the areas designated by experienced lifesavers using IoU (Intersection over Union). This allows the user to determine which of the two is more likely to identify the areas where rip currents occur, depending on whether image processing was used or not. The IoU measures the degree

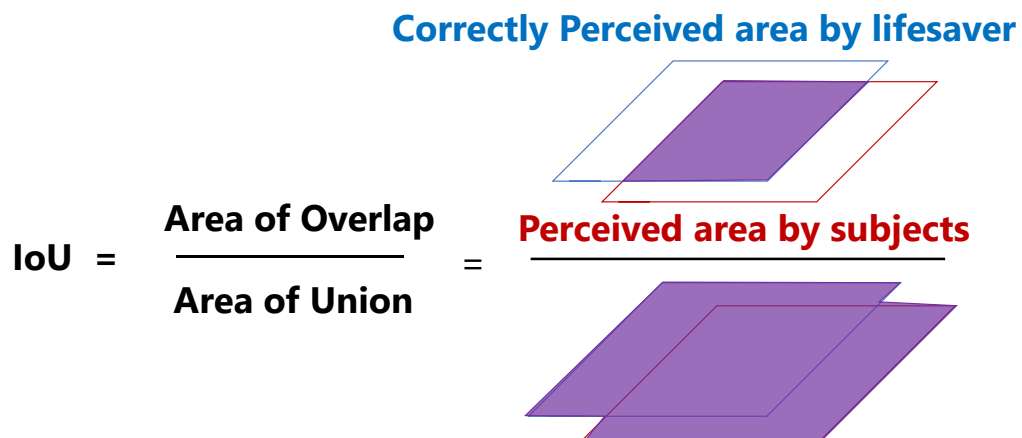
Figure 16. Conceptual diagram of IoU (Intersection over Union).

of overlap between the predicted and correct areas and was calculated as shown in Figure 16. Values are expressed in the range 0 to 1, with the closer to 1, the more accurate the verification.

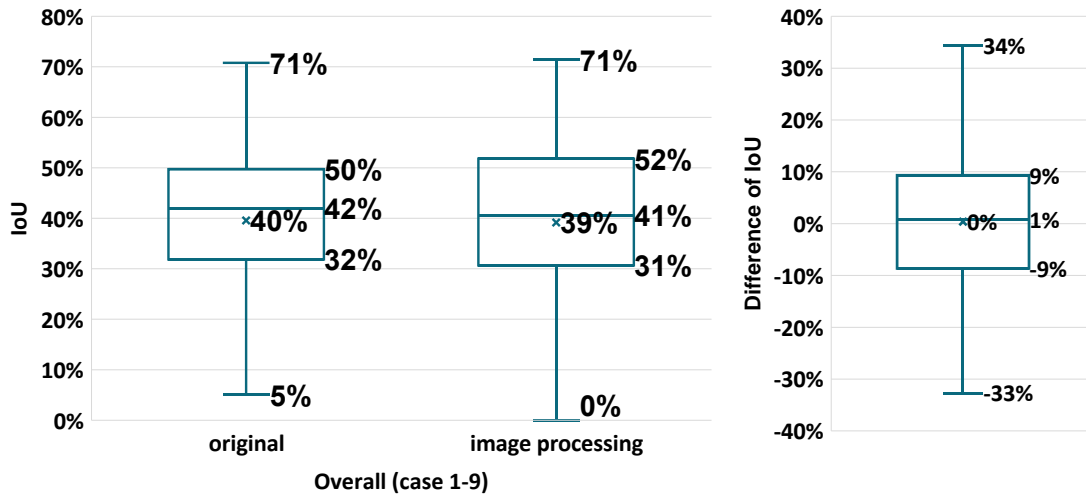
Figure 17. The box plot of experimental results in overall cases.

Figure 17 shows box plots of the IoU with and without image analysis and the difference in IoU with and without image analysis for all videos in Cases 1 to 9. Contrary to expectations, there was no difference in the public's perception of rip currents with and without image analysis for Cases 1 to 9

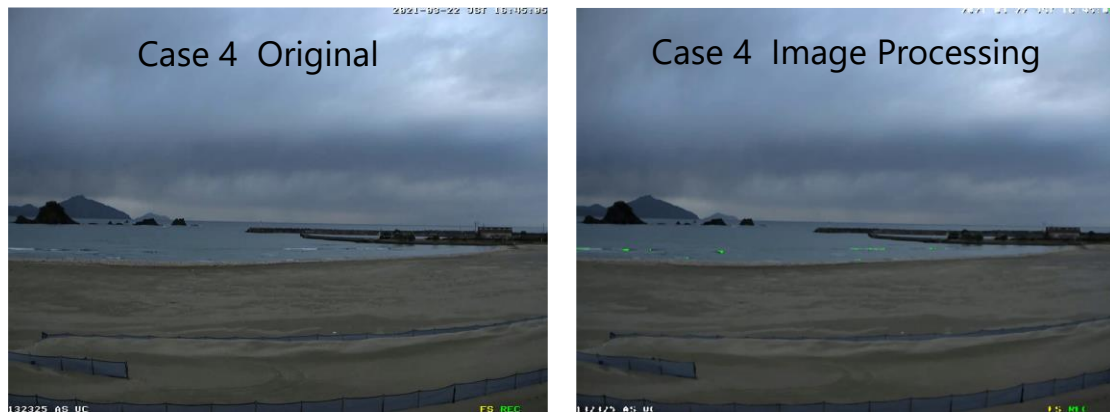
Figure 19. The result of the image processing in Case 4.

overall. On the other hand, Figure 18 shows box plots of the difference in IoU with and without image analysis for each case. In cases 1, 2, 3, and 9, there was an improvement in the IoU up to 62% in verification of rip currents with and without image processing, and the weather in each case was sunny. Conversely, there was hardly any improvement in the verification of rip currents with and without image analysis on rainy and cloudy days. Figure 19 shows an example of a rainy day in Case 4. It was considered that on such bad weather days, the differences between consecutive images became smaller and it was difficult to recognize the location of the occurrence of rip currents. On the other hand, Figure 20 is an example of a sunny day in Case 1. The difference between consecutive images was large and the area where the waves break was able to be identified, so it was considered that it was easier to recognize the location of the occurrence of rip currents.
