WAVE, WAVE RUN-UP AND OVERTOPPING MEASUREMENTS IN THE FIELD USING LASER SCANNERS

Patrick Oosterlo, Rijkswaterstaat, patrick.oosterlo@rws.nl
Maarten Overduin, Infram Hydren, maarten.overduin@infram-hydr.nl
Chris Wauben, Infram Hydren, chris.wauben@infram-hydr.nl
Jentsje W. van der Meer, Van der Meer Consulting, jm@vandermeerconsulting.nl
Gosse Jan Steendam, Infram Hydren, gosse.jan.steendam@infram-hydr.nl

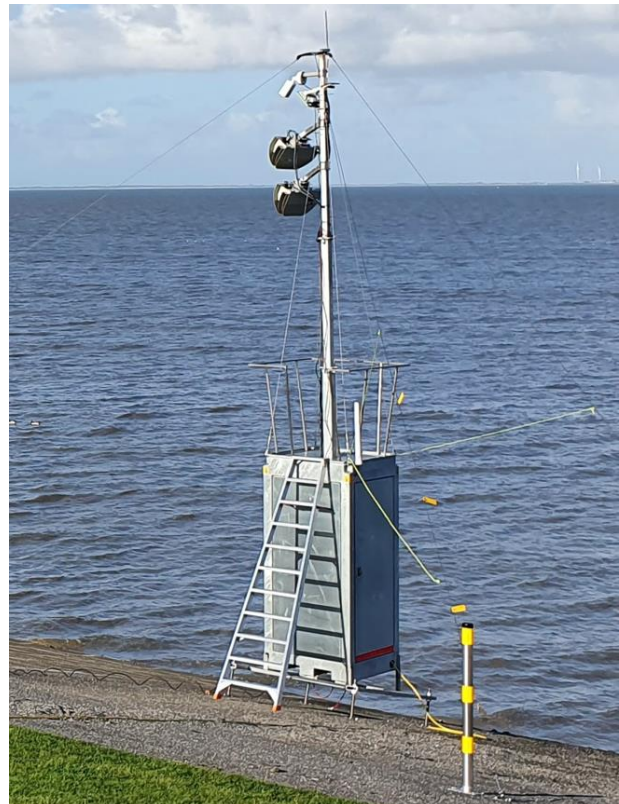
Figure 2 - Laser scanner system on the dike in the Eems-Dollard estuary. From the bottom to the top: laser scanner 1, laser scanner 2, infrared lamp, video camera.

Oosterlo et al. (2021a) developed an alternative flexible solution, using two laser scanners, see Figure 2. Oosterlo et al. (2021b) validated the system for wave run-up heights, depths, front velocities and wave overtopping during a severe winter storm with very oblique wave attack.

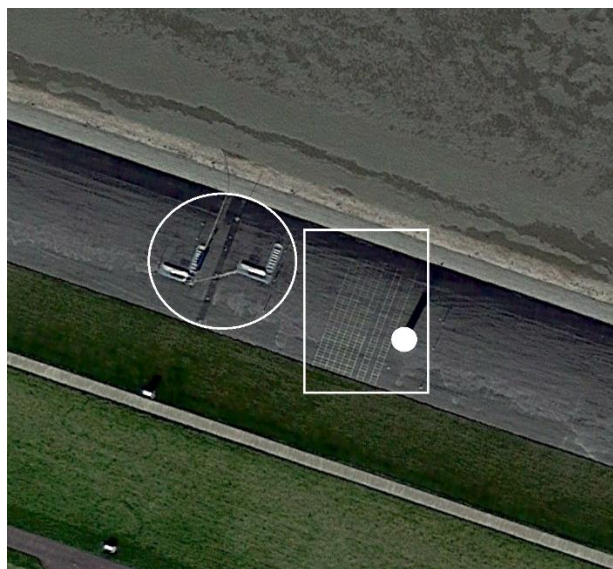
Figure 3 - Laser scanner system (dot) and laser scanner measurement grid (rectangle) next to the overtopping tanks (circle) on the dike in the Eems-Dollard estuary.

The laser scanner system is located on the dike in the Eems-Dollard estuary, next to two wave overtopping tanks, see Figure 3. The estuary contains deep tidal channels and shallow flats and is part of the Wadden Sea, a shallow shelf sea (see Figure 1). An extensive field measurement campaign is performed in the estuary for a period of at least 12 years, see Van der Meer et al. (2019). In addition to the run-up and overtopping measurements, incident wave conditions are measured using a step gauge, radar, wave buoy and ADCP. The dike design conditions in this area consist of very obliquely incident wind waves, up to 80° relative to the dike normal. However, lower frequency energy at angles more perpendicular to the dike is present too, originating from the North Sea. The aim of the measurements is twofold. First, to understand the processes yielding nearshore wave conditions better, which should lead to improved numerical prediction models. Second, to understand the processes related to oblique wave run-up and overtopping better, which should
