# PRELIMINARY REFLECTIONS OF 1<sup>ST</sup> BIODIVERSITY RESTORATION PROJECT IN POLAND

Grzegorz Różyński, Inst. Hydro-Eng., Polish Acad. Sci. [grzegorz@ibwpan.gda.pl](mailto:grzegorz@ibwpan.gda.pl)

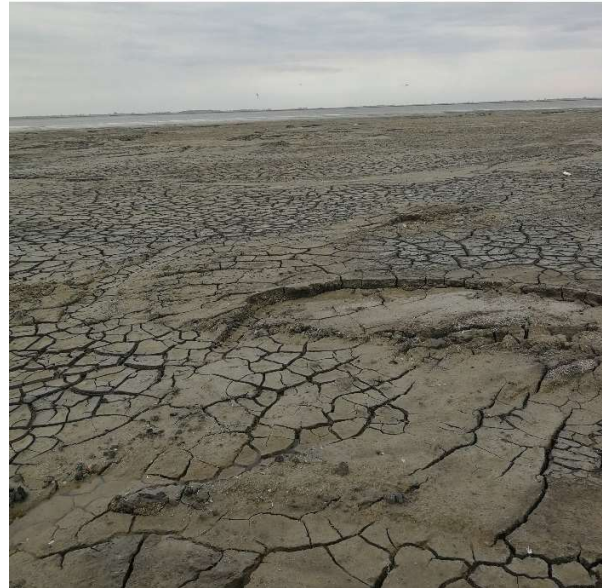
Figure 2 - Drying silt on the island in Jul. 2023, photo. G. Różyński

Fig. 2 shows the recently deposited silt with low organic matter content below 5%, which is much less than initial estimates predicted. Thus, its consolidation time (reduction of moisture content over time) will be rather short and spontaneous appearance of grass can occur sooner than expected. This is positive from the point of view of the major restoration goals and points to potential success of the scheme in future. However, the current conditions favor birds which were not targeted for restoration. Some of them are quite rare in the area though, and hence, unexpectedly, they have become a restoration target as well.

Some targeted birds (ducks and geese) have already appeared on the island - it can be expected they will start hatching when grass, planted either spontaneously or artificially, begins to take root. This process can start earlier than expected due to faster than initially estimated reduction of moisture content in the deposited silt.
