# STORM IMPACT ON BEACH NOURISHMENT MORPHOLOGY IN A SHALLOW BAY

Anna Adell, Lund University & University of Copenhagen, [anna.adell@tvrl.lth.se](mailto:anna.adell@tvrl.lth.se)  
Gregor Luetzenburg, Geological Survey of Denmark, and Greenland, [grelu@geus.dk](mailto:grelu@geus.dk)  
Aart Kroon, University of Copenhagen, [ak@ign.ku.dk](mailto:ak@ign.ku.dk)  
Björn Almström, Lund University, [bjorn.almstrom@tvrl.lth.se](mailto:bjorn.almstrom@tvrl.lth.se),  
Caroline Hallin, Lund University, [caroline.hallin@tvrl.lth.se](mailto:caroline.hallin@tvrl.lth.se)

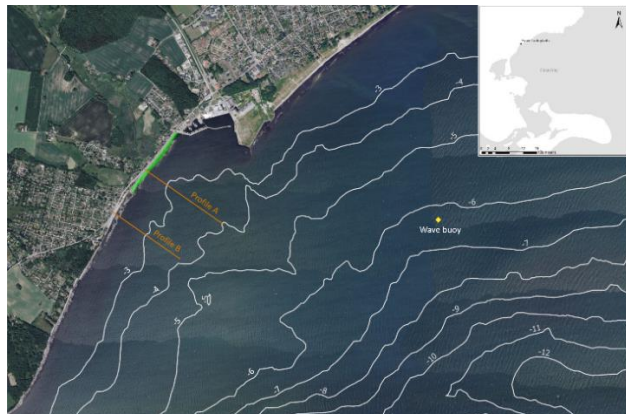
Figure 1: Map showing the field site and profile locations, the green area represents the placement of the nourishment.

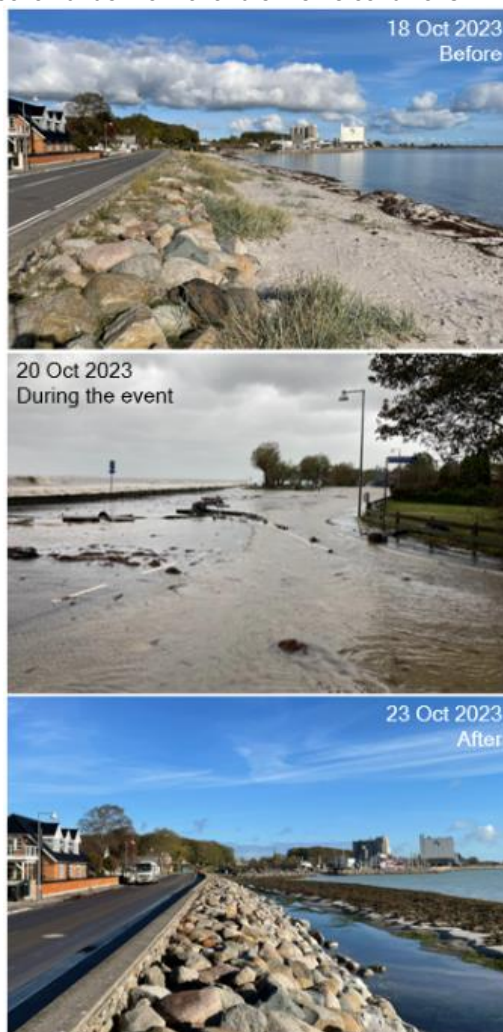
Figure 2: Pre- and post-storm conditions showing the impact along the nourished stretch of coast. Photo: Anna Adell and Klaus Roenholt.

A combination of RTK-GPS and single beam surveys were conducted to obtain comprehensive topographic and bathymetric assessment. The RTK-GPS technique covers the beach and shallow water depths until -1 m. Single beam profiles extended offshore approximately to -4 m depth and were collected with an echo sounder system from a zodiac boat. The map in Figure 1 shows the placement of the survey profiles A and B and the in-situ measurement equipment along with the depth contour lines. The most recent nourishment was performed 6 months prior to the first survey date and approximately 35 m<sup>3</sup>/m was supplied in profile A. Figure 2 shows the coastal protection under normal and extreme conditions.

On October 20<sup>th</sup>, 2023, the area suffered the most extreme storm conditions in over 100 years, with a combination of extreme water levels (+169 cm) and strong easterly winds. Figure 2 shows the storm impact along a section of the coast, where the beach plane was eroded and deposited in a storm bar, giving elevation changes of about 1.5 m. In addition, part of the sea wall collapsed. This signal in the dataset is several orders of magnitude greater than the changes observed during moderate storm conditions discussed previously. Future work will focus on analyzing the coastal protection under extreme conditions.

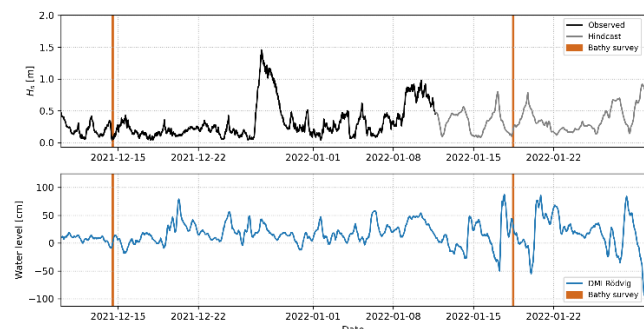
Figure 3: Hydrodynamic conditions during one survey period, Dec 2021 - Jan 2022.

Figure 3 shows the hydrodynamic conditions during one selected survey period. Table 1 presents the conditions at the storm peak during the maximum observed conditions between two survey dates, recorded at the wave buoy at 7 m.
