Design and Management of Natural and Nature Based Features Case Studies in Southwest Florida, USA

Mohamed A. Dabees
Humiston & Moore Engineers, 5679 Strand Ct., Naples, FL, 34110
md@humistonandmoore.com

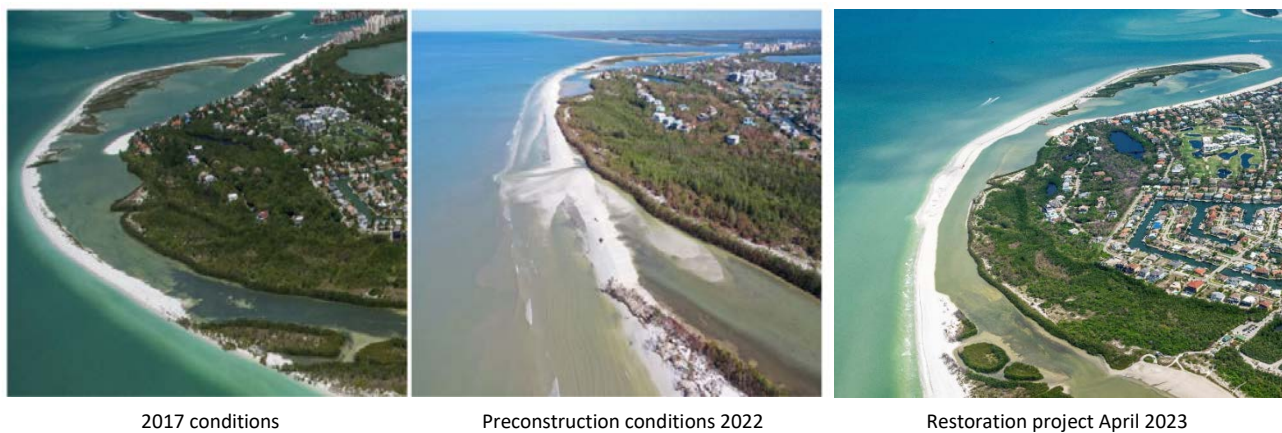
Figure 1. NNB example of Tigertail Lagoon/ Sand Dollar Island Restoration

The Clam Bay NRPA represent the coastal front of Pelican Bay development in Naples and include 570 acres of nature preserve including 420 acres of mangroves, multiple tidal bays connected to the Gulf of Mexico through the small tidal inlet of Clam Pass. The Tigertail Lagoon/Sand Dollar Island Ecosystem in Marco Island consists of a 2-mile long sandspit backed by large tidal lagoon/ wetlands and mangrove shorelines on the northwest part of Marco Island. The Tigertail Lagoon/Sand Dollar Island Ecosystem habitats cover over 200 acres of wildlife habitat encompassing over 100 acres of tidal lagoon, wetland and mudflats with over 12 acres of seagrass beds, 48 acres of coastal vegetation, and over 40 acres of sandy habitat areas while acting as the coastal front of the northern part of Marco Island. The initial restoration project was constructed in 2023 followed by a comprehensive monitoring and maintenance program. **Figure 1** shows the collapse of the sand spit and tidal lagoon system due to natural evolution and hurricane Ian impacts in 2022 and the restoration project completed in 2023.
