## CHAPTER 178

### DOLOS ARMOUR DESIGN CONSIDERATIONS

J A ZWAMBORN\* and J D P SCHOLTZ\*\*

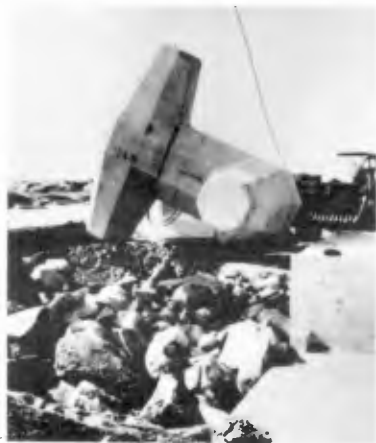
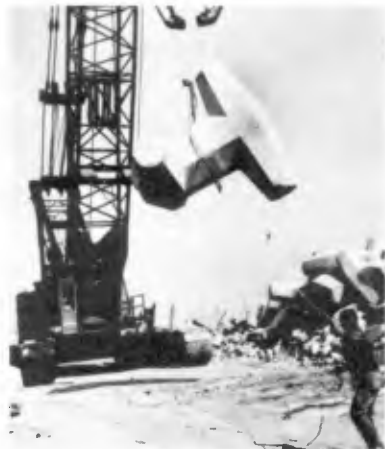
### Gioia Tauro Free Fall Test

Test on Rock

Test on Core Material

Figure 2: Free-fall tests with 30 t dolosse

The most significant result of these tests is that the critical fall heights with a realistic yield are about 10 times greater than for the rigid-base case which means that unreinforced dolosse should be able to withstand considerable movements/rocking without breakage, a fact which is born out by prototype observations.

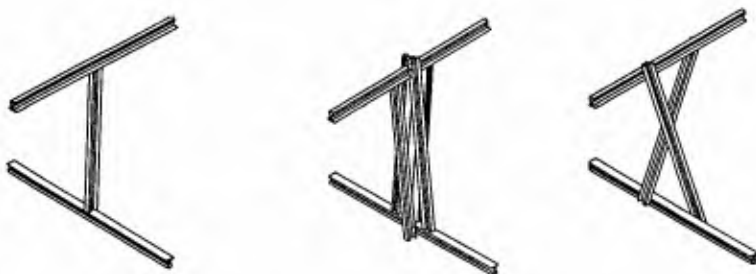
The height of the 9 t test dolosse was 2,9 m and the waist-to-height ratio was 0,30. The units were made of 40 MPa concrete (28 days). The tests included dolosse without reinforcing and with three types of 43 kg/m **scrap rail reinforcing**, that is a single central rail, the so-called double-V reinforcing designed by Grimaldi and Fontana (1984) and the X-type reinforcing developed by the NRIO (see Figure 4).

Single-rail Reinforcement    Double-V Reinforcement    X-Type Reinforcement

Figure 4: Rail Reinforcement in 9 t Dolosse

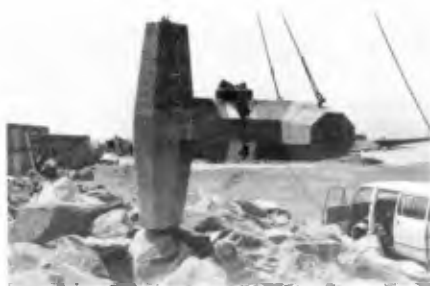
Figure 5: Free-fall tests on 0,5 to 3 t rock.

To determine a realistic yield, representing the impact of dolosse on underlayer stone or other dolosse, the first test series involved dropping a 9 t (reinforced) dolosse onto 0,5 to 3 t underlayer stone (Fig. 5). Decelerations on impact were measured during these tests with two PCB Piezotronics shock accelerometer with 500 g range, fitted on the trunk and on the top shank (Fig. 5).

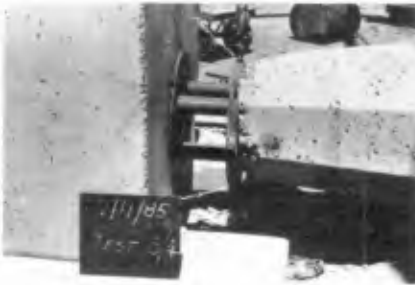
Because the impact on rock will depend largely on the rock packing and will thus be variable (see spread of points in Fig. 6 for large impact time values), swing test were done using a representative "cushioning device". Considering that, in reality dolosse could either fall onto underlayer rock or on parts of other dolosse, a "cushioning device" consisting of three collapsible "yield pipes" (Fig. 7; 3 pipes: 89 mm OD, 4,5 mm thick and 250 mm long) was

designed to give approximately twice the initial deceleration of the free drop-on-rock case but with a similar ultimate impact time of 40 to 60 ms. In this way, a conservative test condition was developed representing breakwater conditions quite realistically.

Figure 7: Cushioning Device

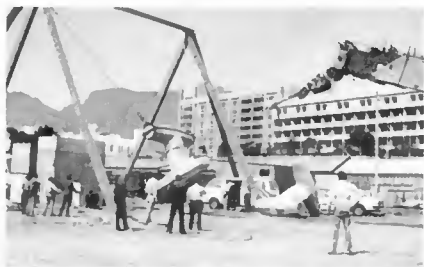
The actual test configuration is shown in Figures 8 and 9. The tests are still underway at present but preliminary results of the tests, according to the Test Layout 2 of Fig. 3, are given in the following table:

Figure 8: General Test Arrangement

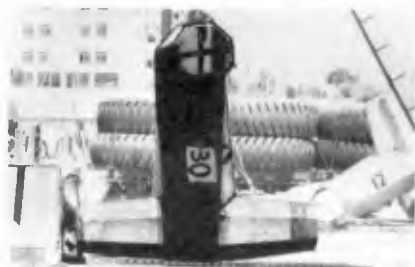
Figure 9: Dolos (9t) at impact
