Case Report

Management of Vertical Crown Fracture with Post and Core: A Case Report**Dr. Ruchi Gupta¹, Dr. Nivedita Saini², Dr. Geetika Sabharwal³, Dr. Ayan Guin⁴, Dr. Shaik Muzammil Taj⁵****¹Professor, Department of Conservative Dentistry and Endodontics, DivyaJyoti College of Dental Sciences and Research, Modinagar, Uttar Pradesh.****²⁻⁵Postgraduate students, Department of Conservative Dentistry and Endodontics, DivyaJyoti College of Dental Sciences and Research, Modinagar, Uttar Pradesh.****Received: 10-11-2022 / Revised: 13-12-2022 / Accepted: 19-12-2022****Corresponding author: Nivedita Saini****Conflict of interest: Nil****Abstract**

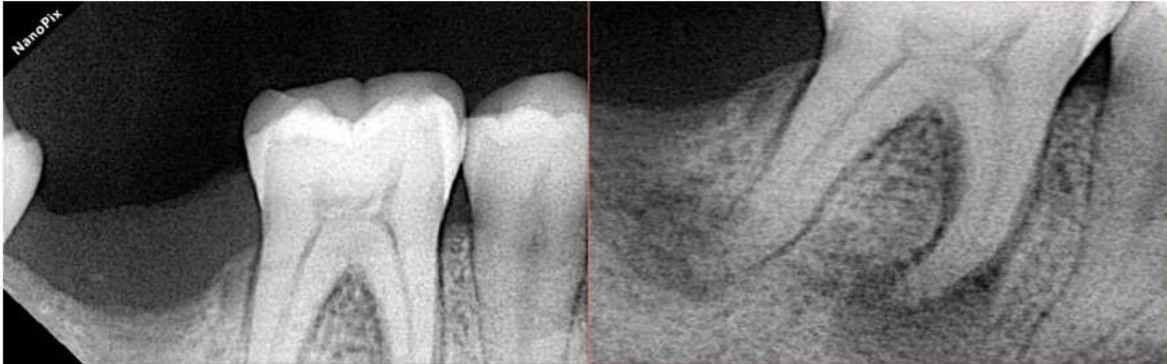
Figure 1: Pre-operative radiograph **Figure 2: Pre operative radiograph showing periapical Radiolucency**

A 38 year old male patient came with chief complaint of pain in lower back right tooth region since 1 week ,clinically there was no evidence of caries in the coronal area .On radiographical examination ,periapical radiolucency (figure 2) was seen. Treatment plan of root canal therapy followed by crown was advised. Endodontic therapy was initiated with the access opening of 46 ,however during the access opening , a vertical fracture was seen in the coronal portion ,which was not noticed prior to the initiation of root canal treatment. The fracture extended below ,till the roof of pulp chamber .Now , because

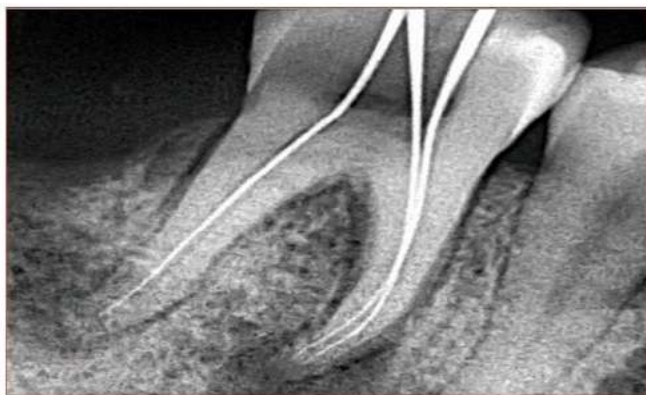
Figure 3: Working length.

of the vertical fracture the changes were made in treatment plan. the broken fragment were removed by the help of forcep. After removal of the broken fragment (figure- 5) ,the access cavity was refined ,the orifice were located and enlarged with orifice shaper. Working length was determined with help of apex locator and radiographically and three canals were located - distal, mesiobuccal and mesiolingual (figure 3).BMP was done by protaper gold (dentsply) followed by copious irrigation by 3% sodium hypochlorite and 17%EDTA . After this temporary material was placed and patient was recalled after 3 days

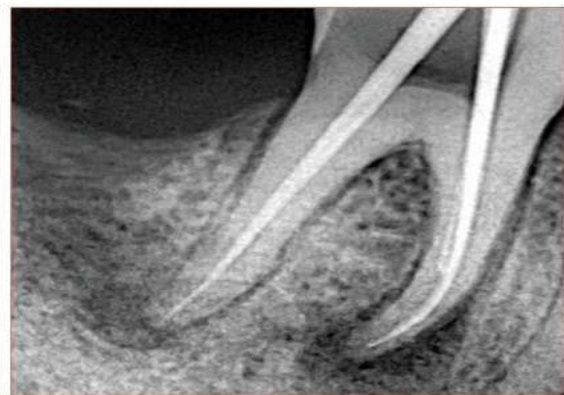
Figure 4: Master cone

Now ,master cones were placed ,tug back was confirmed and the rvg was taken to confirm the proper fit and working length . After,which the

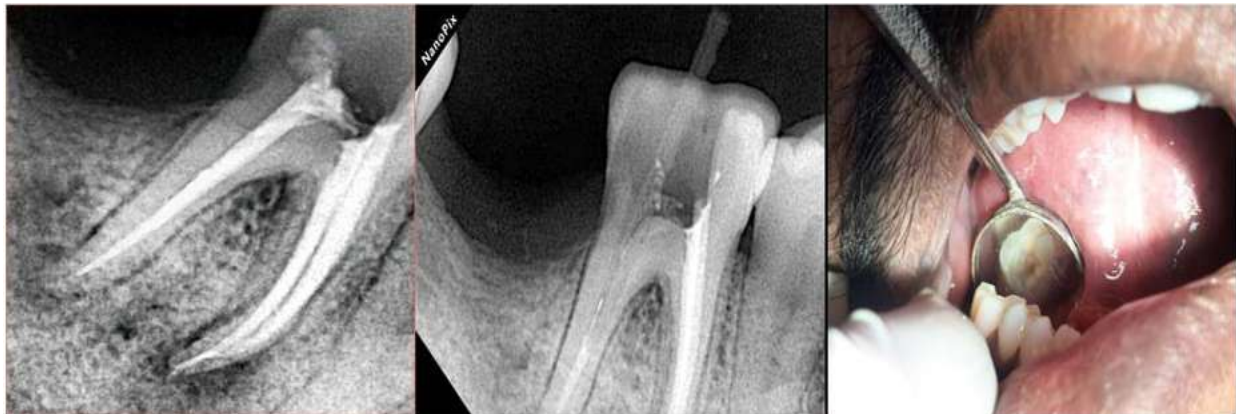
Figure 6: Obturation

obturation was done with calcium –hydroxide based sealer(apex seal).

Figure, 7: Placement of fibre post after creating post space,

Figure 8: Fibre post placed

After,obturation it was decided to provide post and core to patient as tooth structure was compromised, the distal canal was prepared for the fibre post.

Post space was created by the help of peeso reamer #2 and 3 . Length of the post space was 12mm and the entire working length was 20mm. the fibre post was placed and the fit was checked with help of an xray. The canal was irrigated and dried. and a thin, uniform coat of bonding resin cement (prevest)was applied over the post and thinned further with a slight air stream. The post was carefully seated into the canal using light pressure. The marginal seat was reaffirmed. The post was light-cured in place for 1 min on all surfaces. Core build – up was done with the help composite resin
