Ball Street Bridge Conservation Management Plan

Abstract: This Conservation Management Plan focuses on Ball Street Bridge, a Grade II listed Victorian-era bridge in Sheffield, England, recognized for its architectural and historical significance. The plan identifies key management challenges, including structural aging, environmental impacts, community use, and the absence of heritage interpretation. A detailed action plan outlines strategies to address these issues, ensuring the bridge's structural integrity, environmental sustainability, and role as a community and heritage resource. The plan emphasizes regular structural inspections, the implementation of environmental monitoring systems, and measures to engage the community while mitigating vandalism. Additionally, it recommends the installation of interpretive signage and the development of educational programs to enhance public understanding of the bridge's historical and cultural importance. Through these initiatives, the plan aims to preserve Ball Street Bridge as a vital part of Sheffield's industrial heritage and a resource for future generations.

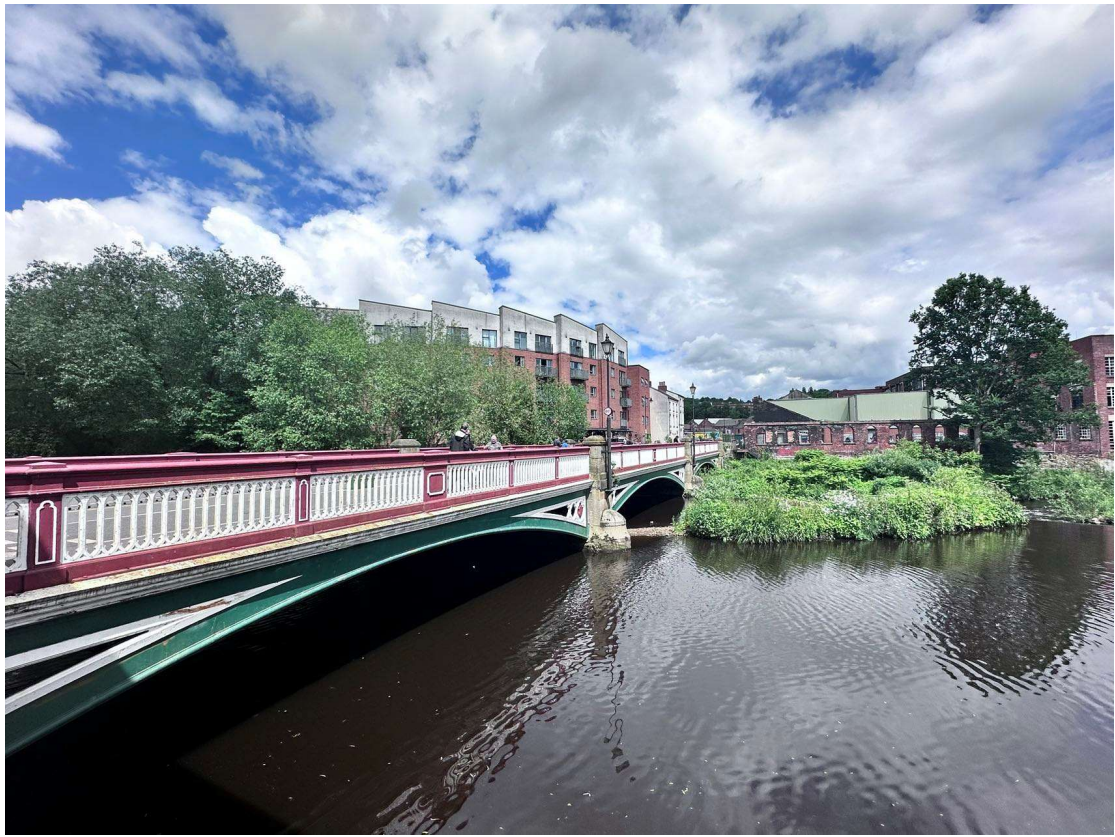
Figure 3. Ball Street Bridge

Ball Street Bridge (Figure 3) is currently primarily used for pedestrian and non-motorized traffic, serving as an important link between Sheffield city center and Kelham Island. It was constructed with steel and stone, reflecting the architectural characteristics of the late 19th century Industrial Revolution. In Table 1, the heritage sites within the selected area are listed chronologically.

Ball Street Bridge (List entry number: 1246509) [1] (Figure

3) is a Victorian-era bridge located in Sheffield. It was originally built in 1856, rebuilt in 1864 (Figure 5), and widened in 1900. The bridge was manufactured by Milton Iron Works of Elsecar and spans the River Don, connecting Kelham Island and Neepsend [1][5].

Ball Street Bridge is composed of three cast iron spans and limestone piers, adorned with spandrels featuring trefoil and quatrefoil patterns [5]. This design combines the functionality and aesthetic elements of Victorian industrial design. The bridge spans the River Don, providing beautiful river views. After its pedestrianization, it has become a popular spot for leisure and relaxation, where many people enjoy watching the river, listening to birdsong, and savoring the tranquil environment. Beehives [20], green vegetation, and wild birds along the bridge enhance its natural beauty and ecological

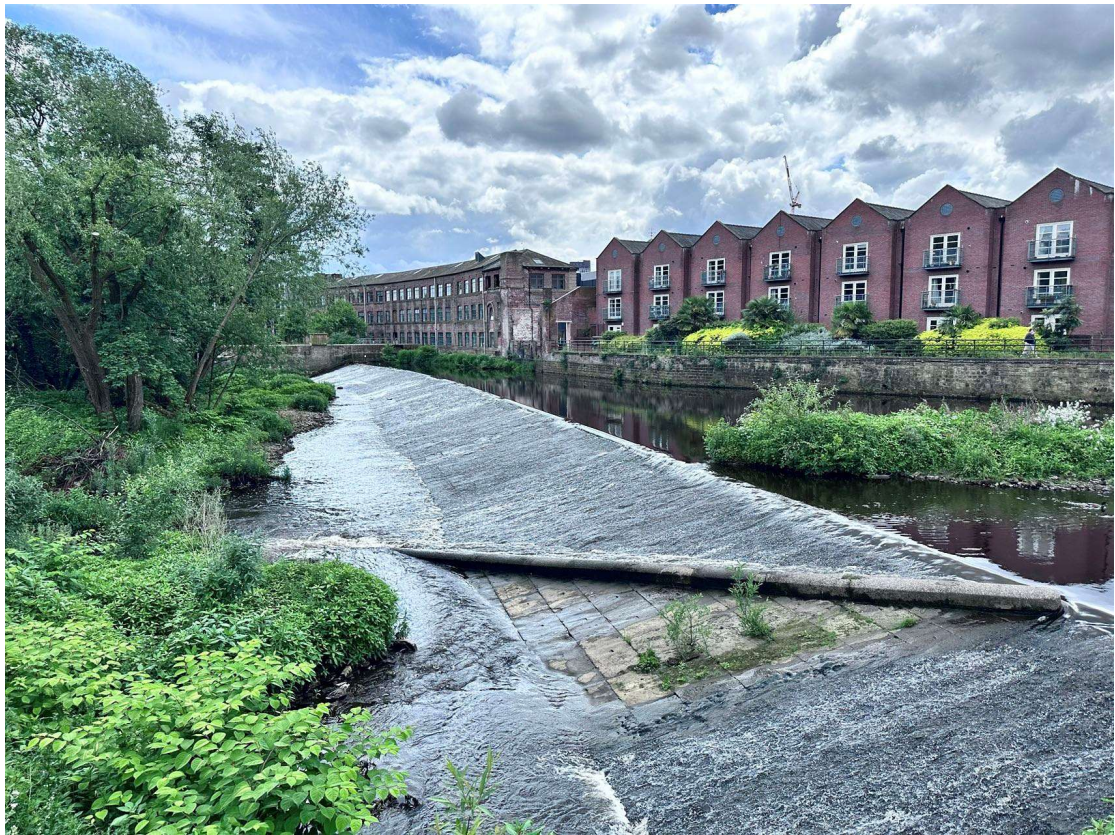
Figure 4. Ball Street Bridge Kelham Weir

The earliest records of human activity near this site coincide with the formation of Kelham Island, where Kelham Weir (Figure 4) played a pivotal role. Constructed around 1800, Kelham Weir (List entry number: 1246510)[2] is built with rows of stones and gritstone steps, extending about 100 meters in length, making it one of the earliest hydraulic engineering works in the area.

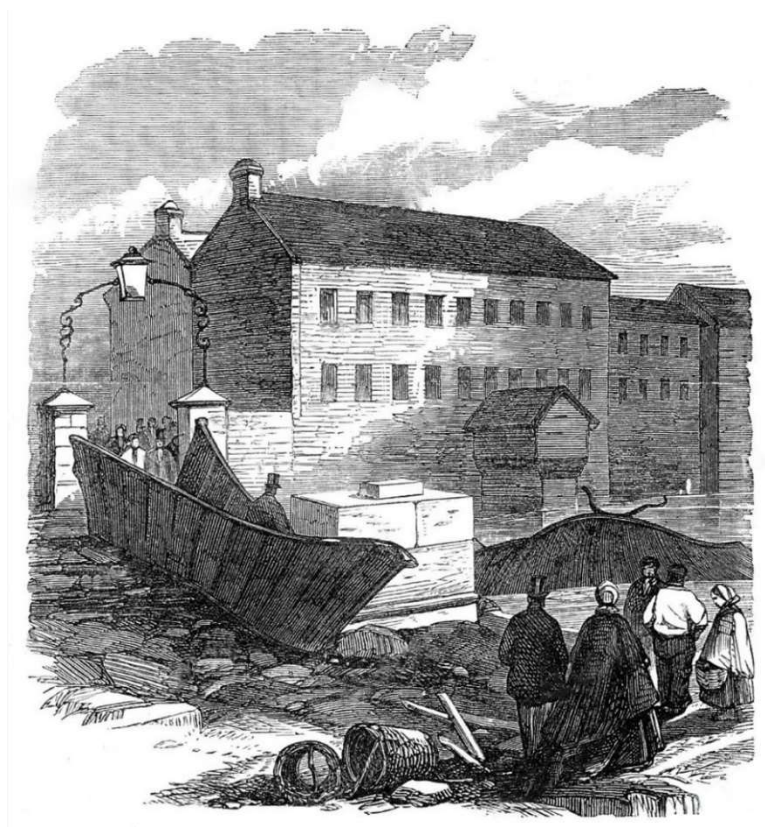
Figure 6. The Flood at Sheffield: remains of Ball-Street Bridge, 1864. (Heritage images, 1864)

According to Harrison (1864) and Sheffield City Council (2015), on March 11, 1864, the Dale Dyke Dam embankment collapsed at night, releasing about 65 million gallons (approximately 3 million cubic meters) of water[8][9]. This massive flood rushed down the Loxley Valley, destroying villages and urban infrastructure along its path, and caused significant damage to the city of Sheffield. The structure of Ball Street Bridge could not withstand the powerful impact of the flood, resulting in severe damage to the bridge (Figure 6). This disaster caused extensive damage to local industrial facilities, residential buildings, and public structures.

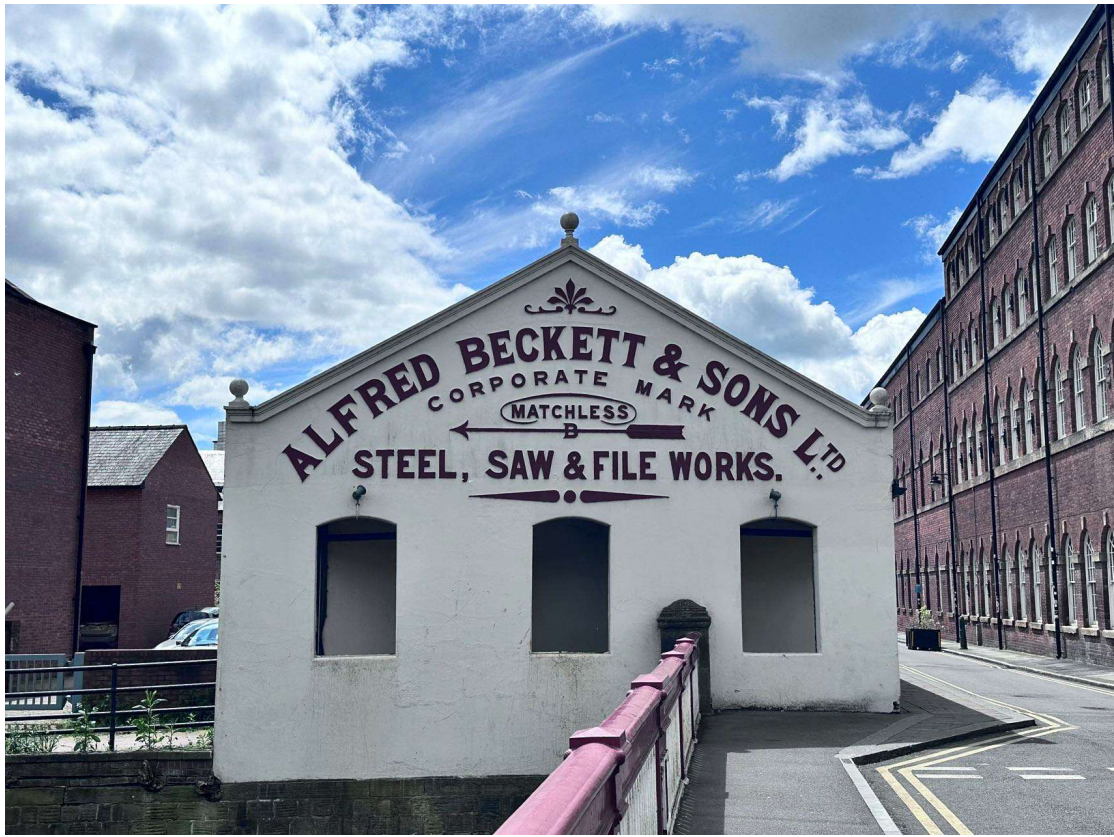
Figure 7. Brooklyn Works

Brooklyn Works (Figure 7) is located on Green Lane in the Kelham Island area and was built in the mid-19th century, forming an important part of Sheffield's industrial history. The factory was founded and named by Alfred Beckett in 1859 [10], producing steel, saws, and files.

According to Harrison (1864), during the Great Sheffield Flood on March 11, 1864, water rushing from the Dale Dyke Dam destroyed the boundary wall of Brooklyn Works[8]. The ferocity of the flood tore a large steam boiler from its base. Additionally, the flood damaged a vast amount of machinery, extinguished furnaces, and destroyed finished products. Brooklyn Works was rebuilt over the following years and continued to operate until the mid-20th century.

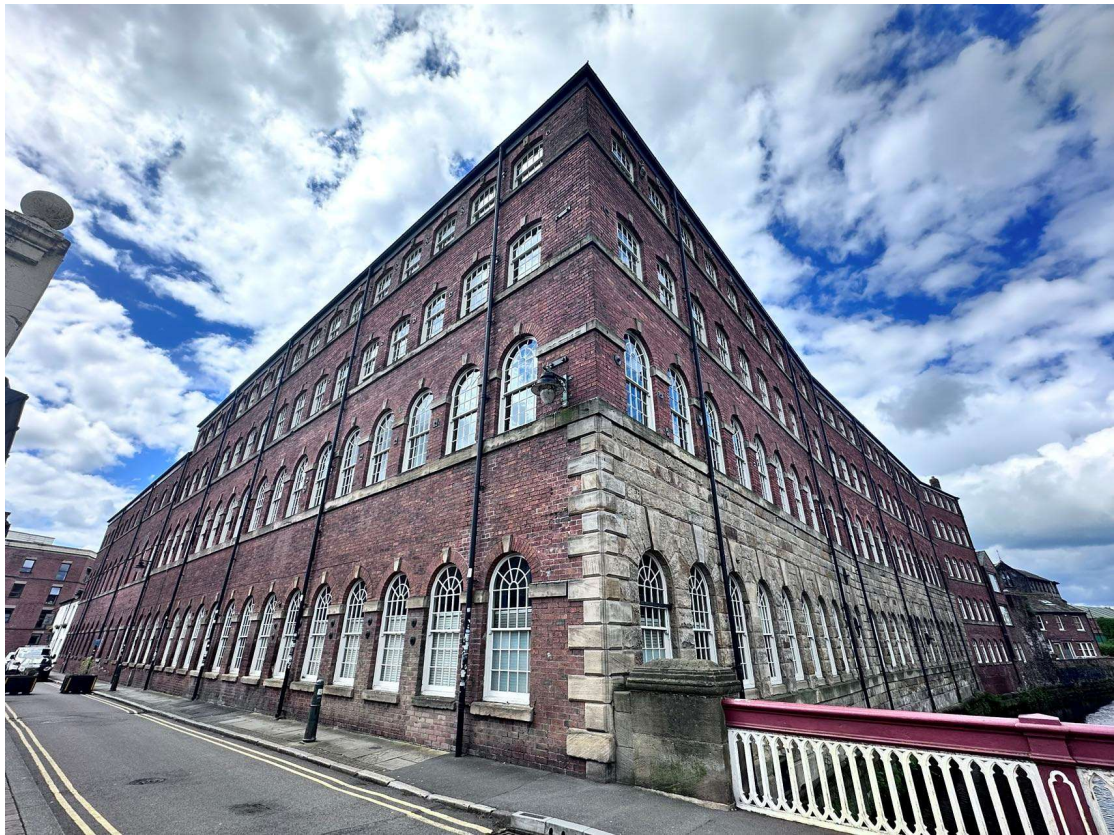
Figure 8. Cornish Place Works

Cornish Place Works (Figure 8) is one of Sheffield's historic industrial buildings, with the East Range originally constructed between 1851 and 1854. It was renowned for producing Britannia metal, Sheffield plate, and cutlery. Initially built between 1851 and 1854, the factory shifted towards steam power and was further expanded between 1857 and 1859, adding warehouses and a showroom. It manufactured a variety of items, which are now on display at the Kelham Island Museum.
