Esthetical and Functional Rehabilitation of Severely Worn out Dentition: A Case Report

Full mouth rehabilitation, Vertical dimension, Metal-ceramic restorations, Worn out Dentition

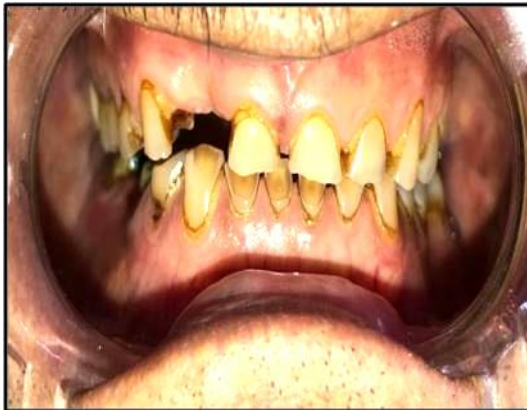
Fig 1: Pre-operative Intraoral view

anterior deep bite and loss of vertical dimension of occlusion (Figure 1 & 2).

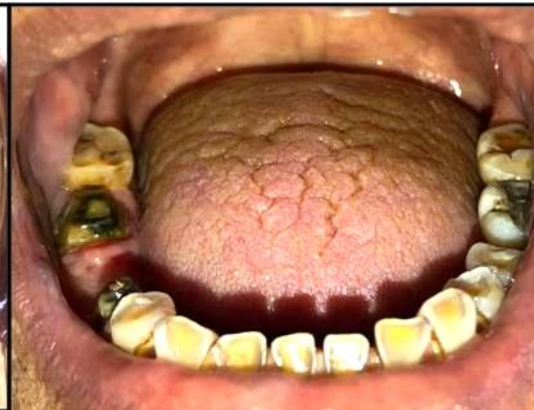
Fig 2: Pre-operative mandibular arch

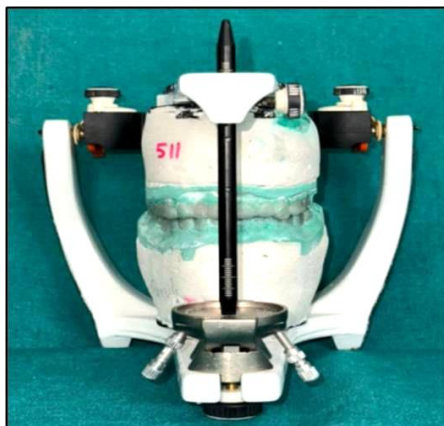
Fig 3: Diagnostic wax up at 3 mm raised VDO

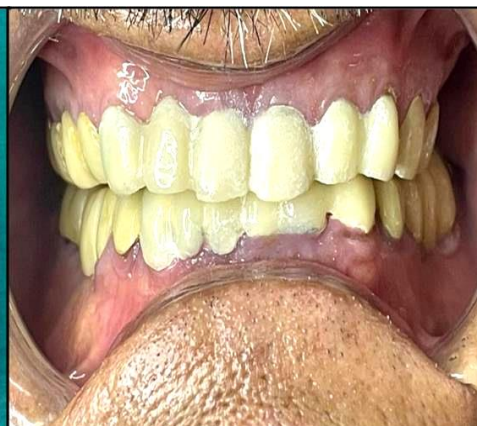
Fig 4: Temporaization

Crown lengthening was done for the mandibular central and lateral incisors followed by subgingival tooth preparation for metal-ceramic restorations posteriorly followed by the anteriors. 3M ESPE Protemp, USA material was used to fabricate temporary restoration with the help of putty index made on the diagnostic wax up. Temporary restorations were finally adjusted intraorally and cemented with non-eugenol temporary cement (Rely X Temp NE, 3M ESPE, USA). (Figure 4) After 4 days, impressions were recorded with irreversible hydrocolloid along with the temporary restorations placed intraorally and the casts were mounted using facebow and centric record. Final

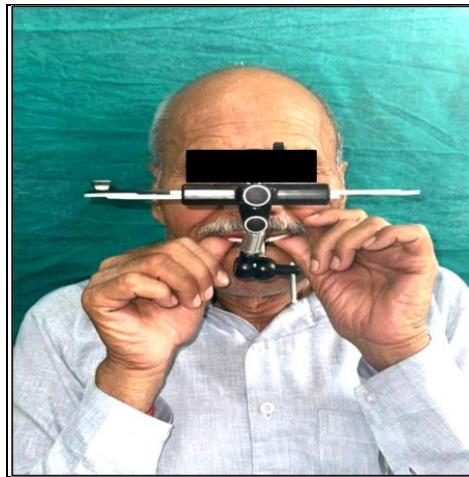
Fig 5: Facebow Transfer

facebow transfer done accordingly (Figure 5). Articulator was programmed to adjust incisal and condylar guidance. Temporary restorations were then removed from oral cavity and final impressions were recorded with addition silicone impression material. Impressions were then poured with type IV die stone. Die cutting and die ditching was done on the cast and the casts were mounted on the articulator using centric and facebow records. The wax pattern was made and the casting was done for the metal ceramic restoration and the metal coping were tried intra-orally to verify marginal fit and inter-occlusion clearance (Figure 6). Shade was taken using the classical Vita shade guide. Interferences were removed from the metal ceramic

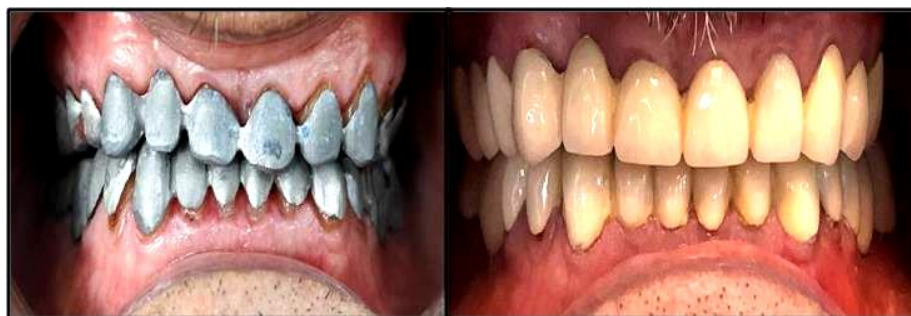
Fig 6: Metal Try-in

Fig 7: Final Restoration

polished. Once they were evaluated they were cemented using Glass Ionomer cement and the excess cement was removed (Figure 7). Instructions were given to the patient for the maintenance and the patient was scheduled for the follow up visits.
