Evaluation of the Effectiveness of Fracture Repairing of the Ceramic-Metal and Zirconia Prostheses by the Direct Method (In Vitro Study)

Objectives: to compare the effectiveness of the direct method in repairing fractures of porcelain fused to metal (PFM) and porcelain fused to zirconia (PFZ) restorations using nanohybrid composite and universal ceramic primer by studying shear bond strength.

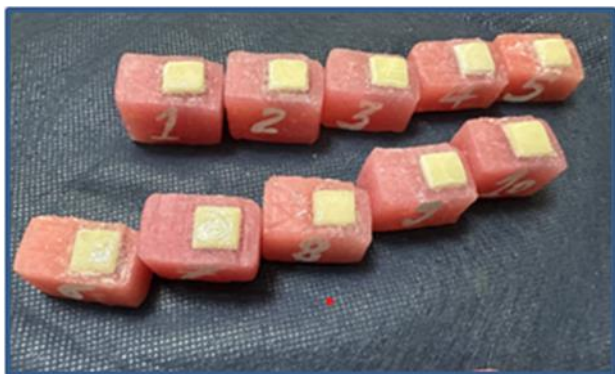
Figure (1) The intact ceramic-metal samples after being cast in acrylic bases, trimmed, and numbered .

After designing and manufacturing the intact ceramic-metallic and ceramic-zirconia samples in the laboratory, they were placed in a thermal incubator at 37°C for 48 hours. They were then cast into acrylic bases, trimmed, and numbered for each sample in the four groups from 1 to 10. See Figures (1) and (2).

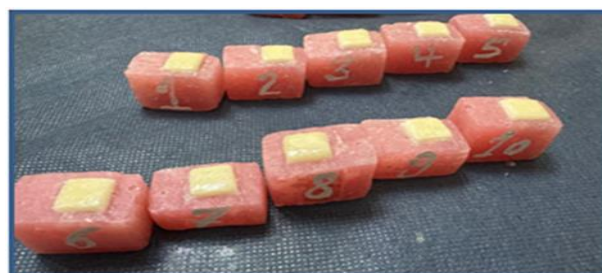
Figure (2) The intact zirconia ceramic samples after being cast in acrylic bases, trimmed, and numbered .

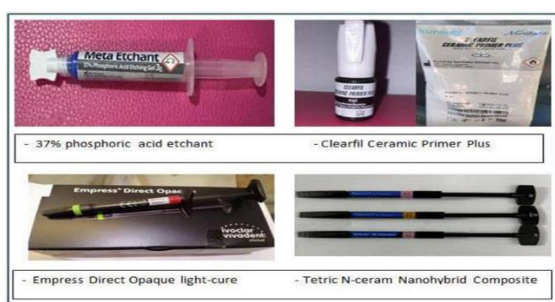
Figure(3) shows the materials used in the direct repair in our research

The sample was rinsed with running water for a full minute and then dried with oil-free dry air for two minutes. The fracture site of both the exposed metal and the feldspathic porcelain-covered surface involved in the fracture was sandblasted using an intraoral sandblaster with 50-micron aluminum oxide particles under a pressure of 4 bar for 15 seconds, with the distance between the sandblaster tip and the fracture surface being 3 mm. Then, the residues of sandblasting were rinsed off the sample surface with running water for 30 seconds. The surface was then cleaned using ultrasonic waves for two minutes and then dried with dry air for a full minute. A 37% phosphoric acid etching agent was applied to the fracture site on both the metal and the porcelain involved in the fracture for only 5 seconds to remove contaminants, followed by thorough rinsing and drying of the sample for a minute. A first layer of the ceramic primer Clearfil Ceramic Primer Plus was applied to both the exposed metal surface and the fracture line within the porcelain layer using a brush, and then the sample surface was dried with oil-free dry air. A second layer was applied, followed by a third layer of the ceramic primer Clearfil Ceramic Primer Plus, according to the study by (Klisiri A & Maneenacarith et al. 2022), using the same method A layer of light-curing opaque Empress Direct Opaque was applied to cover the color of the metal with a thickness of 0.5 mm and then cured with a light-curing device for 40 seconds. A first layer of Tetric N-Ceram Nanohybrid Composite Color B2 Dentin was

applied with a thickness of 0.5 mm and cured with a light-curing device for 40 seconds. A second layer of Tetric N-ceram Nanohybrid Composite Color A1 was applied with a thickness of 0.5 mm, cured for 40 seconds, and then a third and final layer, also with a thickness of 0.5 mm, was applied and cured for 40 seconds. Thus, the total thickness of the applied composite is 2 mm, equal to the thickness of the adjacent porcelain covering layer. Then, the repair composite was finished and polished using appropriate burs and tools.

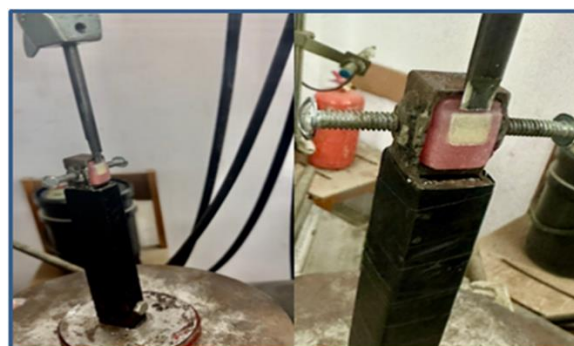
Figure (5): Application of Shear Force Parallel to the Interface Surface.

All samples were subjected to shear strength testing using the Universal Testing Machine (UTM) available at the Faculty of Mechanical and Electrical Engineering at Tishreen University. The tests were conducted using a wedge-shaped head (knife edge) with a thickness of 1 mm and a width of 8 mm made of steel. The force was applied parallel to the bonding surface in all samples at a speed of 0.5 mm/min. The force application continued until failure, which was identified by a fracture on the surface of the sample. The device was then stopped, and the digital value of shear strength in megapascals was recorded, calculated using the following equation: **Shear Bond Strength (SBS) = Applied Force (N) / Surface Area (mm²)**
