An Evaluative Study of Restoration Works on a Historical Landmark: Okba Bin Nafi' Mosque in Biskra Province

This remarkable structure underwent restoration work in the late 20th and early 21st centuries. However, these efforts were not without their flaws. The use of materials that lacked the same characteristics as the original ones led to alterations in the mosque's appearance and obscured its historical authenticity, both in terms of architectural style and construction materials.

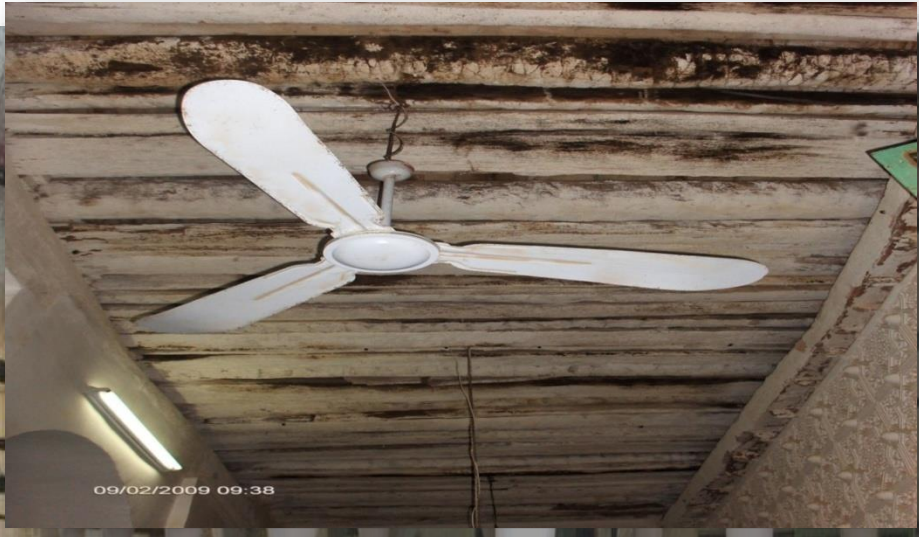
Photo01: the original roofing method.the work of the researche

Photo 02:Under the ceiling with plaster.The work of the researcher

removing originally existing parts, introducing new parts and elements, or disfiguring its distinctive styles and characteristics (قادوس، 2003، صفحة 248). This is what we noticed in Sidi Okba Mosque, where essential elements of the mosque were hidden. For example, the researcher will not be able to identify the roofing methods except by referring to the original files of the mosque, as the restoration work led to the concealment of the roofing elements and techniques, or rather "construction techniques and materials" because the entire mosque was subjected to covering all its parts and elements with the use of gypsum, cement, and ceramics.

If the purpose of using it is to give the mosque an aesthetic appearance, the authenticity of the roofing materials and their method of installation express the aesthetic and artistic value of the building. In addition to this, this process will lead, as we have already mentioned, to the obscuration of the roofing elements, as it will not allow us to have a complete view of the causes of the resulting damage, especially from the spread of insects such as termites, which are considered one of the main factors in causing damage to the building, as they are considered one of the most dangerous insects that attack archaeological sites, as they feed on crushed straw and dig tunnels. Termites can also destroy wood, as they have the ability to secrete an enzyme that helps decompose cellulose, which is the main component of wood, and damage the binding material between the fibers "lignin", which leads to the destruction of wood. (توراكا، 2003، صفحة 97)

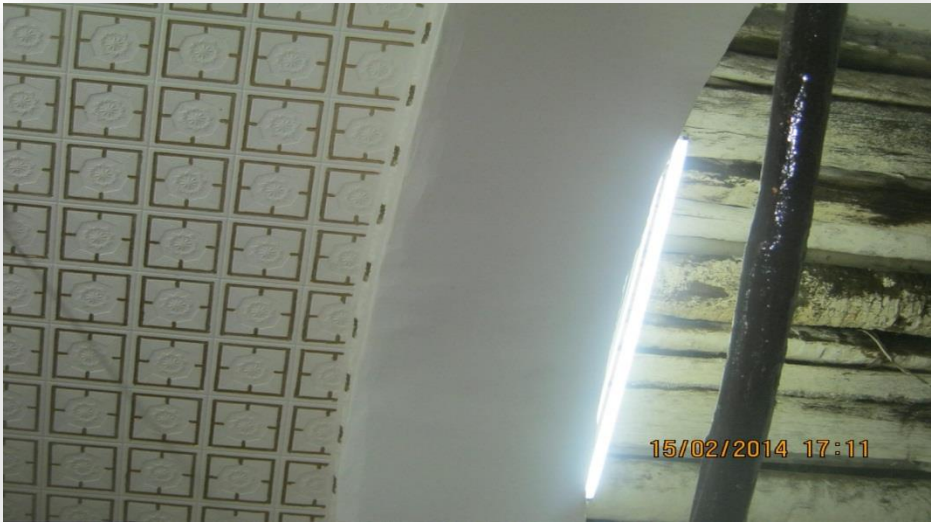
Photo 03 :Restoration with ciment and ceramic mosaics.The work of the researcher.

We have also noticed the use of cement mortar and ceramics in the restoration operations, although the binding material in the stones is clay. This leads to the penetration of salts from the cement material into the wall surfaces, which then crystallize in different places. The crystallization of salts and the associated local stresses cause the disintegration of the wall surfaces. In addition, the use of cement isolates the ventilation of the inner mortar of the wall, which leads to the retention of moisture inside it, causing an internal pressure problem between the mortar particles and consequently their explosion through cracks in the walls. (قادوس، 2003، p. 248)

In addition to these drawbacks, the use of cement in the construction of some parts of the building has caused it to lose some of its distinctive architectural and historical features. This is because it is observed that the restoration process was carried out by a builder and not by a specialized restorer.

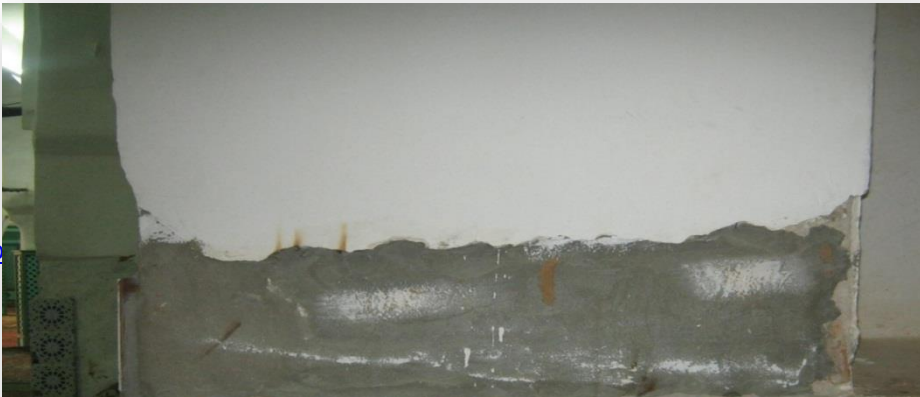
Photo 04 :The original roofing and additions under the ceiling with gypsum.The work of the researcher.

In addition to the complete covering of the internal and external walls with gypsum, one of the damages is the complete concealment of the building's original materials and evidence, making it difficult to retrieve them. One of the principles of restoration is the ease of removing the restoration material without damaging the elements of the historic building, when it is desired to modify the method and method of maintenance and restoration.

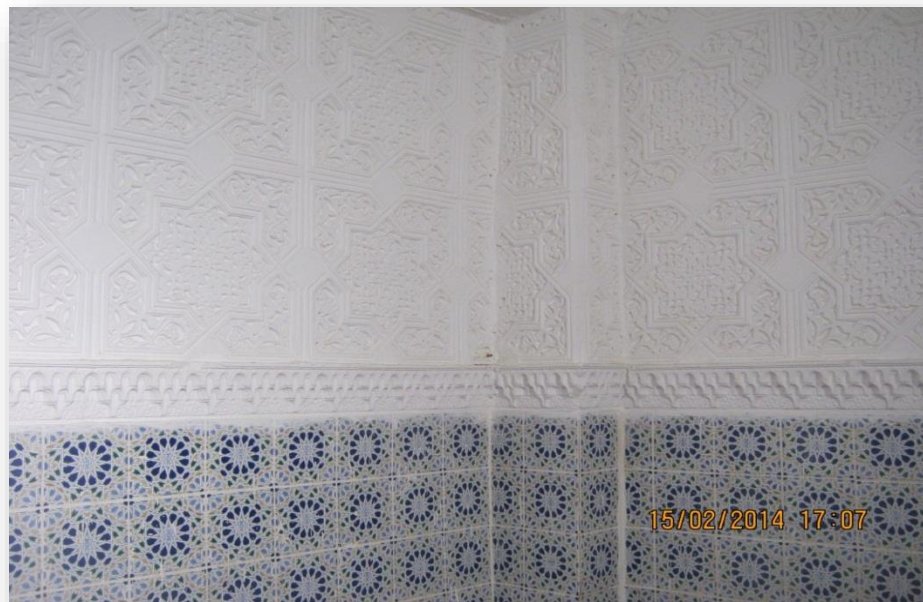
Photo 05 : Decorating with plaster on the walls.The work of the researcher.

However, it is noted that the process of retrieving the restored materials of cement and gypsum will lead to the damage of some of the original building materials.
