# Digitization and Cultural Heritage Conservation: A BIM-Based Approach to Seismic Monitoring in the Basilica of Santa Maria degli Angeli

CLAUDIA CERBAI, FABIO BIANCONI, MARCO FILIPPUCCI and NICOLA CAVALAGLI,  
University of Perugia, Italy

Cerbai, Claudia, Fabio Bianconi, Marco Filippucci, and Nicola Cavalagli. 2025. "Digitization and Cultural Heritage Conservation: BIM-Based Approaches to Seismic Monitoring in the Basilica of Santa Maria Degli Angeli." *Studies in Digital Heritage* 9 (1): 129–146.

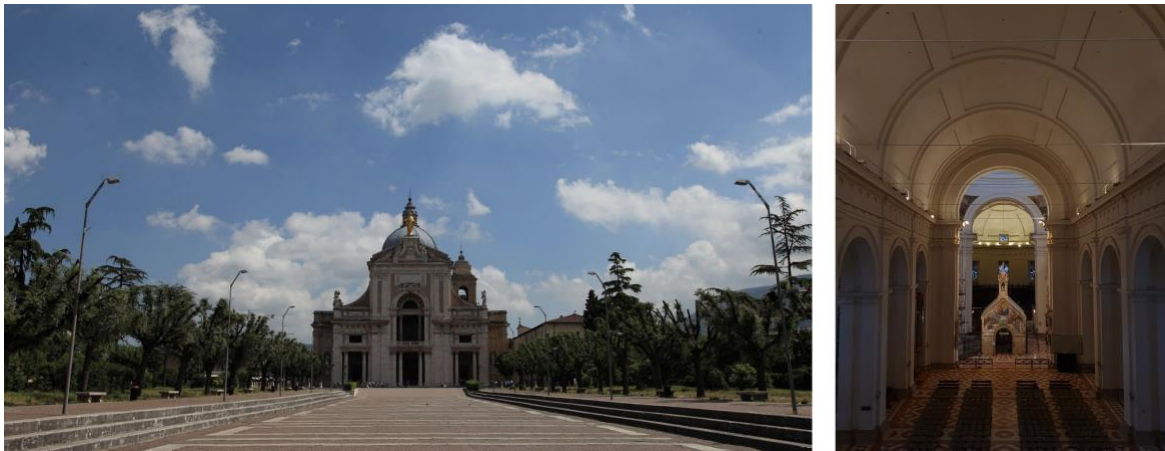
*Figure 1. The Basilica of Santa Maria degli Angeli and its heart, the Porziuncola.*

The Basilica of Santa Maria degli Angeli dominates the area at the foot of Assisi to protect and exalt the holy places of St Francis's life, who chose the Chapel of the Porziuncola (Fig. 1), currently the heart of the Basilica, as the fixed point of the Order (Scotti 1989, Romanini 1989).

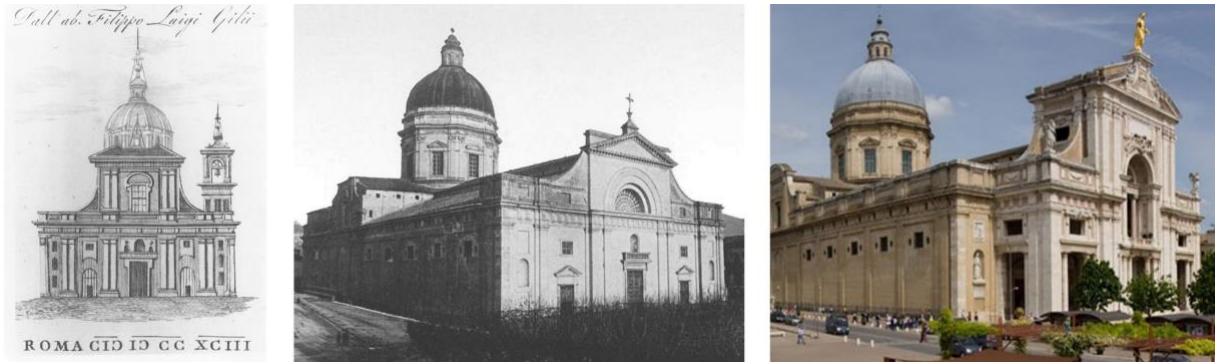
Figure 2: The evolution of the Basilica façade. From left: the original façade<sup>1</sup>, Luigi Poletti's intervention<sup>1</sup>, the new front by Cesare Bazzani.

degli Angeli a new image, more majestic, to enhance the splendor of the architectural complex. In 1930 the work was carried out by Cesare Bazzani (Bartelli 1989) (Fig. 2), but this intervention did not help to improve the statics of the building, on the contrary, over time contributed to further inconveniences.

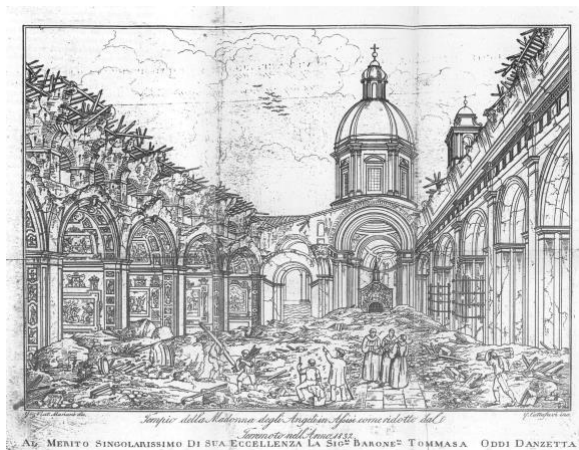
Figure 3: The collapse of the Basilica's nave after the 1832 earthquake [3].

Between the end of 1831 and the beginning of 1832, Santa Maria degli Angeli was struck by the violent earthquake that shook a large part of Umbria, causing numerous collapses inside the Basilica. The main damage was to the central body, with the collapse of the nave and the left aisle (Fig. 3).

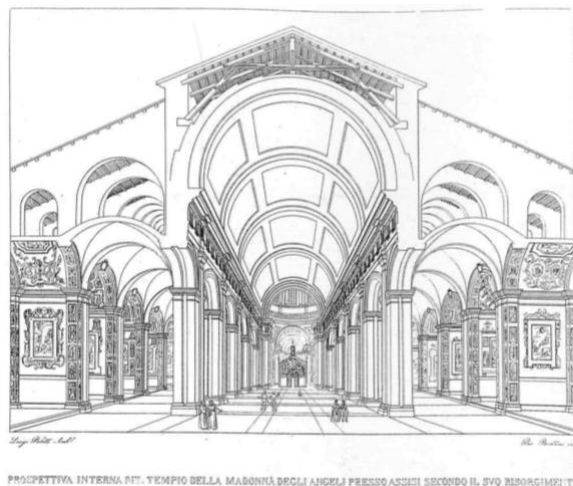
Figure 4: The central body of the Basilica of Santa Maria degli Angeli after Luigi Poletti's intervention<sup>3</sup>.

The central body of the basilica consists of three naves and five chapels on either side (Fig. 4).

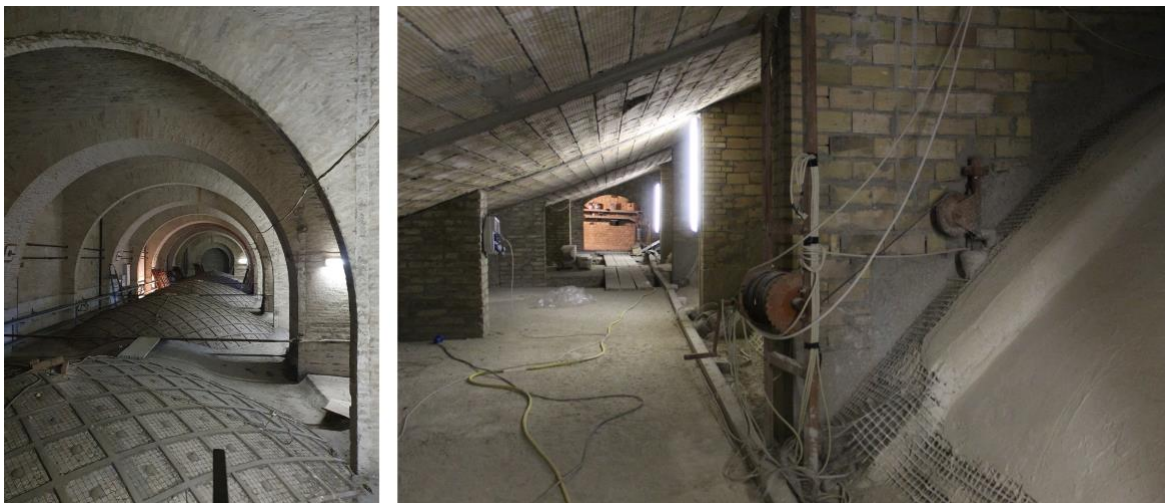
Figure 5: (left) Work on the vaults of the aisles and (right) support structure for the roof of the apsidal area.

In the light of these considerations, the work carried out to restore the correct functioning of the structure was limited to compensating, as far as possible, the weaknesses of the structure, some of which could only be remedied by extremely invasive interventions that would distort the current structural and aesthetic scheme of the monument. The works therefore focused on a slight stiffening of the roof slopes and the reinforcement of the vaults, intervention that guaranteed an insignificant increase in the weight of the original structure (Fig. 5).

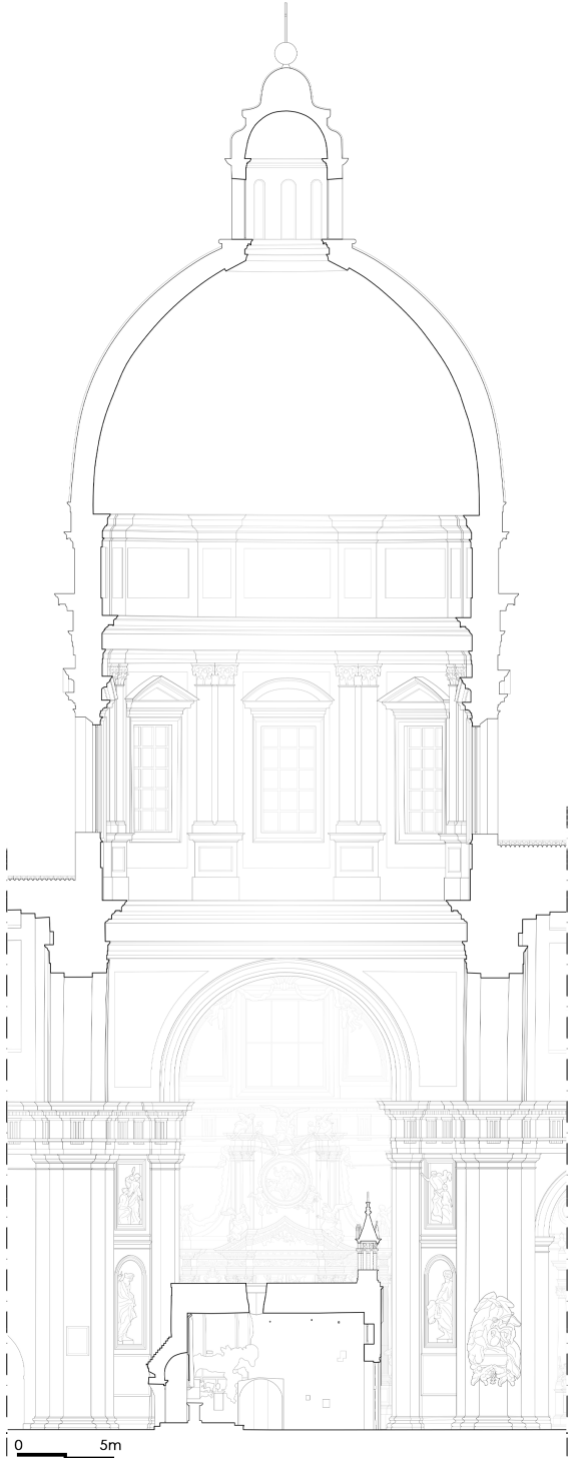
Figure 6: The dome as a landmark of the Porziuncola, graphic reworking by the author.

So far, the restoration work currently underway in the Basilica has focused on restoring the proper structural functioning of the drum-dome system and the introduction of new monitoring sensors.

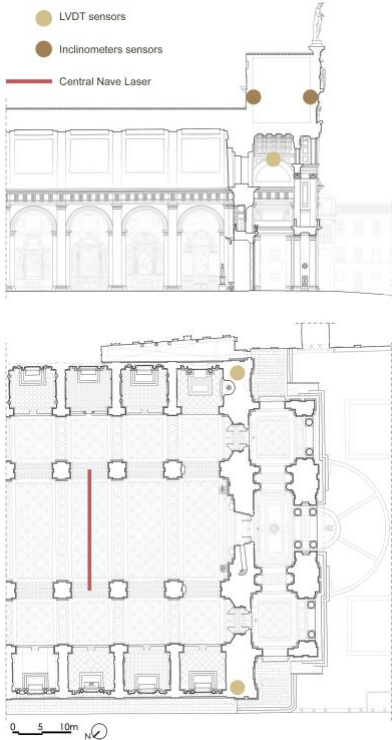
Figure 7: Static monitoring system.

The static monitoring system is constituted by 6 displacement sensors, 3 LVDTs and 1 laser sensor installed on specific parts of the structure, in particular corresponding to the presence of past damages and on the double façade system (Fig. 7).

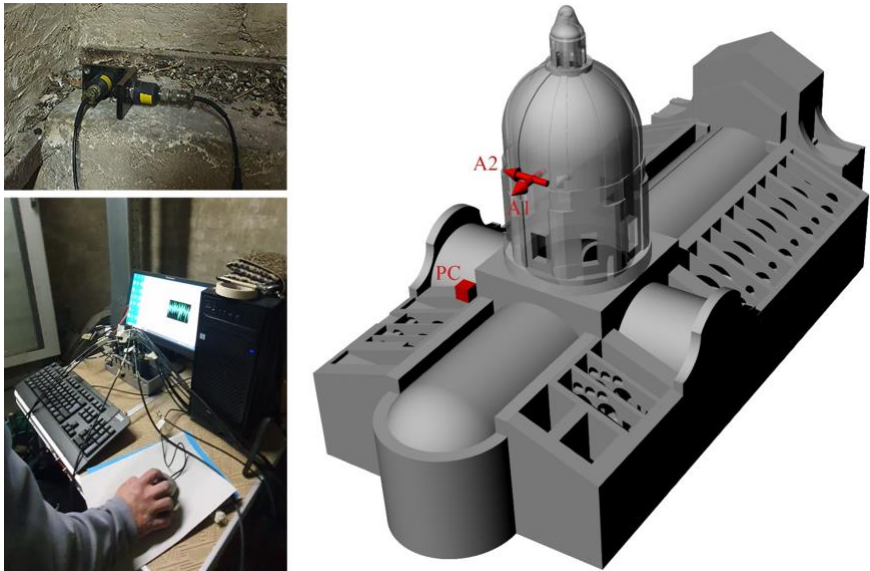
Figure 8: Dynamic monitoring system since 2017.

The dynamic monitoring system only consisted of 2 piezoelectric accelerometers installed on the base of the dome (Fig. 8).

The vibration data were recorded continuously under operating conditions using a multi-channel system and stored in 30-minute time series (Cavalagli et al. 2016).

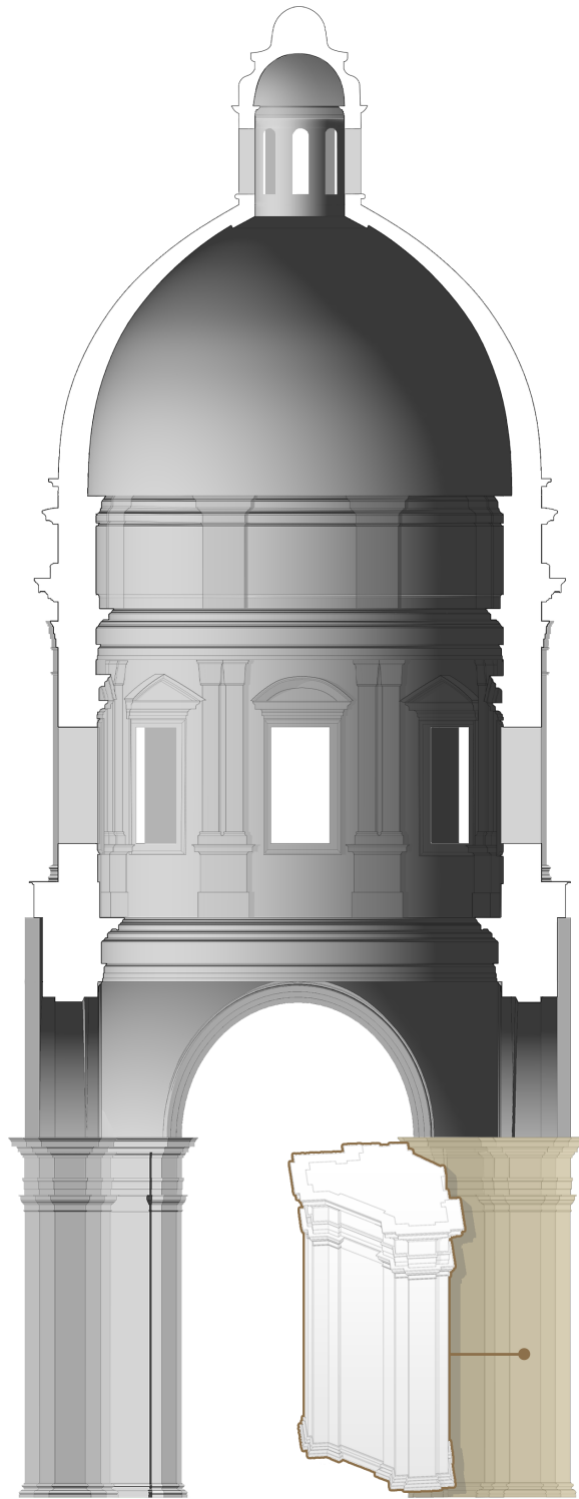
*Figure 9: The dome's model.*

To model the dome, a methodological approach was adopted, beginning with the establishment of a structural model composed of three principal macro-areas: the core structure, the drum and the dome. Within these areas, the level of detail was gradually increased, the elements were divided into parameterized families and subjected to varying degrees of modelling in accordance with aesthetic and functional requirements.

The modelling process began with the four main pillars, which constitute the load-bearing elements of the structure. These pillars were modelled through the use of parameterised families, thus ensuring their correct classification within the model in both a geometrical and an informative sense. In this case, the decorations were added subsequently due to their close relationship with the supporting structure itself. The modelling of the connection structure between the pillars and the drum was particularly challenging due to the articulated geometry of the surfaces, which exhibited multiple curvatures. In this context, the decorative apparatus was deliberately simplified to emphasize the primary role of the supporting structure, as the decorations were not functional to the structural behavior.

The drum was modelled in three sections, with the central band hosting the large windows that provide illumination to the area below. In this phase, the level of detail of the decorative apparatus was increased to enhance the aesthetic value of the element and to ensure that the stylistic characteristics of the dome under study were recognizable in comparison to other similar structures.

The final and most complex phase was the modelling of the actual dome, including the additional portion of the roof lantern. Since the model is based on a detailed and accurate survey, the geometry of the dome result not perfectly circular, increasing the complexity of the modelling. To address these difficulties, two separate local models were developed: one for the dome and one for the roof lantern. This subdivision made it possible to obtain a representation more faithful to the real conformation of the structure.
