# Texas Water Journal

Volume 16 Number 1 | 2025

# Dam Failure and Reconstruction in the Guadalupe Valley Lakes Region of Central Texas

Citation: Adams AT, Villagran M, Mace RE. 2025. Dam Failure and Reconstruction in the Guadalupe Valley Lakes Region of Central Texas. Texas Water Journal. 16(1):57-79. Available from: <https://doi.org/10.21423/twj.v16i1.7182>.

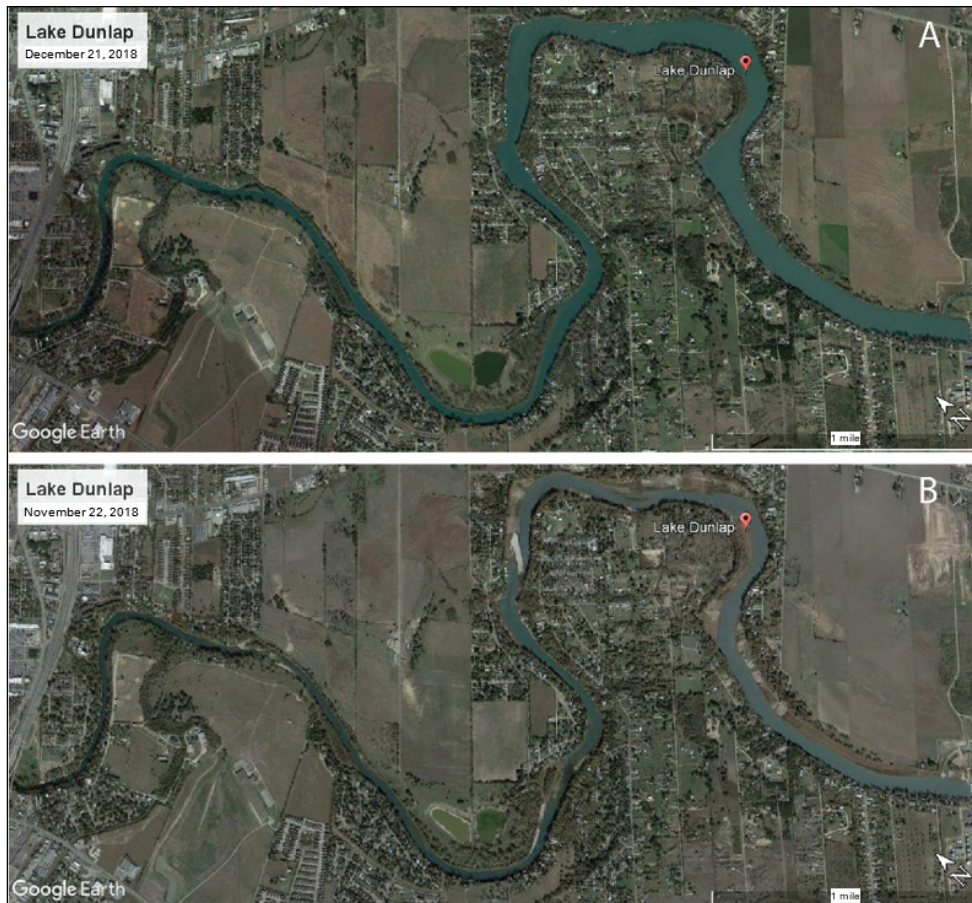
**Figure 3.** Entire lake comparison. Map depicting entirety of Lake Dunlap, Texas. Version A shows imagery from 2018, before the dam failed ([Google Earth, n.d.-a](#)). Version B shows imagery from 2019, after the dam failed ([Google Earth, n.d.-b](#)).

At approximately 7:49 a.m. on Tuesday, May 14th, 2019, the structural steel hinges of Lake Dunlap Dam’s middle gate, one of three total gates, failed—causing the total detachment of the spillgate that ejected from the dam’s concrete superstructure downstream (Black & Veatch 2019; Dascher & Meitzen, 2020; GBRA, 2019b, 2020a, 2021c, 2023b; NID, 2022; TCEQ, 2022b; TWDB, 2021). The failure event “sent flows of up to 11,000 cubic feet per second (cfs) [311 cubic meters per second] downstream, resulting in the dewatering (draining) of the lake” (GBRA, 2020a, p. 2).

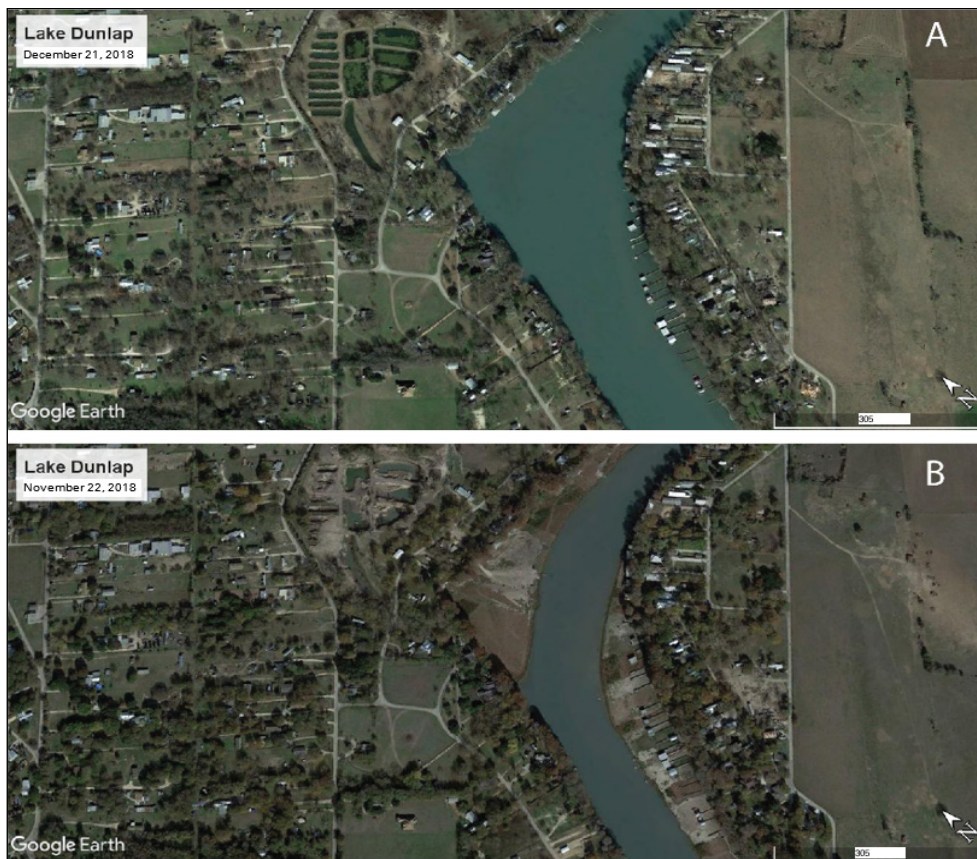
**Figure 4.** Zoomed lake comparison. Map depicting Lake Dunlap, Texas at its final bend before the dam. Version A shows imagery from 2018, before the dam failed ([Google Earth, n.d.-c](#)). Version B shows imagery from 2019, after the dam failed ([Google Earth, n.d.-d](#)).

As a result of the dam failures, the physical landscapes of multiple lake communities were significantly altered: Houses were left hanging above barren riverbanks, once peaceful porches became falling hazards, and piers and boat ramps led only to a muddy, waterless lake bed. Appraisals for real estate across entire communities tanked, and the lifestyle and business of recreation ceased. It would take years to resolve the question of responsibility, the resolution of anger, and the journey to find a solution that these communities agreed was in their best interest.

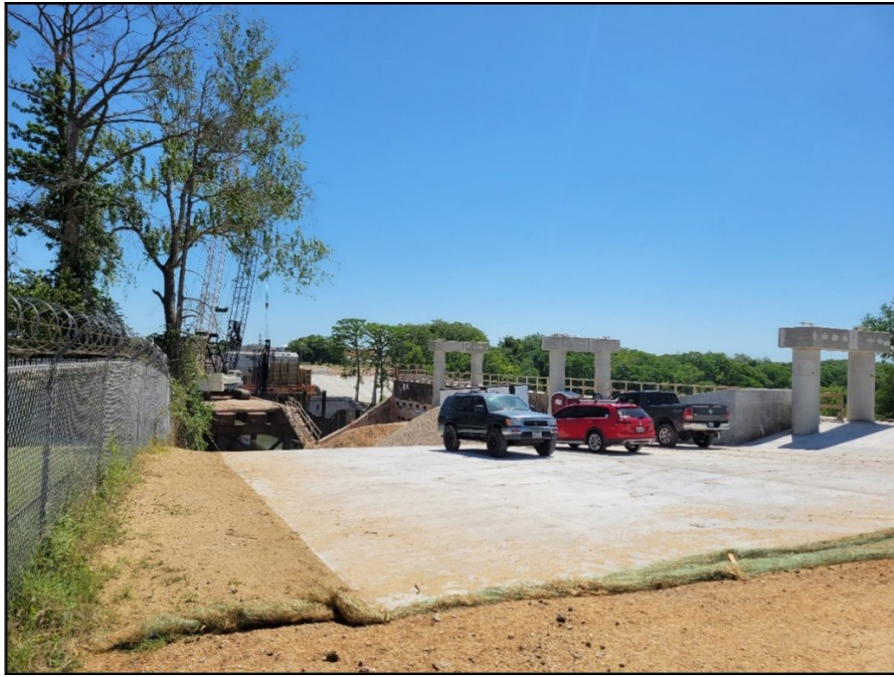
**Figure 5.** One year into the construction phase, Lake Dunlap Dam. A photo of construction on the Lake Dunlap Dam. May 26th, 2022. Photo by Andrew Adams.

GBRA initiated the construction phase to replace, rehabilitate, and update Lake Dunlap Dam in May 2021 (Figure 5; [GBRA, 2023a](#); [TCEQ, 2022b](#); [TWDB, 2021](#)). The project's estimated timeline was 24 months, pending weather events and

The construction of the new spillgate required dewatering the area below the existing concrete, excavating about 6 meters (19.7 feet) into the mud of the river channel, and installing a concrete bulkhead about 6 meters (19.7 feet) upstream to form a maintenance dewatering system ([GBRA, 2021c, 2022d](#)). While the previous design did not allow for maintenance on the upstream side of the spillgates without completely dewatering the lake, the new maintenance system includes a dewatering system that employs a bulkhead to allow GBRA to dewater the upstream area and complete maintenance ([GBRA, 2022d](#)). In all, GBRA removed numerous original dam components; structurally modified and hardened the earthen dam components; structurally modified the spillway; installed three

hydraulically actuated steel crest gates; and made upgrades to the mechanical, electrical, and safety systems (GBRA, 2023d).
