## PRESERVATION TREATMENT GUIDE FOR AMK RANCH (UW-NPS RESEARCH CENTER)

MARY M. HUMSTONE, AMERICAN STUDIES PROGRAM  
UNIVERSITY OF WYOMING ♦ LARAMIE

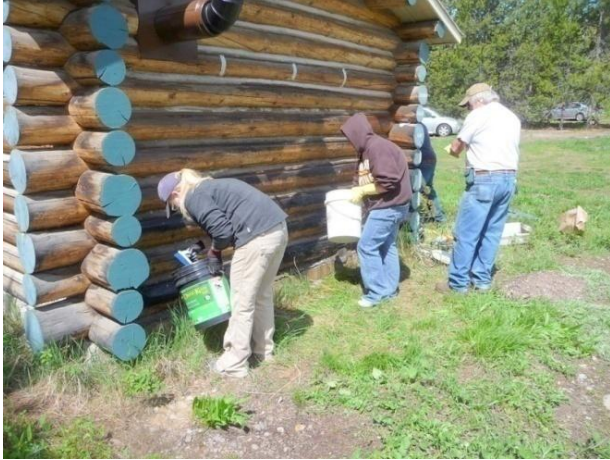
Figure 3. Students prepare a log wall for testing to compare the effects of different log cleaning techniques. (Mary Humstone, 2011)

The students conducted several experiments in cleaning the logs, using different products and different methods of abrasion. They also demonstrated proper log daubing techniques for the staff at AMK.

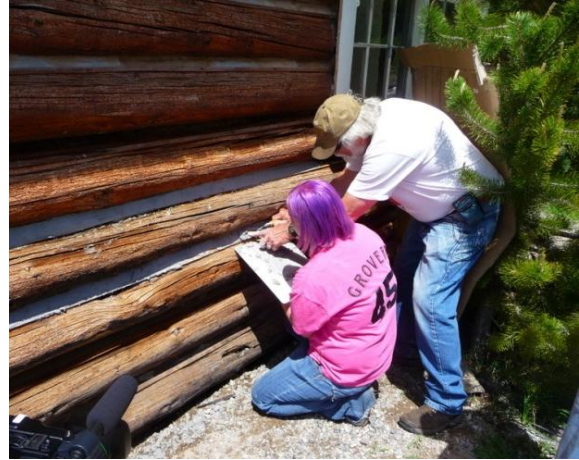
Figure 5. Harrison Goodall shows student Cassie Loveland how to apply daubing to the logs of the boathouse at AMK Ranch. (Mary Humstone, 2011)

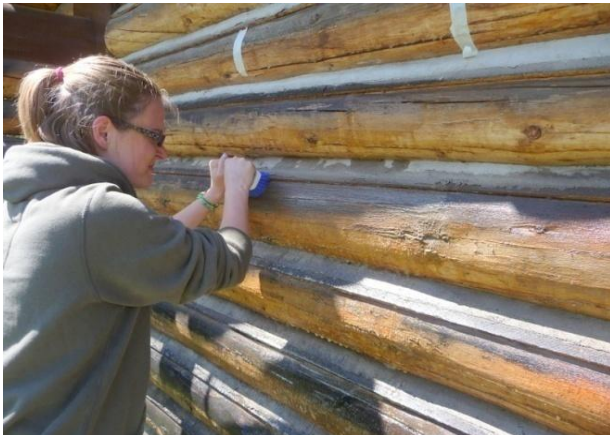
Figure 4. UW student Andrea Lewis cleans logs with abrasive brush after applying a cleaning solution. (Mary Humstone, 2011)

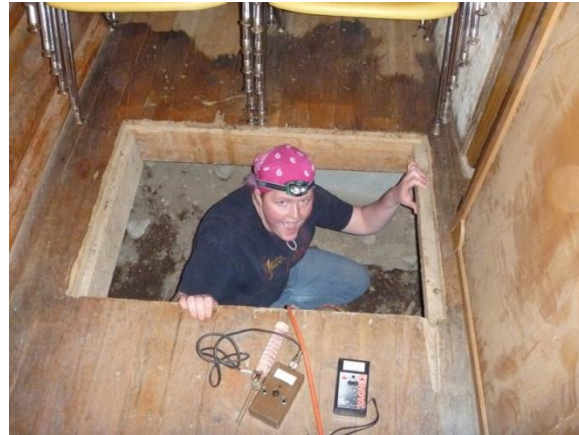
Figure 6. Student Cassie Loveland emerges after conducting moisture-level tests underneath the Berol Lodge at AMK Ranch. (Mary Humstone, 2011)
