ANALYSIS OF CORROSION PRODUCTS FROM WW2 CONCRETE BUNKERS IN CZECHIA

ABSTRACT. The paper deals with analysis of corrosion products from historic concrete bunkers which were built in the 1930's. Most of these objects evince numerous failures due to water penetration into the concrete structures. Two heavy bunkers became the target of research which was focused on chemical and biological analysis of corrosion products from concrete structures. The results showed that concrete used for two analyzed fortifications successfully resisted the long-lasting effects of chemical corrosion as well as bio-corrosion (this corrosion causes only aesthetic defects).

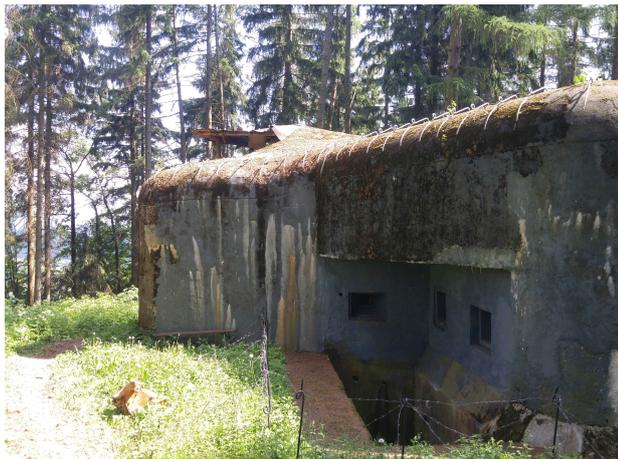
FIGURE 1. Sampling site: bunker No. T-S-20.

For the purpose of the work, 10 samples were taken. 5 for salinity and 5 for localization of mold. The probes were carried out using a disinfected spatula by scraping off the surface of the concrete walls. The sampling sites were selected to map the chemical and biological damage of two object heavy concrete fortifications. These are bunkers No. T-S-20 and No. T-S-19 (figure 1, figure 2).

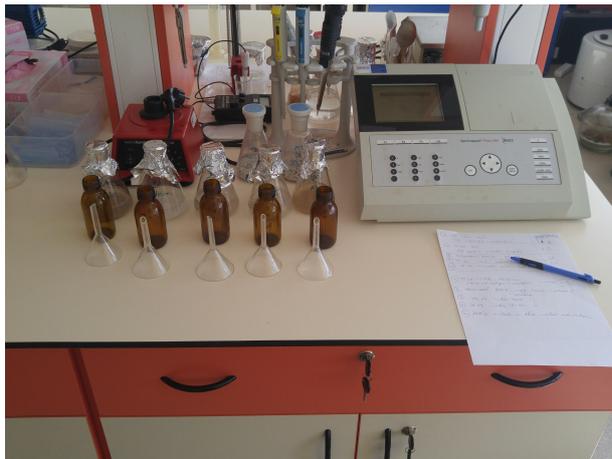
FIGURE 4. Inserting the samples into clean glass cap.

The prepared solution was sedimented for 24 hours. The portion of the sample without haze and sediment was removed using a pipette. The prepared samples were then placed in clean glass caps and prepared for further examination (figure 4).

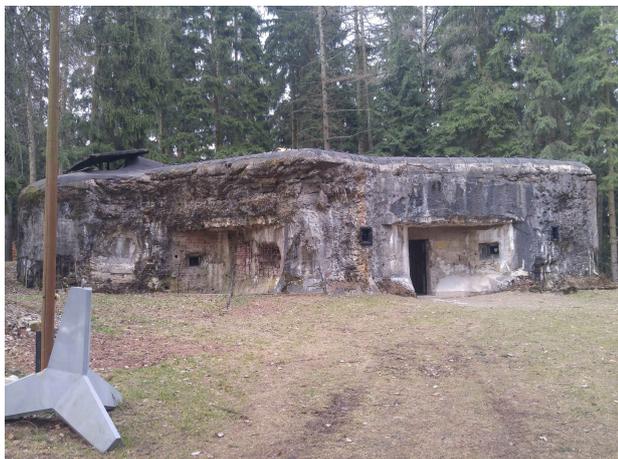
FIGURE 2. Sampling site: bunker No. T-S-19.

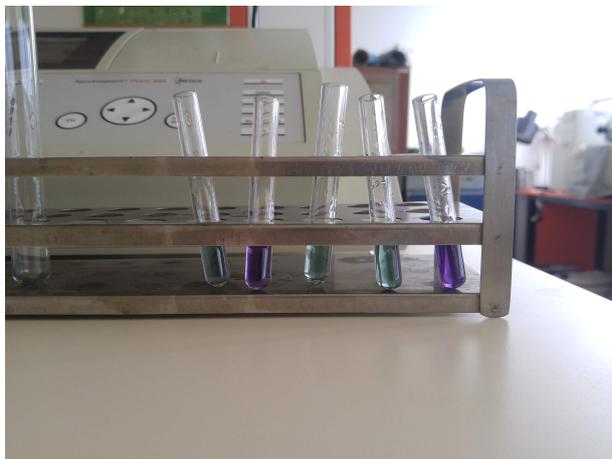
FIGURE 5. Samples with added pH indicator.

Using a pipette, 1 ml of pre-prepared sample and 3 drops of universal indicators were added to the tube. After shaking and terminating the reaction, the sample changed color. On the basis of the colorimetric reaction, the approximate pH was determined (figure 5, figure 6).

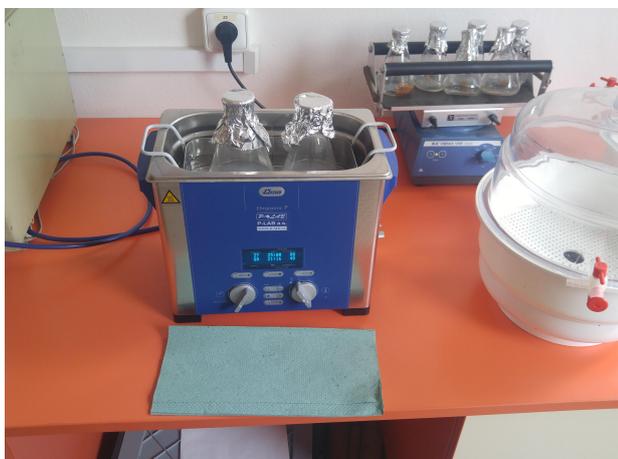
FIGURE 3. The samples are exposed to ultrasound.

A total of 5 samples of concrete from two heavy fortification buildings were tested. Most inorganic compounds are water-soluble due to their ionic structure. It is possible to detect the contents of these by using an aqueous solution. The salinity evaluation was started by weighing 2 g of the crushed sample into the Erlenmeyer flasks. After addition of 100 ml of distilled water, the flasks were transferred to an electric cooker, where they heated to boiling point and then subjected to ultrasound. This step resulted in the fragmentation of individual parts (figure 3).

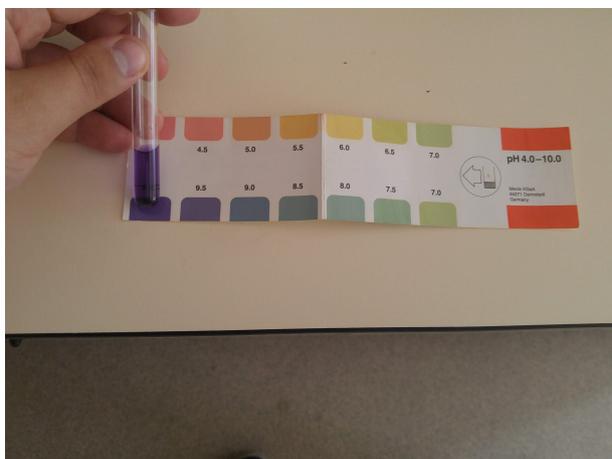
FIGURE 6. Colorimetric evaluation of pH by color and scale.

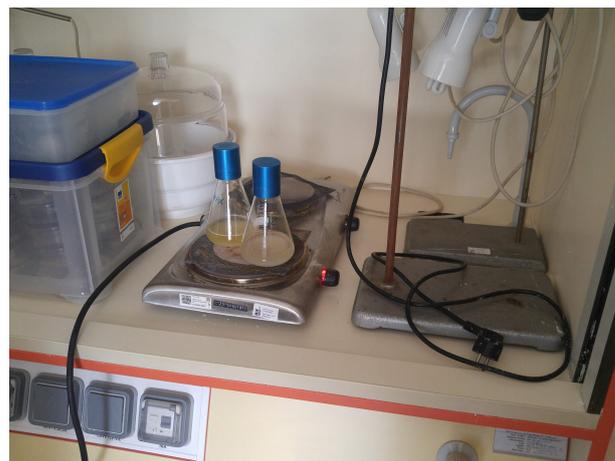
FIGURE 7. Heating the agar solution on an electric cooker.

were mixed and heated with 200 ml of distilled water (figure 7). The prepared agar solution was sterilized in an autoclave for exactly 20 minutes at 120 °C and pressure 100 kPa (Figure 8). To the clean, sterile Petri dishes, about 3 mm thick solution was poured and quickly covered to prevent contamination from outside. It is then possible to transfer specimens to the solid solution. Samples were cultured in a thermostat at 22 ± 3 °C for 2 weeks. The mold appeared in all 5 samples (Figure 9, Figure 10).

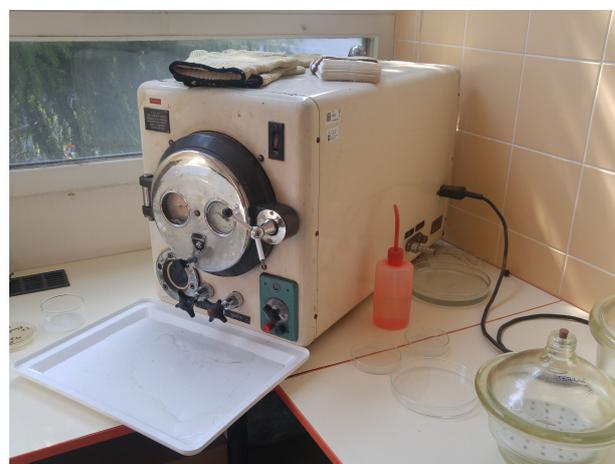
FIGURE 8. Used sterilization device.

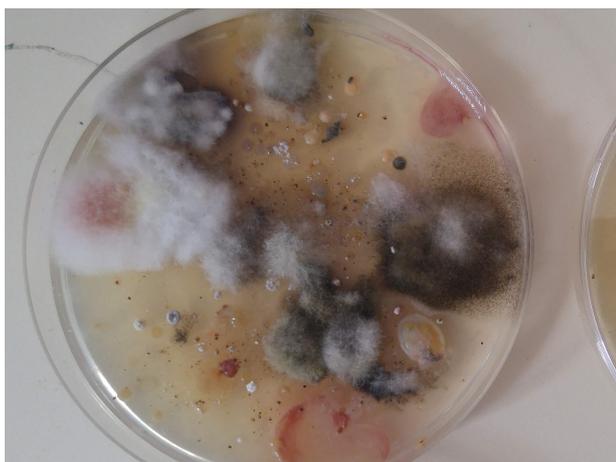
FIGURE 9. Mold on sample number 1.

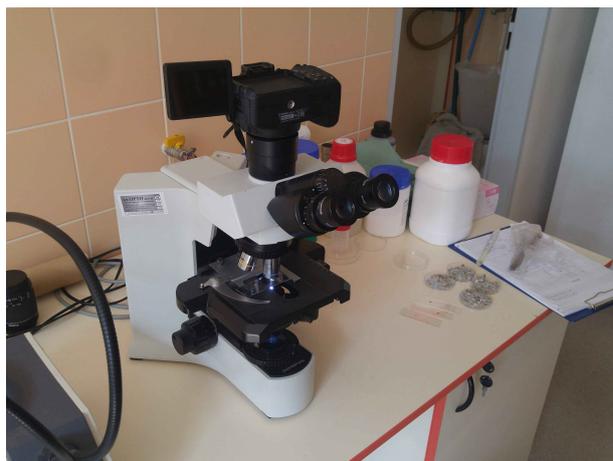
FIGURE 11. Observation of mold samples by microscope.

The mold sample was transferred to the glass slide. Then it was folded over the glass cover and viewed under a microscope with magnification of $\times 40$ and $\times 100$ (Figure 11). After consultation with the microbiologist, 6 species of mold were identified and identified. *Alternaria alternata*, *Fusarium culmorum*, *Trichoderma viride*, *Cladosporium herbarum*, *Phoma eupyrena* and *Penicillium* (Figure 12 – Figure 14).

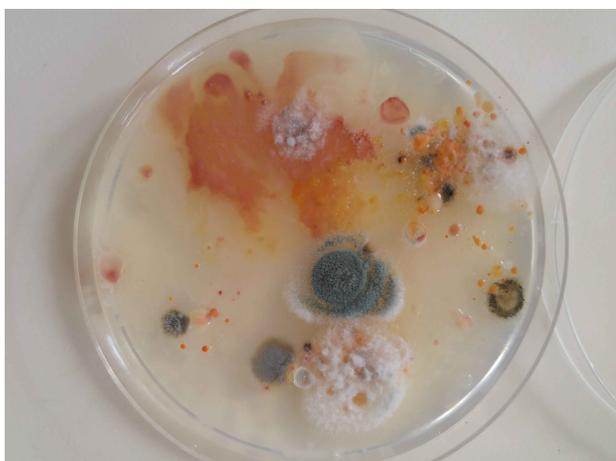
FIGURE 10. Mold on sample number 2.

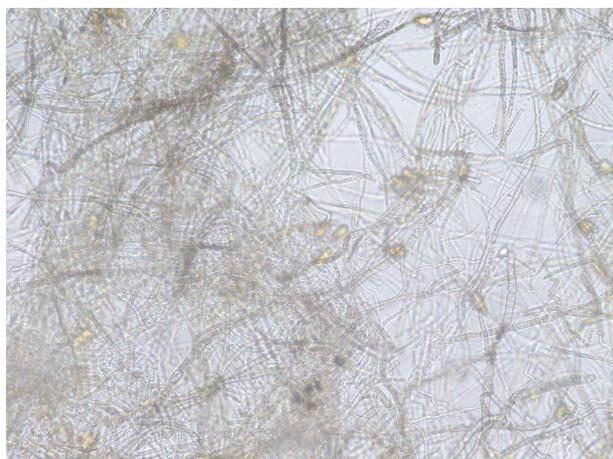
FIGURE 12. Alternaria alternata.

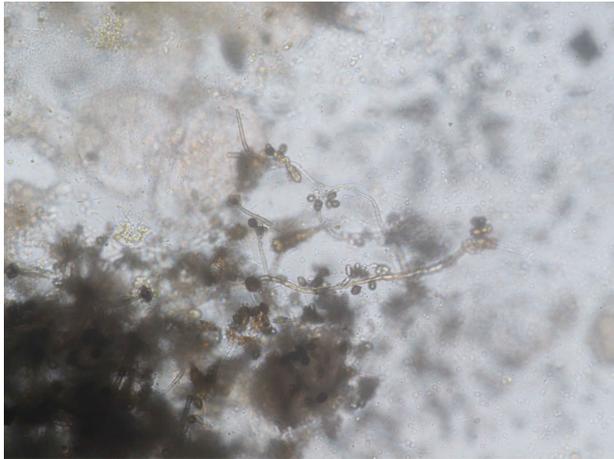
FIGURE 13. Cladosporium herbarum.

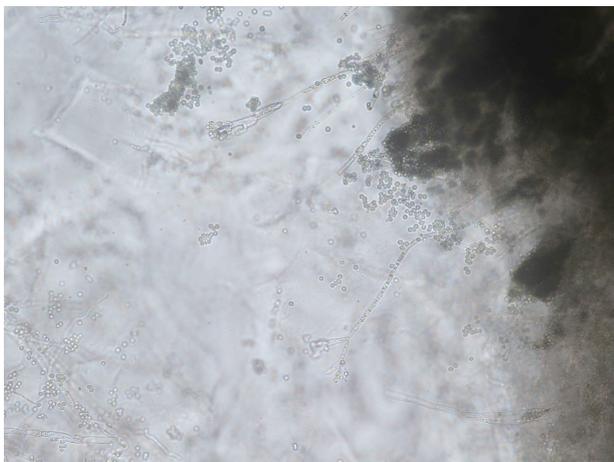
FIGURE 14. Penicillium.
