PREPARATIONS FOR REMEDIATION OF A FORMER SURFACE MINE – A TECHNICAL RECLAMATION AREA

ABSTRACT. The reclamation area for secondary float energy by-products is located on a spoil heap, 45 m thick and 30 years old, and consists mostly of clay stone with high plasticity. When depositing a first 18 m high stack, it was necessary to verify stability and to analyse deformations during the reclaiming operation. Stability and deformation depend on the shallow groundwater level. Therefore, it was necessary to propose a technical solution for drainage of the structure concerned. This can be divided into two parts: drainage of surface water and drainage of the shallow underground water. It means a complex solution for the entire construction that would not be possible without long-term monitoring of the construction and field mapping. Completion of the proposed facilities will increase the stability of the reclamation area and it will then be possible to continue with remediation of the former surface mine.

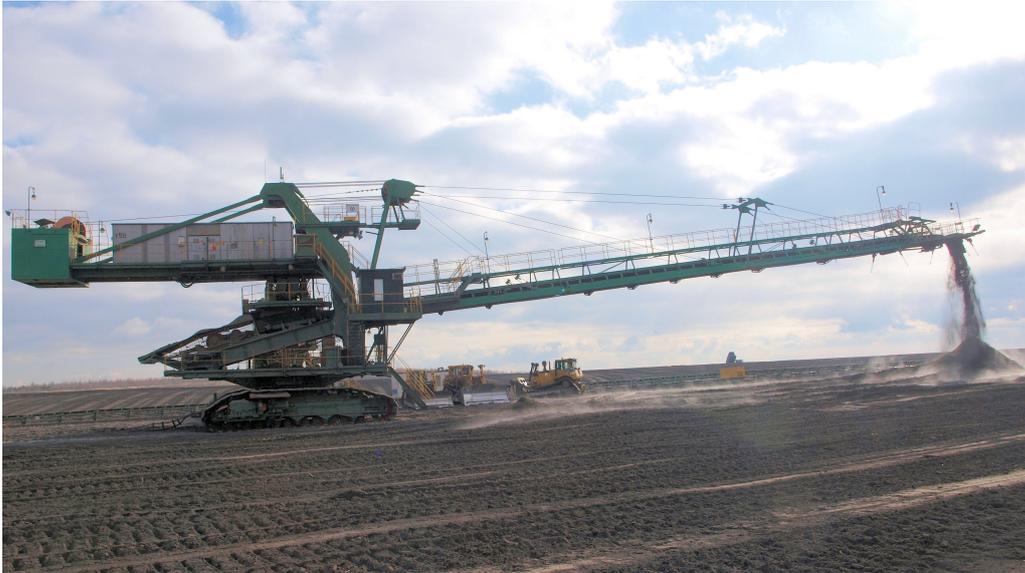
FIGURE 1. Stacking the deposit material in the technical reclamation area using a belt stacker.

The technical reclamation area is used in order to deposit energy by-products, specifically power plant fly ash mixtures, energy gypsum and other deposit materials. The depositing activities started in 1996. The materials are deposited with a belt stacker (Figure 1)

– a PVZ2500 crawler wagon with a boom length of up to 45 m and a total specified weight of 350 tons. The tripper car (weight 63 tons) supplying the stacker with material from the conveyor belt and the cable drum car (69 tons) that supplies power are essential parts of the material stacking technology. Subsequently, the material is shaped and compacted by a bulldozer.

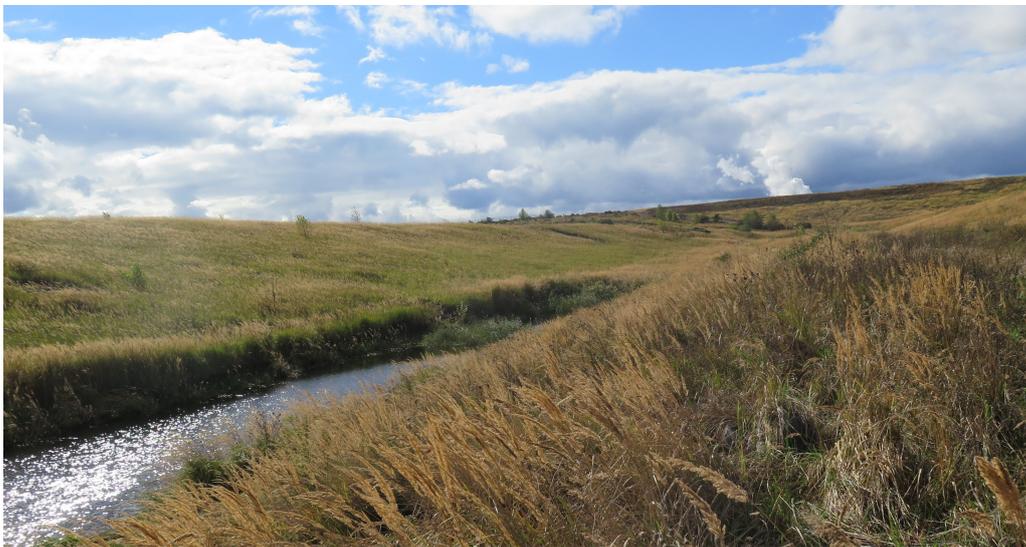
FIGURE 3. Waterlogging as a result of clogging or absence of surface drainage.

From the above, the necessity arose of detailed mapping of the technical reclamation area with a focus on the current state of the surface waterlogging and drainage of the structure. The reconnaissance of the area of interest included a precise geodetic survey of significant hydrological elements and phenomena. During the fieldwork, concrete troughs were found to be clogged (with a layer of mud up to 40 cm thick) in many places, or entirely missing. In some places, undesirable aquifers thus formed (Figure 3). Surface water and rainwater from the mine service road should be channelled through an open ditch to the existing accumulation sump in the eastern part of the area of interest; however, the ditch is blinded and hence not functional.
