Lessons Learned by the Strong Local Earthquake at the Petrochemical Plant

On 11 and 12 April, 2011, unexpected strong local earthquakes stroke petrochemical plants in Fukushima Prefecture. That local earthquake is caused by the old active fault near the plant activated by the Great East Japan Earthquake. The plants were attacked by the Great East Japan Earthquake, and all facilities of the plant had been stopped since 11 March, 2011. In spite of having received twice earthquakes (especially the bigger second local earthquake), damages of main facilities of the plant were little. The investigation team constituted by specialists of material safety, plant engineering and engineers of that petrochemical company, searched the damage of the facilities and emergency response, and recovery efforts. We summarized the lessons learned from the large earthquake of the chemical plant, related with the emergency correspondence and its organization, support for surrounding, recovery and reconstruction program, etc.

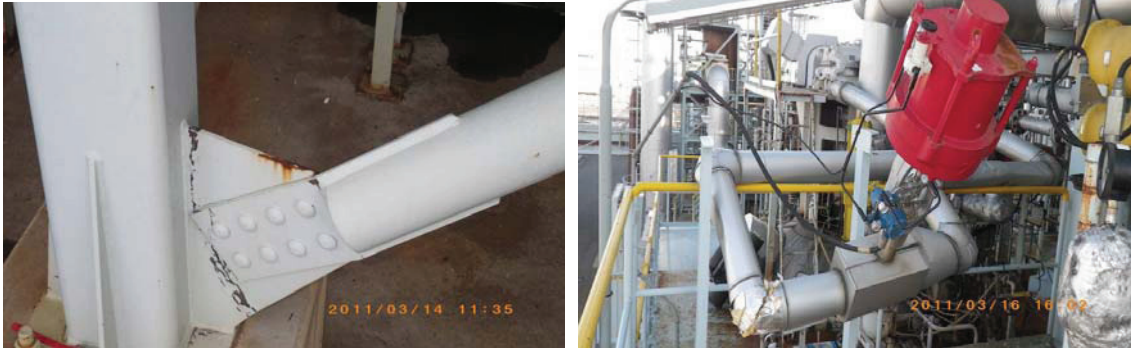
Figure 1 Damage to column base braces and detachment of pipes and automatic valves

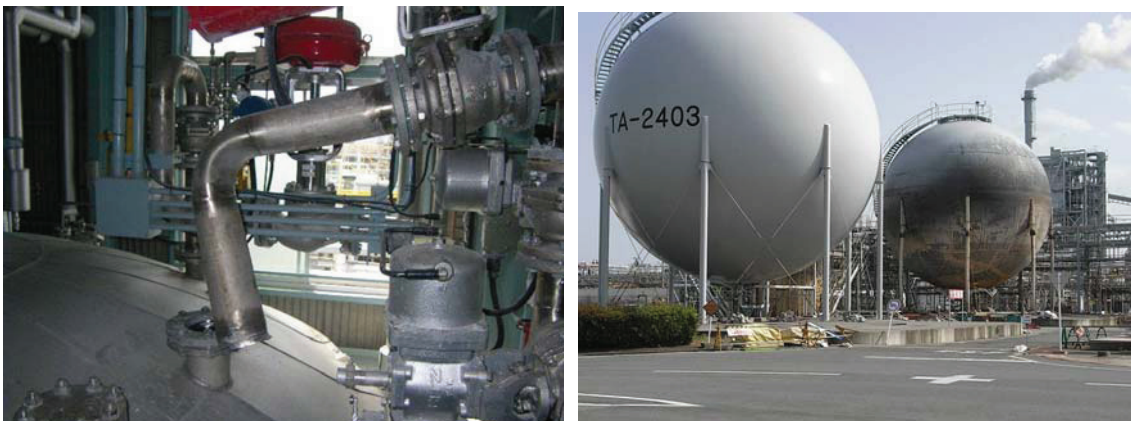
Figure 2 Damage to pipes in the upper section of a container and a hydrogen pipe holder due to pipe damage

- Securing of utilities, particularly nitrogen gas and water supply, is important.
- It is necessary to expedite seismic reinforcement and countermeasures for aging facilities.
- It is necessary to increase the frequency of inspections of safety valve effectiveness.
- It is necessary to consider measures to maintain refrigeration for catalytic chemicals requiring cold storage (organic peroxide).
- It is necessary to review the emergency communication network for contacting employees.
- It is necessary to consider alternate means of communication (such as satellite telephony) in cases where mobile phones and wireless communication fail.
- Imagine emergency scenarios and re-examine risks.
- Since boiler pipe damage was apparent, consider earthquake countermeasures for boiler pipes.

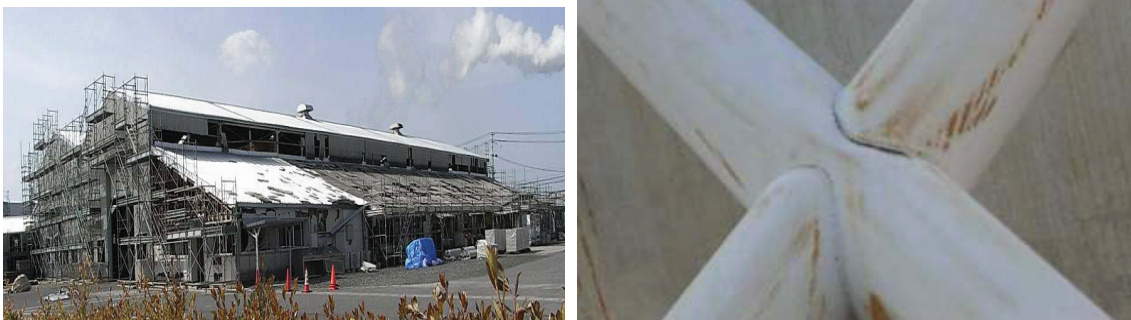
Figure 3 Damage to exterior walls and glass windows from a hydrogen explosion and the steel pipe brace welds of a 2,000 t tank

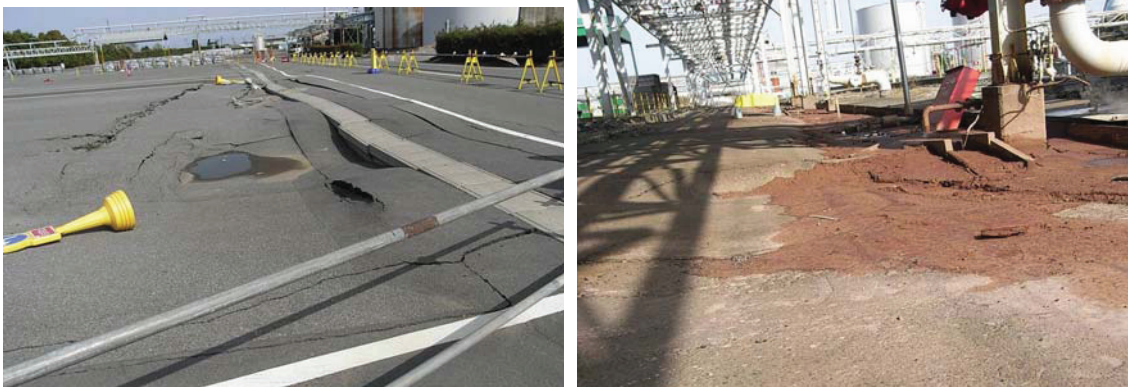
Figure 4 Road caving due to liquefaction and road subsidence below pipe racks due to liquefaction (no damage on the pile foundation pipe racks themselves)

However, in view of the tendencies found in the damage situation from these earthquakes concerning plant piping, tank foundation, and liquefaction and uneven settling of the ground in particular, earthquake countermeasures should be reinforced. Factors such as the importance of the facilities and the dangerousness of the substances handled should be taken into consideration. Additionally, vibration countermeasures such as methods for pipe repair and support should be reviewed taking earthquake-resistant design, configuration, and strength into account.

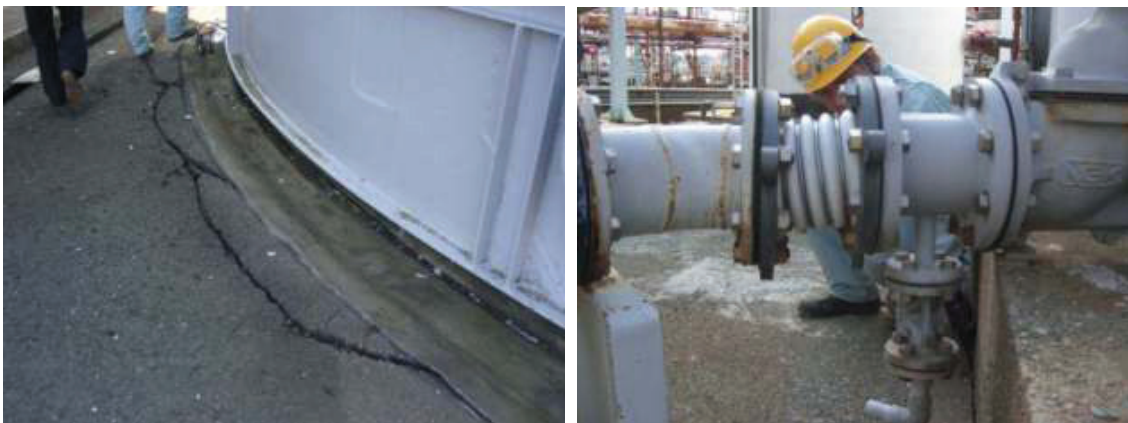
Figure 5 Uneven settlement of the base of a 2,000 kL heavy oil tank and pipe stress due to uneven settlement
