Corrosion behavior of Shape Memory Alloy in NaCl environment and deformation recovery maintenance in Cu-Zn-Al system

ABSTRACT. Shape memory effect (SME) and the relation with corrosion behavior of Cu-Zn-Al Smart Memory Alloys (SMAs) were investigated using different techniques: Scanning Electron Microscopy equipped with an Energy Dispersive System, X-Ray Diffraction analysis, Electrochemical Test in NaCl solutions with different concentrations (0.035%, 0.35% and 3.5%), which simulate coastal conditions, mechanical characterization through tensile test and guided bend test.

Citation: Brotzu, A., De Filippo, B., Natali, S., Zortea, L., Corrosion behavior of Shape Memory Alloy in NaCl environment and deformation recovery maintenance in Cu-Zn-Al system, *Frattura ed Integrità Strutturale*, xx (2022) 64-74.

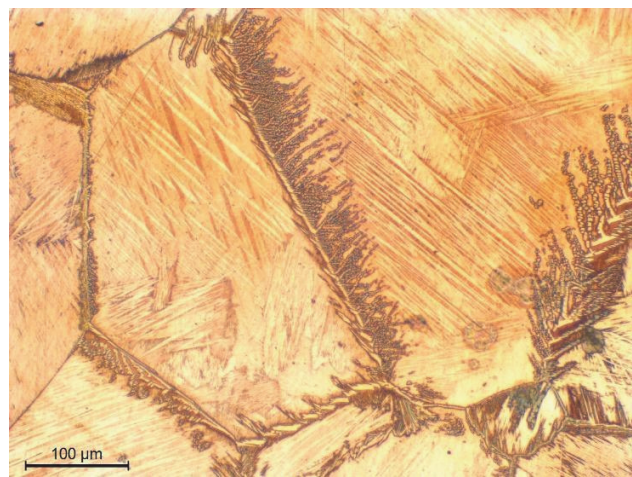
Figure 2b: Alloy microstructure after ferric chloride metallographic etch coarse-equi-oriented needle microstructure.

Microstructural analyses were carried out on several specimens. Fig. 2a shows the microstructure of tested alloy, where a relative coarse grain structure can be observed. These grains are characterized by an internal needle-like structure typical of martensitic phases. Some austenitic areas are also detected. On the grain boundary a secondary phase can be observed (Fig. 2b), in these areas coarse equi-oriented needle microstructures appear. They grow from the boundary to the center of the grain, always with the same inclination/orientation. The EDS microanalysis carried out on these secondary phases doesn't point out any difference with the composition of the central area of the grain. Their low quantity and their reduced dimensions don't allow to define which kind of phase they could be. In previous works it has been observed that these microstructures tend to disappear with a homogenization thermal treatment which is usually done to reduce the amount of residual austenite and to consequently maximize the shape memory effect. This treatment generally consists in heating the material at a temperature where it is fully monophasic (β phase). Considering the Zn equivalent of the studied alloy (39.5%w) and the Cu-Zn phase diagram, it is fully β at temperatures above 800 °C. The heat treatment time depends to sample thickness. The time must be the shortest possible to avoid an excessive enlargement of the grain. After heating the alloy can be cooled at different cooling rate (air cooling, quenching in hot, cold or ice water, liquid nitrogen quenching). In the previous work a temperature of 850°C has been selected followed by liquid nitrogen quenching. This heat treatment maximizes the quantity of martensitic phase and the second phase observed at the grain boundary disappears. This microstructure is confirmed by the XRD analysis (Fig. 3). The diffractogram shows a great number of peaks just observed in previous works [8, 13-15] on Cu-Zn-Al SMA alloys. Almost all are those of the martensitic structures. Only the highlighted peak can be referred to the austenitic phase. Tab. 1 shows the relative chemical composition of the material.

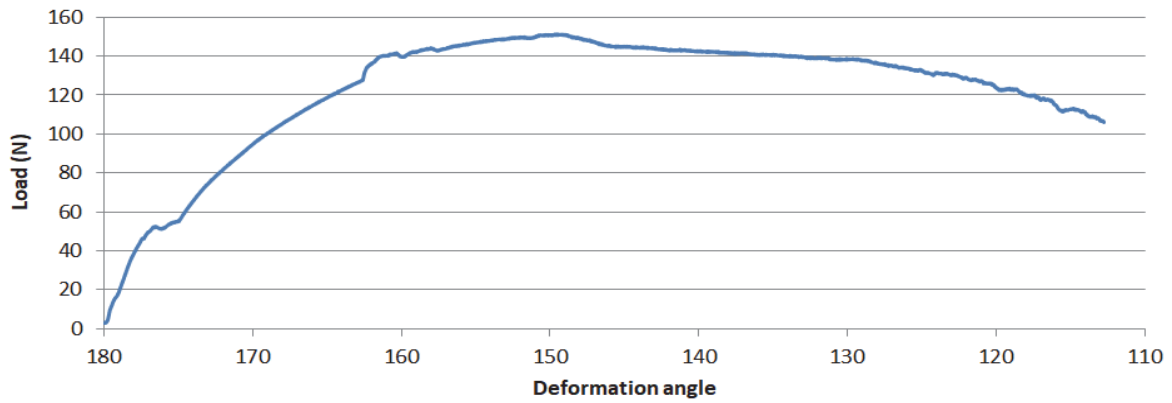
Corrosion effect on shape memory strain recovery was determined using a specially designed bending test described in Section “Experimental - Mechanical Characterization”. Fig. 8 shows the typical bending test plot where load is reported as function of deformation angle (proportional to plunger shift). The reported plot was obtained on an uncorroded sample with a maximum plunger shift of 9 mm. In Fig. 9 the results of the cyclic bending test carried on a corroded specimen were reported. The corrosion damage was obtained using a potentiostatic test as described in Section “Experimental-Mechanical characterization”. Diamond points indicate the specimen deformation angles under load. They indicate the maximum deformation applied to the specimen and are basically constant and increase only when the plunger shift is increased. Square points show the deformation angle measured when the load is removed. They indicate the residual deformation after the elastic recovery. A little increase in the residual deformation is observed during the first cycle. After cycle 8° residual deformation remains almost constant (see square points) and it increases only when a higher plunger shift is applied. Triangle points show the residual deformation after the shape memory recovery, obtained through a heat treatment at 70 °C for 1 minute. It can be noted that the shape memory recovery significantly decreases during the first ten cycles; the final residual deformation angle decreases from 169° measured after the first cycle to 155° measured at cycle 10. Then it slowly decreases up to the last value of 135° measured after 75° cycle with plunger shift of 7 mm.

Figure 8: Typical guided bending test plot obtained on a not corroded specimen.

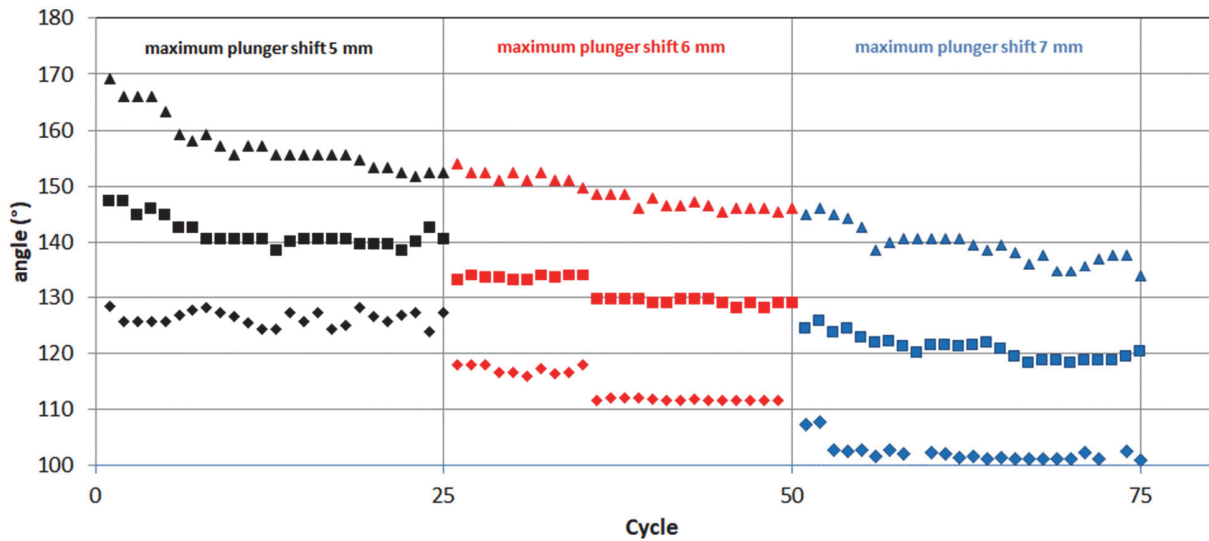
Figure 9: Cyclic guided bending test results on a corroded specimen \blacklozenge deformation angle under load, \blacksquare deformation angle without load (elastic recovery) \blacktriangle residual angle deformation after heating at 70 °C for 1 minute (shape memory recovery).

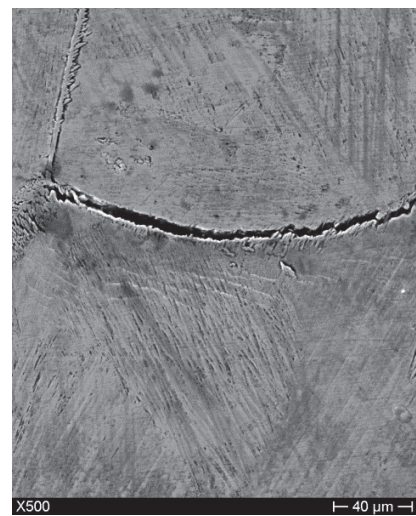
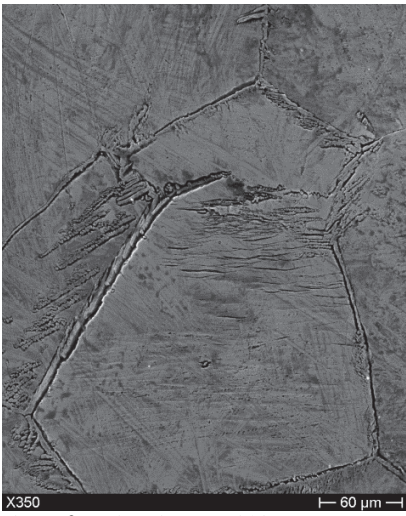
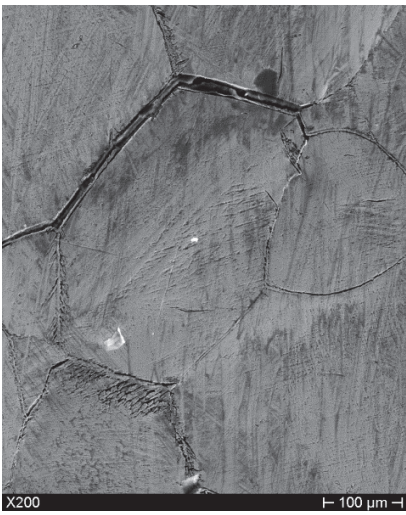
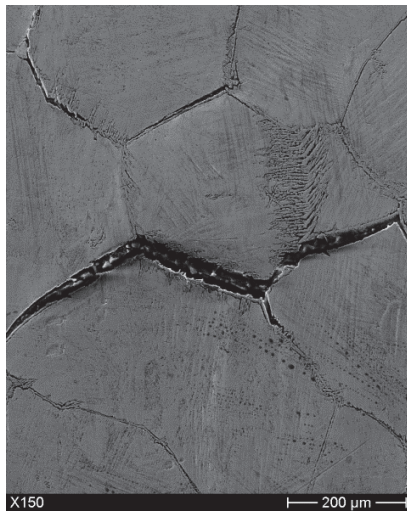
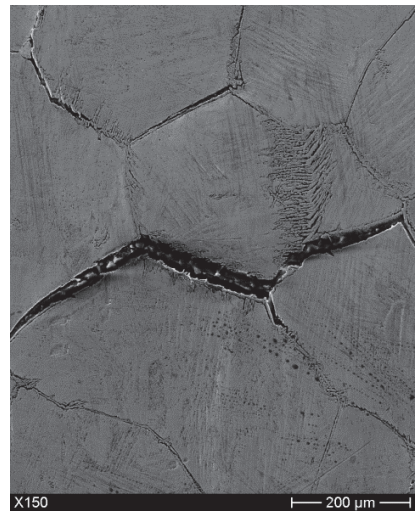
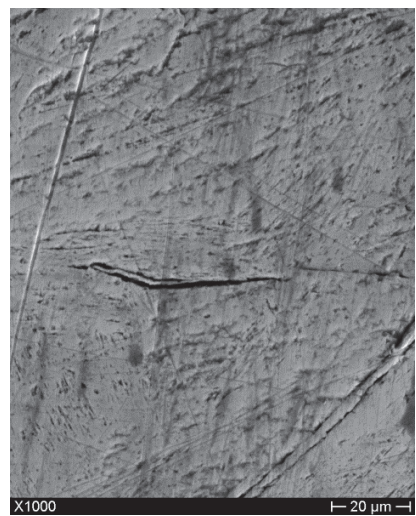
The effect of the corrosion damage can be better evaluated through SEM observations of the tensile subjected surface carried out after the bending test and before the shape recovery treatment (Fig. 10). The potentiostatic test resulted in a surface damage mainly located along the microstructure grain boundaries. In these areas the material surface appears hollowed and the second phase, observed often in Fig. 2, is highlighted. The mechanical deformation produces some cracks at the grain boundary starting from the corroded areas. These cracks do not grow with the cyclic mechanical deformation/shape recovery. They increase in number and length only when the mechanical deformation is increased with the application of a higher plunger shift.

Damage signs appear also inside the grain, both as little cracks with a particular V-shape and as well as little voids (see Fig. 10 – i and k). In this case their length do not grow as a function of cycles, but only their quantity.

Figure 10: SEM observations of corroded surfaces after mechanical deformation (tensile stressed surfaces).

- The effect of corrosion damage on the shape memory alloy is investigated with potentiostatic test and its effect is mainly located in the microstructure grain boundaries. This effect is then compared with cyclic mechanical deformation/shape recovery. The crack produced by mechanical test didn't grow with the cycle applied but only with the application of higher plunger shift. This doesn't imply that the previously damaged SMA exposed to an aggressive environment with or without a superimposed mechanical solicitation can lead to the structural failure of the material.
