REHABILITATION OF DAMAGE REINFORCED CONCRETE COLUMNS

Dr. Adnan S. AL-Kuaity
College of Engineering
University of Kufa

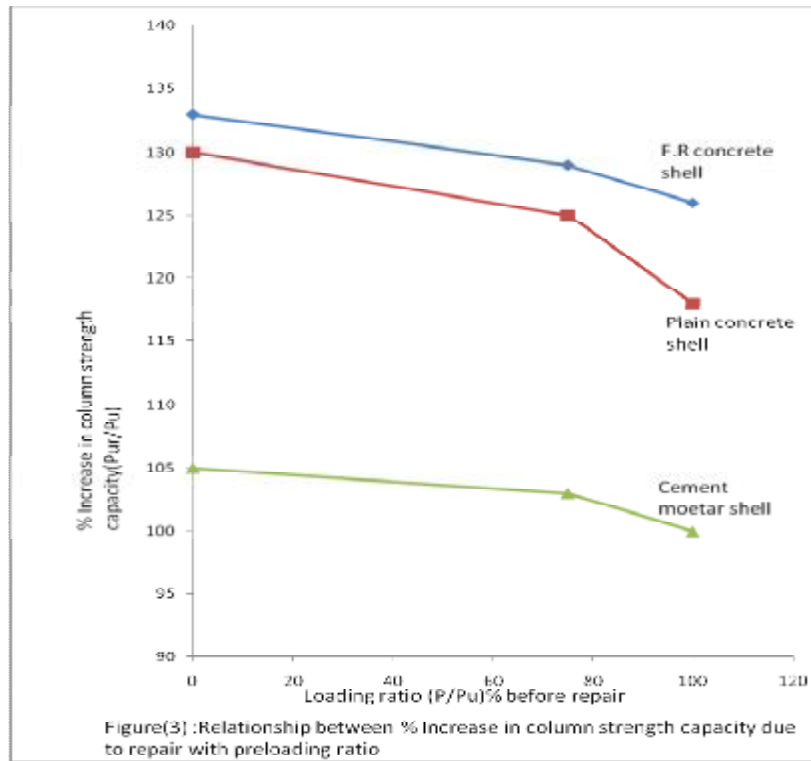
percent of increase in failure load
(Pur/Pu)%

Figure:(3) shows that there is a slight consistent decrease in the relative spalling load ($P_{ur}/P_u \times 100$) due to increase in the relative preloading percentage (P/P_u). Such behavior is similar for the three types of repairs(plain concrete, fiber reinforced concrete and cement mortar). The decrease in the relative spalling load is ranging between about 5% in columns repaired by cement mortar to about 10% in columns repaired by plain concrete. This decrease may be attributed to the effect of restrained shrinkage in the new shell besides the effect of preloading on the original core.

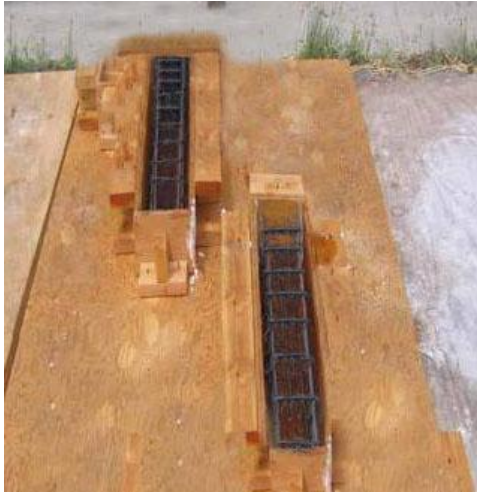
Figure (5) : Forms and steel reinforcement of test specimens

In order to insure good repairing and to restore the original strength capacity of damage column, plain concrete with high compressive strength was used to replace cracked shell. The average thickness of new shell in the specimen tested here is about 25mm as shown in **FigureL.1)**. The average compressive strength of about 45.8N/mm^2 was used in this group. The proportion of concrete mix used for repair was 1 cement : 1sand : 1.5 gravel (by weight) with maximum size 6mm. Water-cement ratio in this mix was 0.37 .To increase workability ,water reducing agent (Feb-flow) was added to the mix by amount of 2.5 kg/m³. Details of test specimen are shown in**Figures: (5),(6),(7)**.

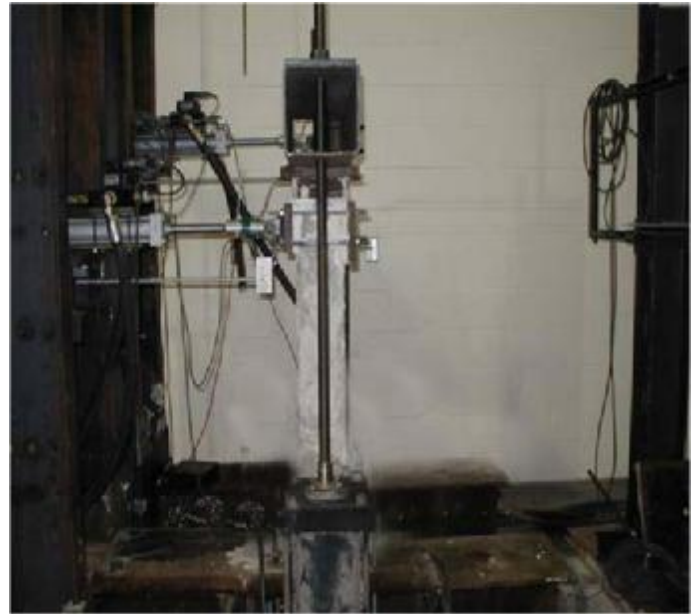
Figure (6) : Experimental setup of test specimen

All columns were tested concentrically after repair **Figures:(6),(7),(8),(9),(10)**. The test results are given in **Table(1)**. During tests, the compressive strain was measured at each load increment until the concrete shell started to crack. The average value of test results of each couple of columns were recorded. The load concrete strain curves for repaired columns, (loaded to cracking load before repair), are shown in **Figure: (2)**.

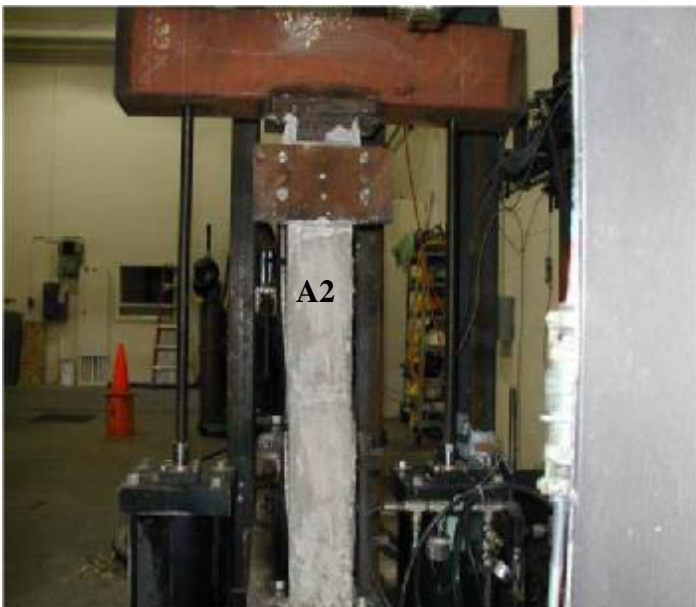
Figure (7) : Typical specimen (A2) under loading

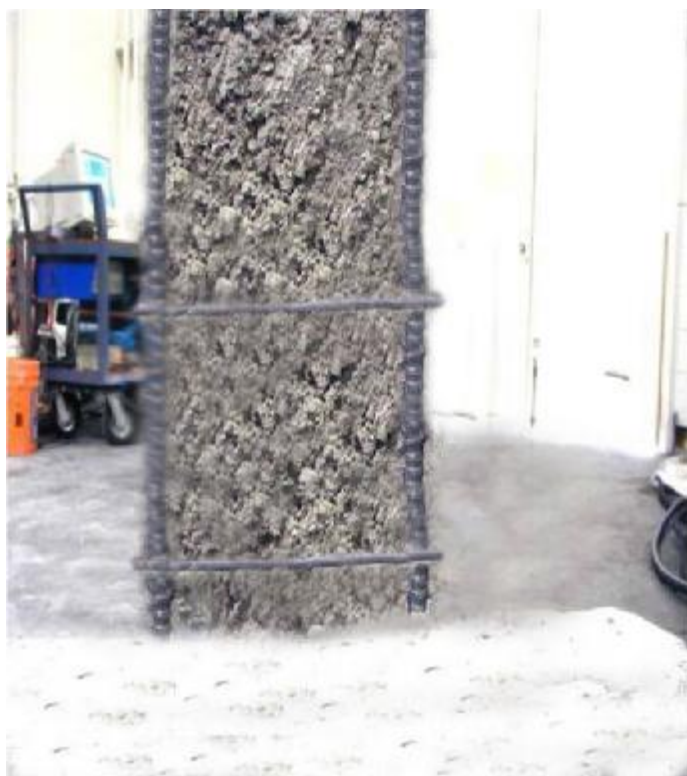
Figure (9) : Removing of cracked shell of specimen A2

However, group (A) consist of six identical basic columns which belongs into three couples. The first couple were loaded concentrically to the spalling load and it is stopped when the outer shell started to spall off. This load is considered to represent about 100% of the ultimate load. The second couple were loaded in similar way to about 75% of the ultimate load. These types of loading are called preloading in this investigation. The third couple have been left without loading (0%). Then the outer shell of all columns were removed **Figure:(9)]** by chisel making the concrete surface rough with a full amplitude of approximately 5mm.
