The investigation of avalanche patterns on railroad tracks with steep slopes

Lusmeilia Afriani* and Iswan

Civil Engineering Department, Universitas Lampung, Bandar Lampung, 35145, Indonesia

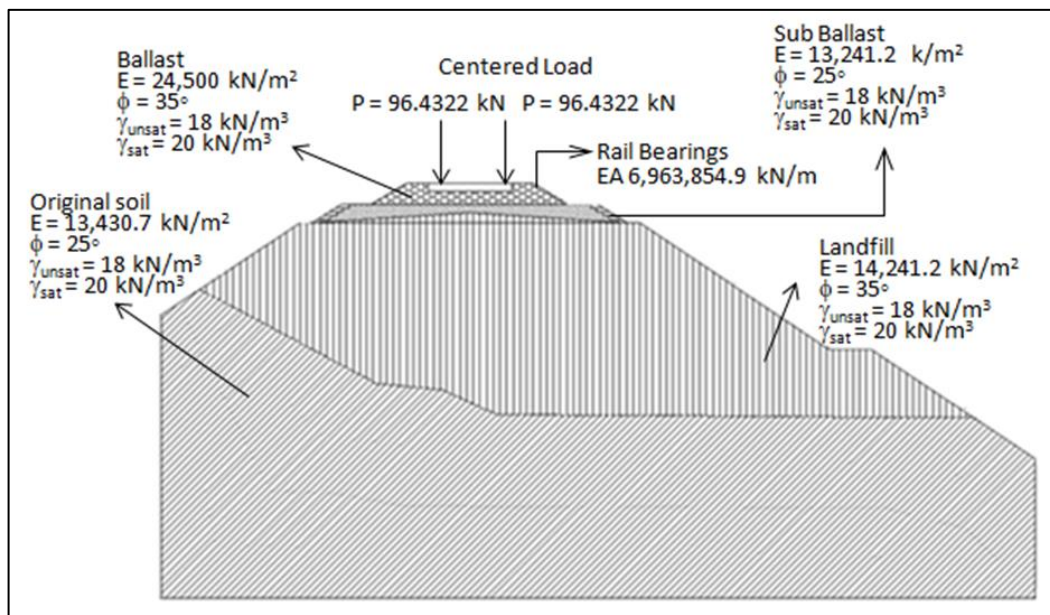
**Figure 3.** Force distribution in the cross section studied

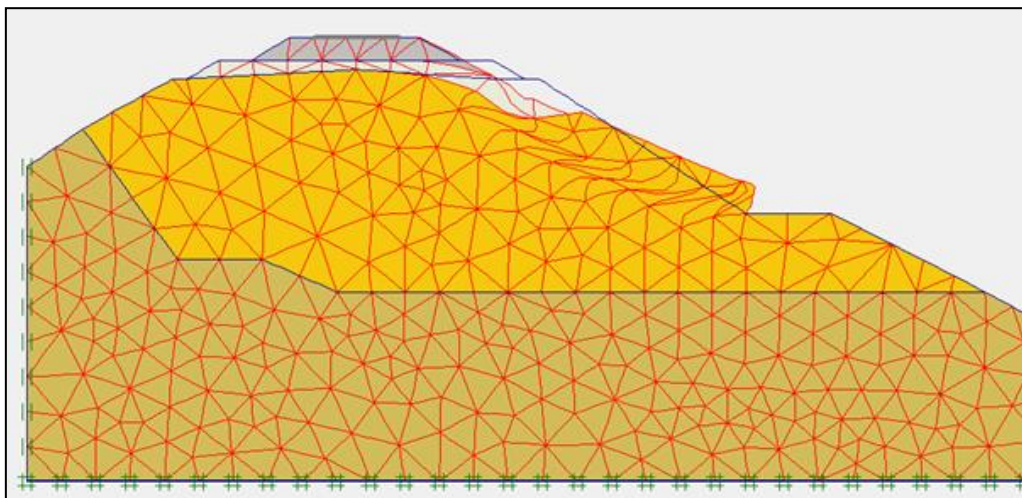
Figure 4. Figure network of deformed elements in the unsaturated condition of the railroad structure which is located at STA 30 + 250

Figure 4 is a display of the results of the deformed element network in the unsaturated condition of the railroad structure which is located at STA 30 + 250. The red grid color is the element distribution that occurs after a stretching analysis of the element density due to the effect of sloping soil displacement on the embankment soil. There was a change in the shape of the sloping soil position on the right side of the embankment in the conditions after analysis, on the sloping part of the embankment there was a temporary settlement. In the cross section of STA 30 + 250 there is a deformation of 1.25 m. The greater the deformation value, the greater the likelihood of landslides due to soil deformation occurring on sloping land, both vertically and horizontally. The amount of deformation is influenced by the magnitude of the slope angle of the embankment soil and the height of the soil slope itself.

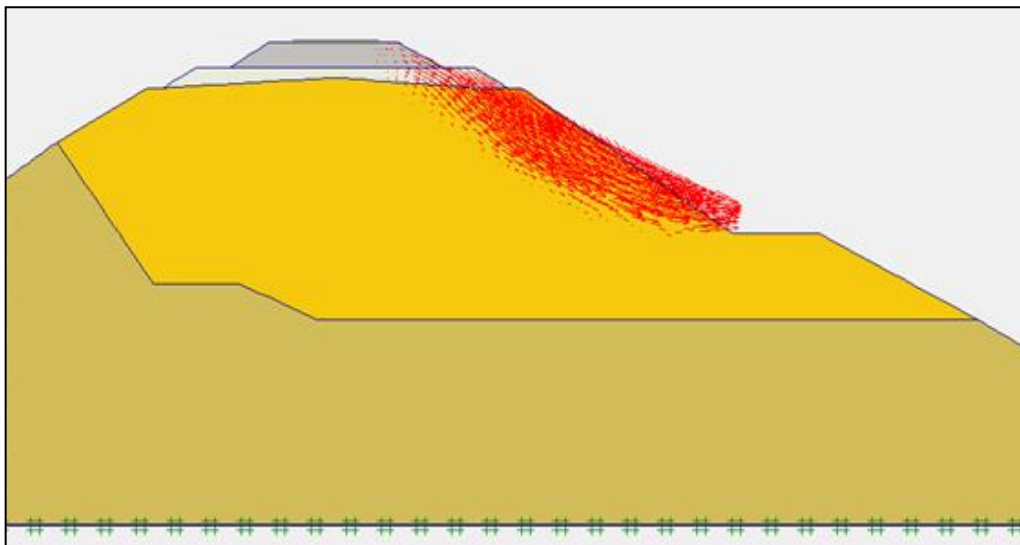
Figure 5. Total soil displacement due to landslides

The illustration of total soil displacement shows the effect of two directions of soil displacement, both horizontally and vertically. There are two directions of arrows that move vertically and horizontally. Soil displacement that occurs is indicated by the largest arrow and the direction as shown. The total soil extreme displacement value at STA 30 + 125 is $1.25.10^3$. The total soil displacement is obtained at 1.25 m.

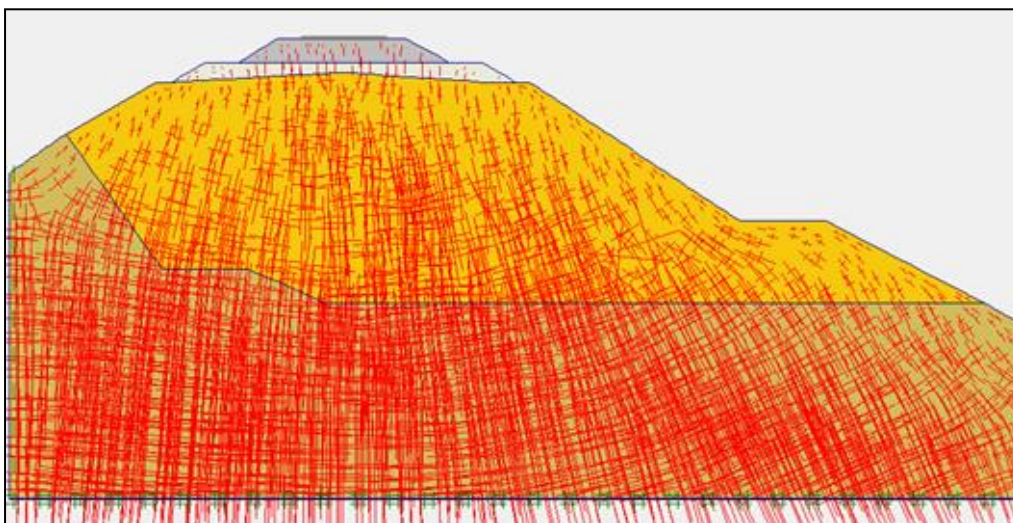
Figure 6. Effective stress illustration

The illustration of the effective stress shows the amount of effective earth stress that occurs at the cross section of STA 30 + 250. Effective stress affects shear strength and changes in volume or soil subsidence that occurs on sloping soil. The deeper the soil, the greater the effective soil stress that occurs. This is indicated by the red density element. The denser the elements, the greater the effective soil stress that occurs. In this condition, the maximum effective stress value is -156.97 kN / m². The negative sign at the maximum value indicates the pressure on the soil particles. The greater the value of the effective soil stress that occurs, the better the condition of the soil particles in providing bearing capacity for sloping soil landslides on the landfill. From the calculation results, the unsaturated sloping soil conditions studied had a safe factor (Fk) value of 1.19, or were in a critical condition (Fk <1.25) for collapsed. Therefore, retaining walls for supporting soil must be installed on steep soils so that the safety factor value reaches a value of more than 1.25 and the construction is safe against landslides.

In overall, in the analysis for STA 30 + 250, it was found that the value of the soil safety factor was <1.25. This means that the soil condition is in a critical condition for collapse. This situation states that the ground will experience landslides which can endanger the safety of the passing trains. For this reason, improvements are needed in the soil that will experience landslides such as the installation of retaining walls, flat sheet piles, steel sheet piles and soil geometric changes on steep slopes.
